# Peer | King Surveyors

## LEVEL 3 Your Survey Report

Property Address 42 Any Street  
Norwich  
NR1 1AA

Inspection date 14 October 1066

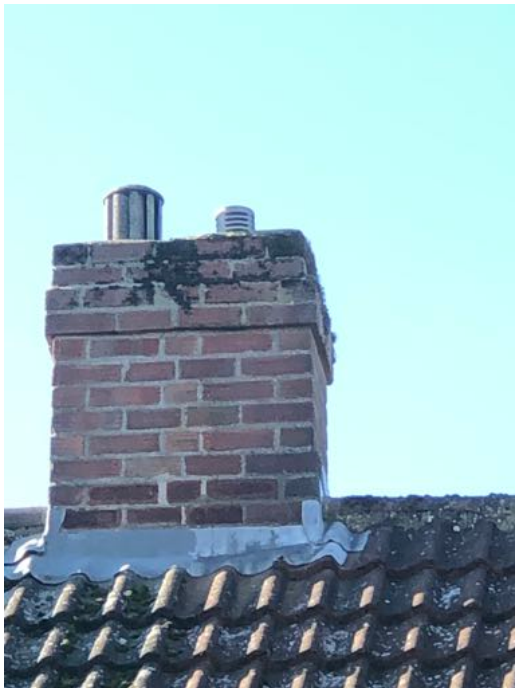
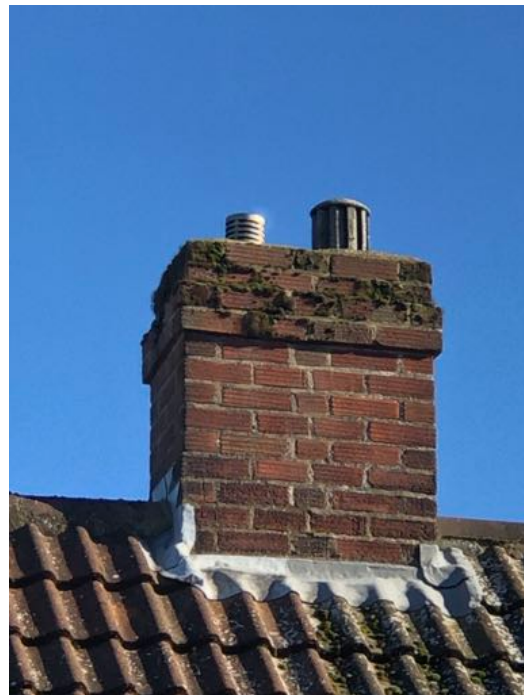
The chimney is built of brick and decorated with a string course. There was no visible spalling or efflorescence, and the pointing is in average condition. There is 1# pot on the #233 side, comprised of material likely to contain asbestos. Although this is not an immediate problem, asbestos fibres are a safety hazard when disturbed, and due care and attention should be taken when working with such material (see Section I3). Flashing was not visible. The flashings were in average condition with no major gaps or separation, however, there was evidence of historic localised repairs. There was some moss growth on the upper part of the chimney that should be removed periodically. Moss absorbs large amounts of water and during a freeze/thaw cycle it can expand and contract significantly, cracking brickwork and pointing. Condition Rating 2.

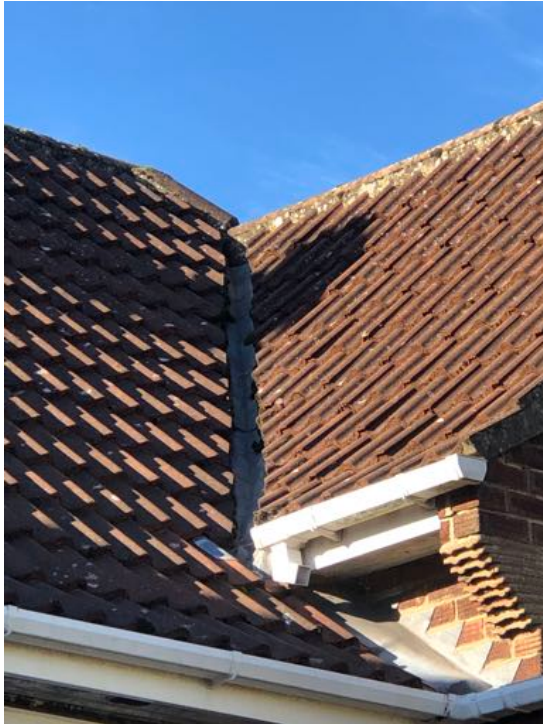
The main roof is clad in clay pantile and its ridge runs north/south, with a gable-ended cross wing at the north side. Both front and rear roof slopes are in good condition, with no visible deflection and no cracked or missing tiles. The flashings at the valley gutter were tight and sound, and cement fillets, where visible, were in good condition also. Condition Rating 1.

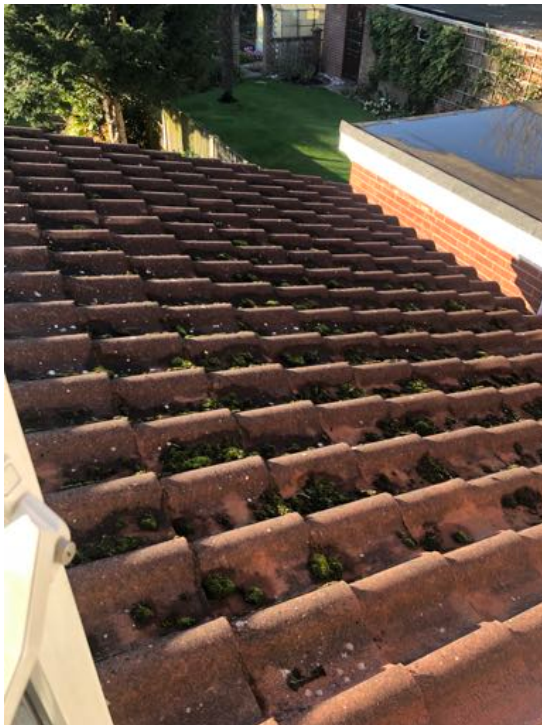
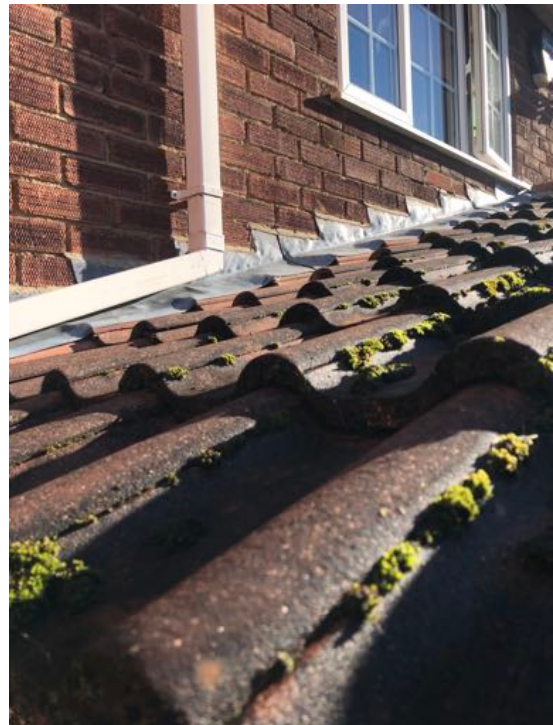
The rear extension roof was in similar condition, and its flashings connecting it to the rear elevation of the main house appeared tight and sound. There is some moss and lichen growth. This should be removed periodically as it inhibits roof efficiency and could lead to gutters and rainwater goods becoming blocked. We recommend that pointing and bedding to the ridge tiles is checked when moss removal is undertaken. Condition Rating 1.

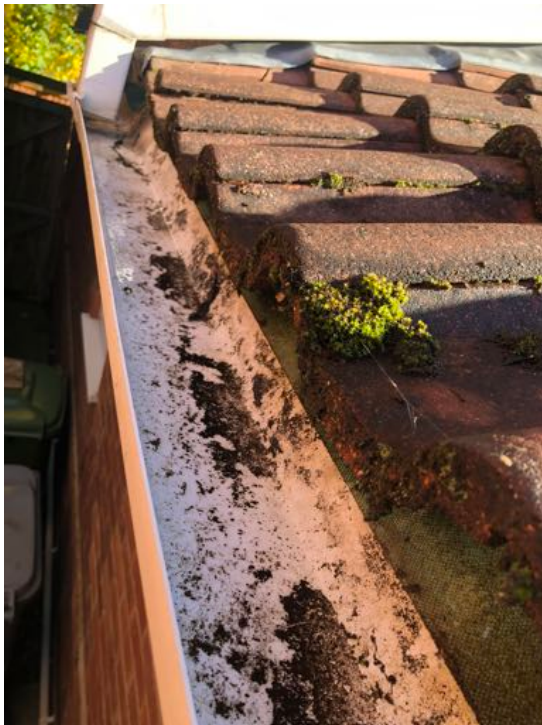
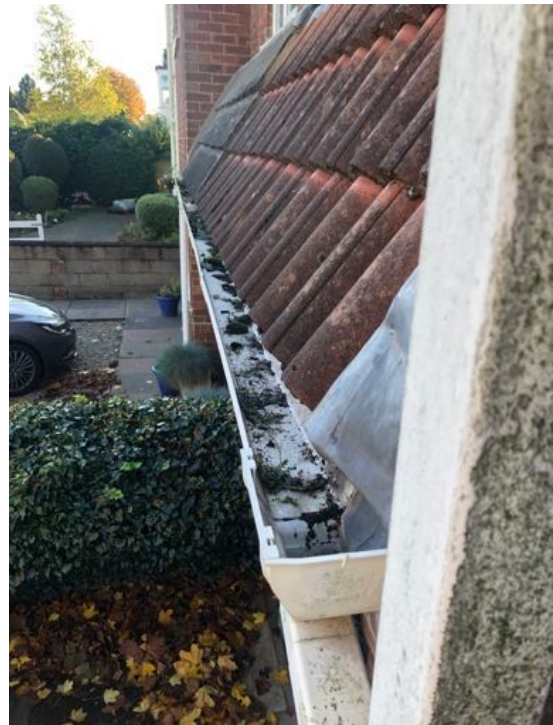
The rainwater goods are made of PVC and in broadly good condition. Where inspected the gutters were clear. Gutters should be cleaned on a regular basis to avoid blockage, which can lead to water overflow onto wall surfaces and downpipe blockage. Condition Rating 1.

Gullies and drains, where inspected, were clear. You should make sure to check these periodically and ensure they are free of leaves and other debris so that rainwater can be efficiently carried off to the mains drainage. Condition Rating 1.

*Informative: the gutters at the front (above the porch) drain rainwater from #233 Any Street across the party wall to a downpipe located at the property.*

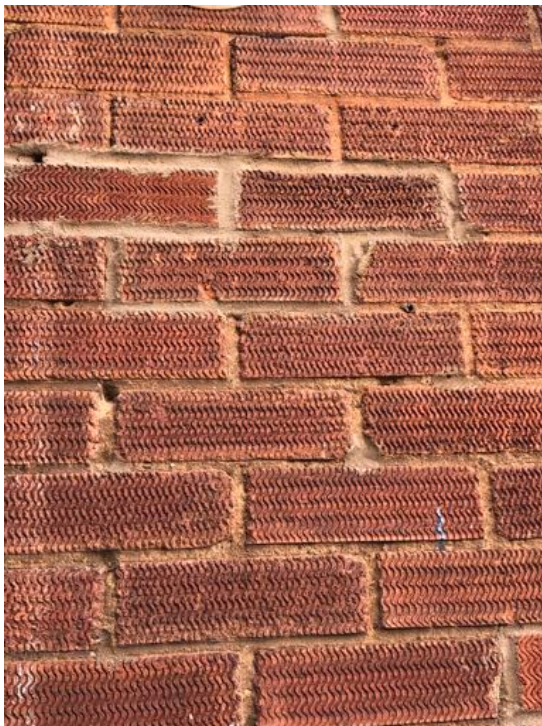
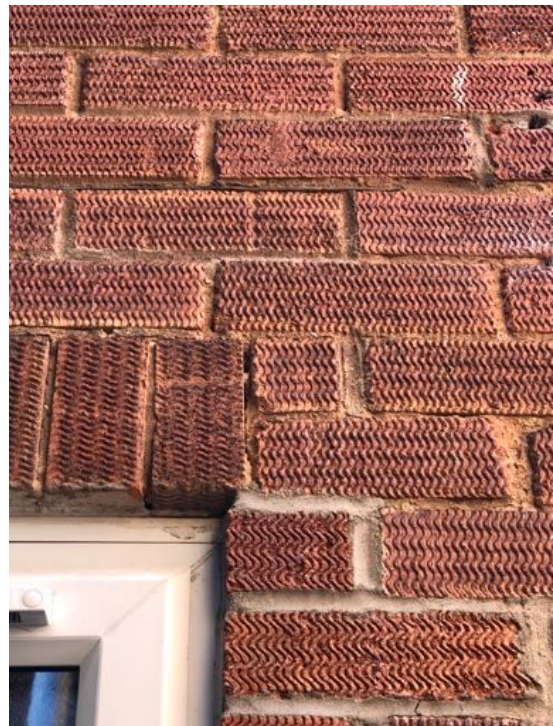
The main walls are of brick and brick cavity wall construction (i.e. with bricks used for both the inner and outer leaves of the cavity), with red rubber bricks laid in Running Bond ('one-over-two'). The elevations are in average condition, with broadly satisfactory pointing and minor cosmetic defects consistent with an early 20<sup>th</sup> century property. The DPC was partly visible at the northeast corner of the house and appears to be comprised of bituminous material, consistent with the age of the house.

There are intermittent holes in the pointing consistent with the installation of blown cavity wall insulation, and evidence of this was found in the loft void (see E1, below). There are numerous instances of localised pointing failure, particularly at door and window heads. We would recommend instructing a competent bricklayer to carry out localised repointing and repair where required. Condition Rating 2.

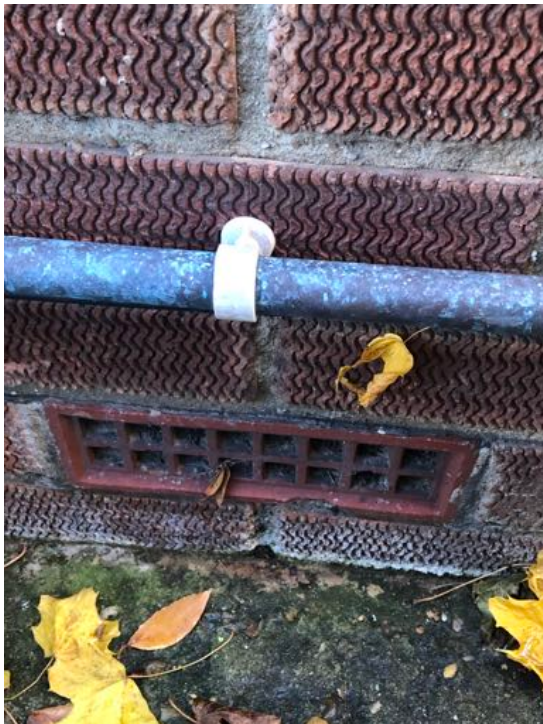
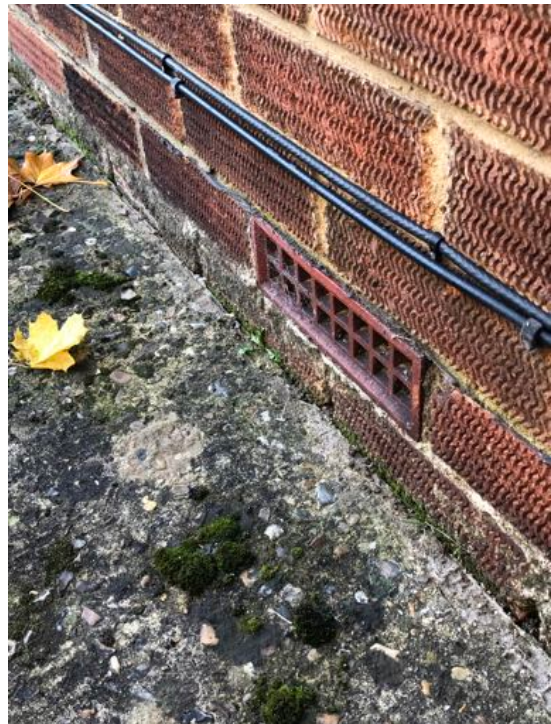
Airbricks provide ventilation to the subfloor void, and you should ensure these are kept clear to maintain airflow and prevent condensation in the subfloor void. Condition Rating 1.

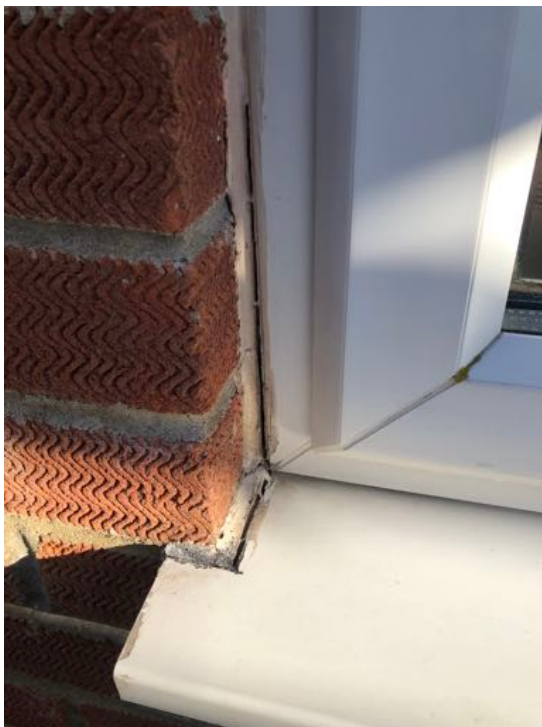
The junction between the kitchen window/cill/wall on the north jamb shows evidence of failing edge mastic. This should be replaced to prevent water ingress and ensure a weathertight seal. Condition Rating 2.

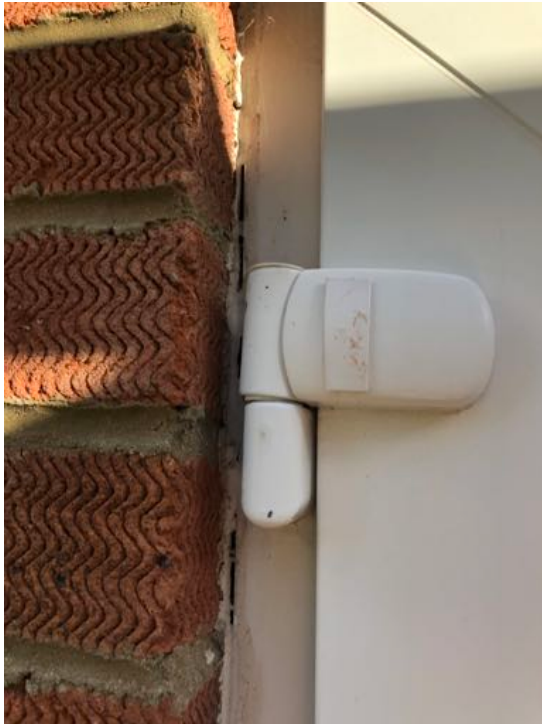
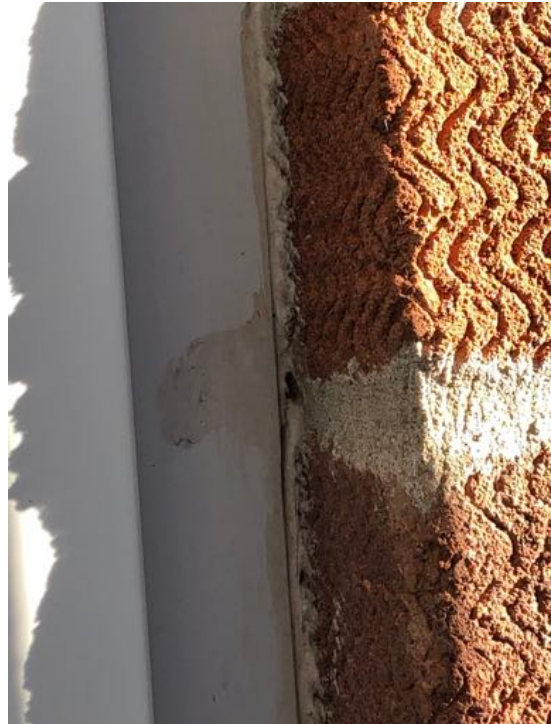
The front door is hardwood timber. The door, cill, and lintel generally appear to be in good condition with no visible damp or cracking. The door opened, shut, and locked cleanly. The edge seal to the jamb on the north side (right-hand side when facing the door) showed a wide gap. The mastic here should be replaced soon to prevent water ingress and ensure a weathertight seal. Condition Rating 2.

The rear exterior doors are PVC with double glazed units and appear to be broadly in good condition. The head flashings have sufficient overhang to form drips and carry water away from the doors. There was no visible misting to any double glazed units themselves. The doors opened, shut, and locked cleanly. These doors exhibited localised failure of the edge seals on both jambs. This should be repaired soon to prevent water ingress and ensure a weathertight seal. We recommend this can be done jointly with the edge seal replacement to the window noted in D5, above, and the front door. Condition Rating 2.

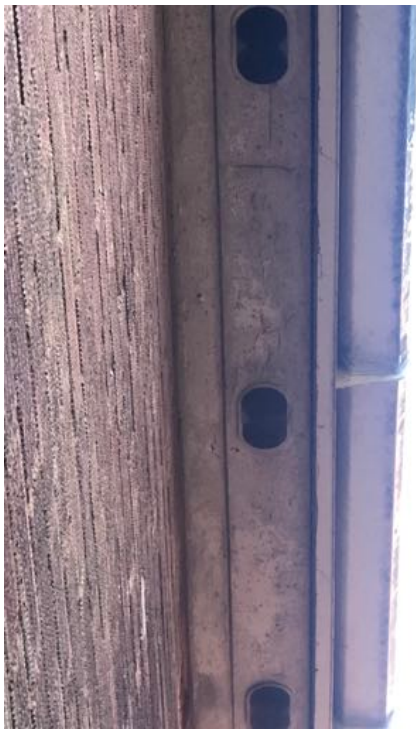
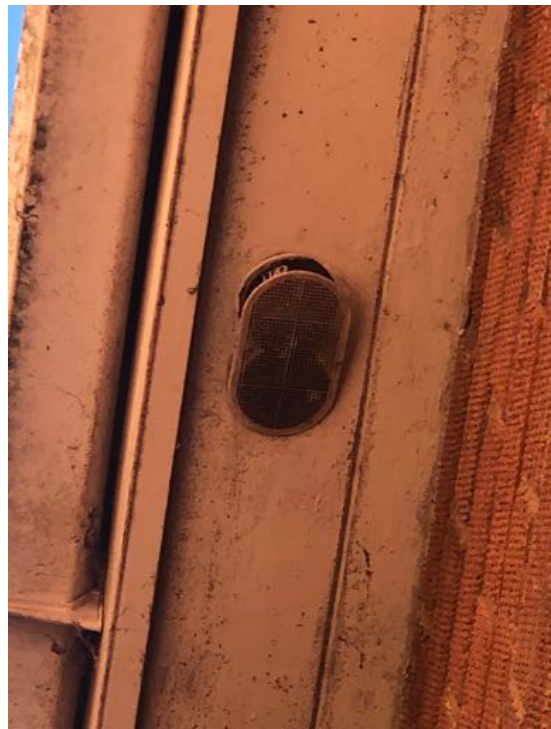
Bargeboards, fascias, and soffits – where present – are generally in average condition. they could benefit from redecoration throughout. There are eaves vents present to ventilate the roof void, however, I could not see evidence of corresponding ridge ventilation (see E1). Some of the soffit vents were loose and possibly blocked. Condition Rating 2.

The soffit panels are of a type likely to contain asbestos cement. Asbestos fibres are a safety hazard when disturbed, and due care and attention should be taken when working with such material (see Section I3). Condition Rating 2.

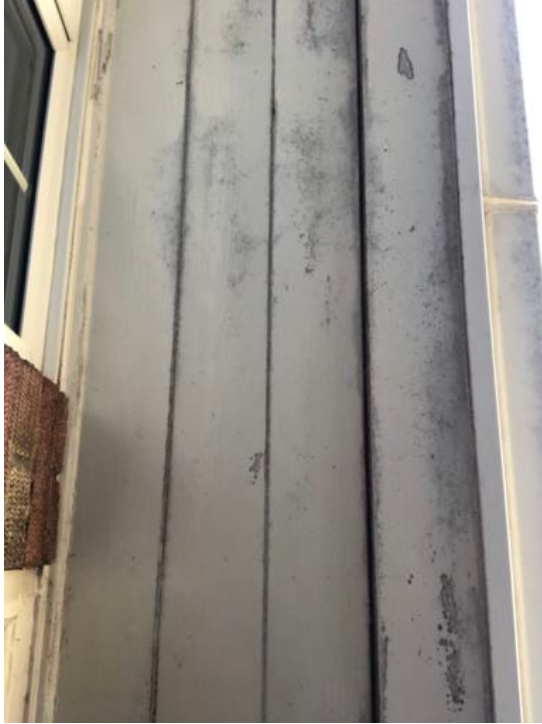
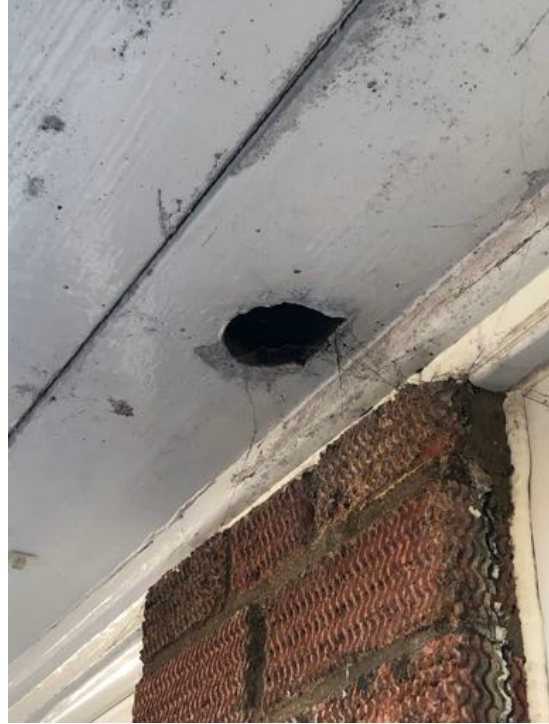
There is a painted timber soffit over the front door that is in generally poor decorative condition. There is a hole in the board nearest the front wall. This should be repaired to prevent birds from nesting in the eaves, and the whole would benefit from redecoration soon. Condition Rating 2.

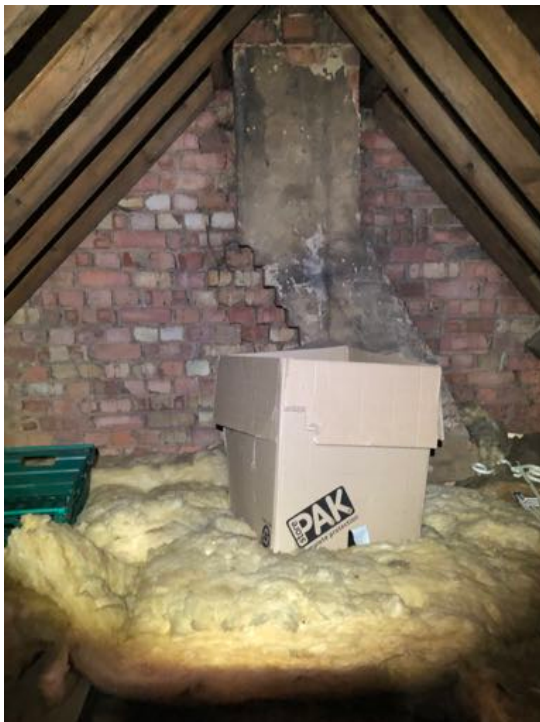
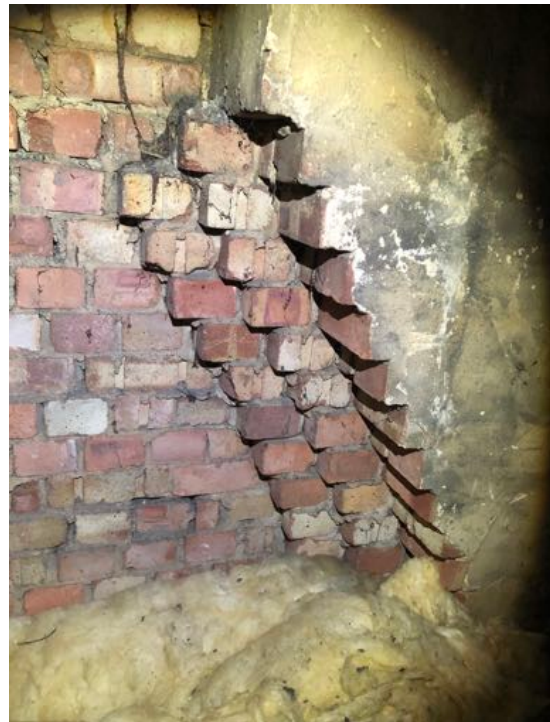
Part of the chimney breast at the party wall with #233 has been removed in an unsafe manner; there is no steelwork supporting the remaining chimney breast or the chimney stack above the roof, and no structural reinforcement of any kind visible. You should instruct a structural engineer to conduct a survey and advise on the implications of the current arrangement as well as any remedial works that may be required.

There is glass fibre batt insulation present above the ceiling and between the ceiling joists to a depth of approximately 260mm and a certificate for its installation is present. Some batts have been disturbed or moved and should be replaced to maximise their thermal efficiency. Condition Rating 2.

One of the original chimney breasts on the party wall with #233 Any Street has been removed in an unsafe manner. There is no steel, no bracket, or indeed any structural reinforcement of any kind under the removed section; this has effectively undermined the support of the chimney stack on the roof. You should instruct a structural engineer as soon as possible to inspect the chimney and advise on remedial measures to reinforce it. The present situation is hazardous. Condition Rating 3.

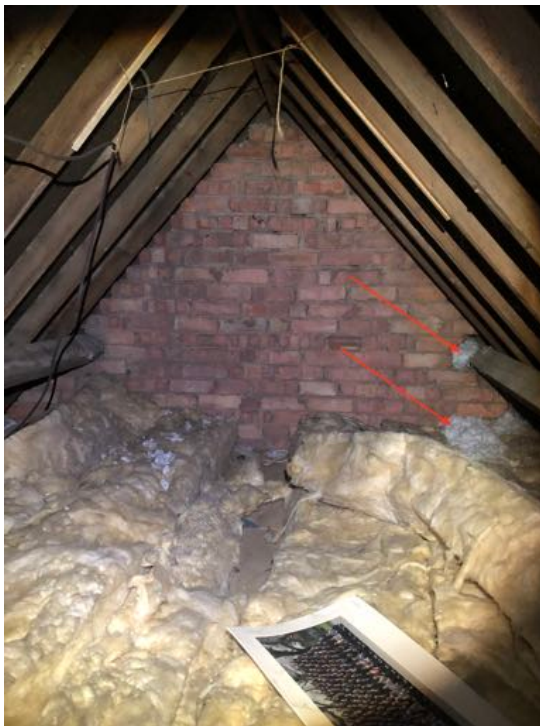
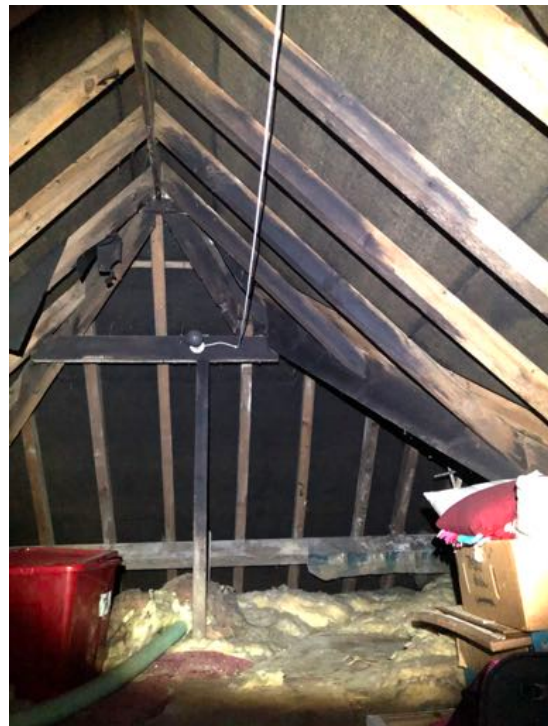
Further to the removed chimney noted above, there is failing pointing to the party wall in several places. Party walls act as a firebreak between properties and any gaps in the wall expose both properties to fire risk from the other. During any remedial works to the chimney you should make localised repairs wherever required to ensure the integrity of the party wall. Condition Rating 3.

There is evidence of the installation of blown cavity wall insulation (see photo at left, below). You should have your legal advisor query the availability of any warranties or guarantees on this installation.

There are several timbers near the junction between the main body of the house and the north cross wing which appear to be blackened. These timbers felt sound during my inspection and showed no signs of fire damage. A sample of damp meter readings taken on them tested dry. Given the likelihood of a removed chimney in this location, it is possible that these timbers are soot blackened (e.g. possibly due to a small failure in the removed chimney's pointing, for example) but were retained when the roof surface was replaced. If you have further concerns about their integrity I would recommend asking a structural engineer to comment during their inspection of the chimney. Condition Rating 2.

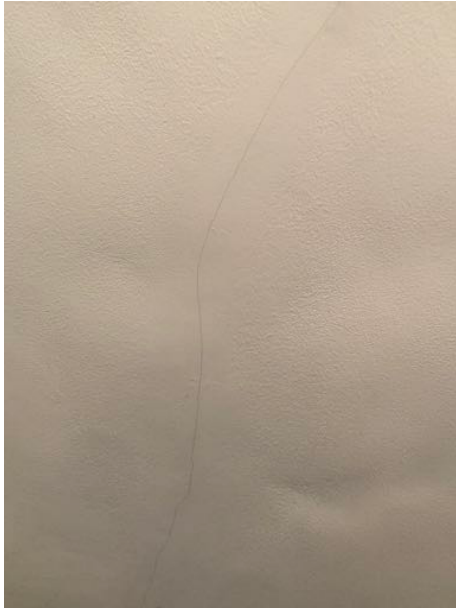
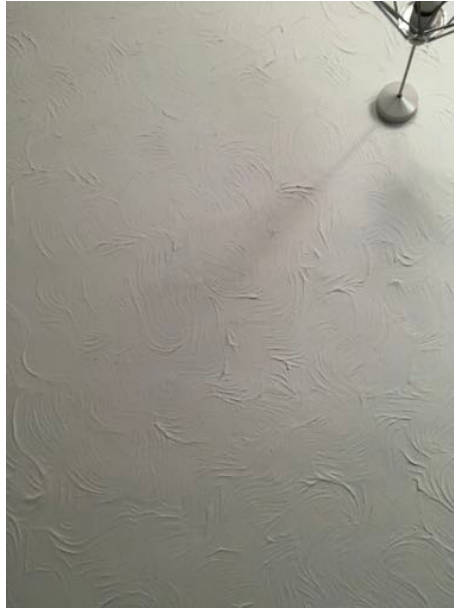
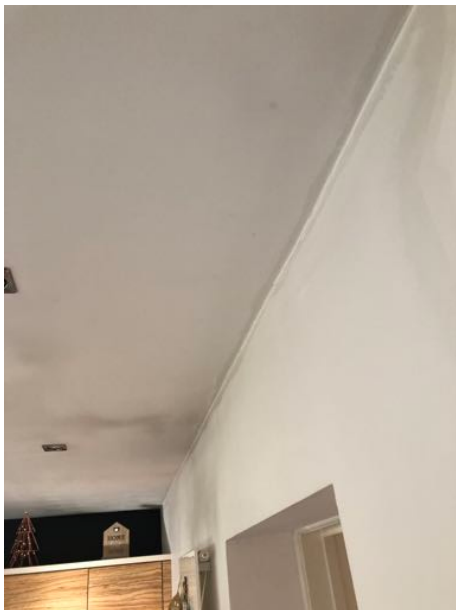
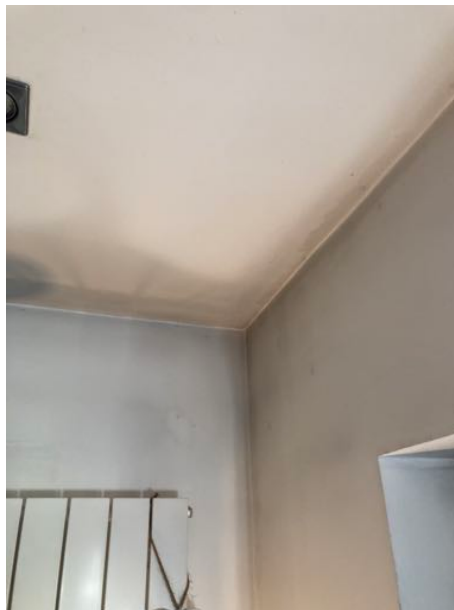
The ceilings are a mixture of textured plaster and skim plastered and painted with some polystyrene covings. They are generally in satisfactory condition, with only minor hairline cracks and some decorative imperfections. We recommend you consider redecorating these areas soon. Where ceilings have been provided with a textured Artex-type finish, it should be noted that such coatings applied prior to 1984 can incorporate an asbestos content. Due care and attention should be taken when working with such material (see Section I3). Condition Rating 2.

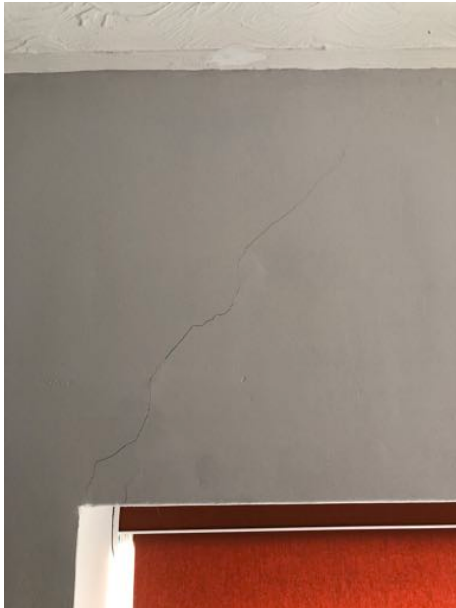
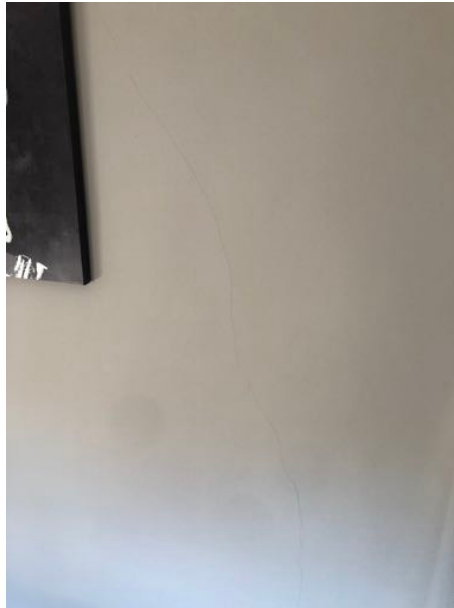
The internal walls are painted skim plaster with papered feature walls, and are in good condition throughout. There is evidence of minor decorative imperfections consistent with the age and use of the property. Condition Rating 1.

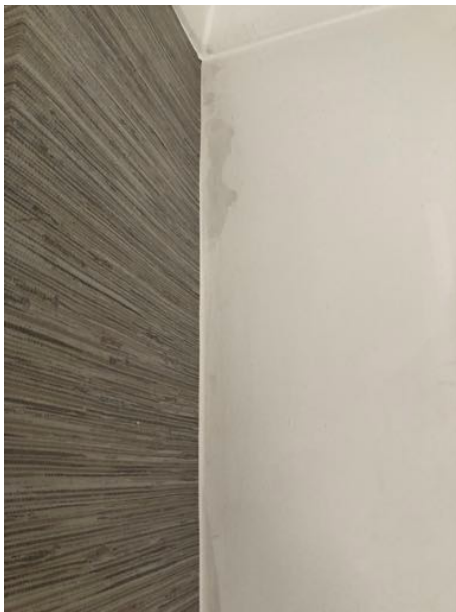
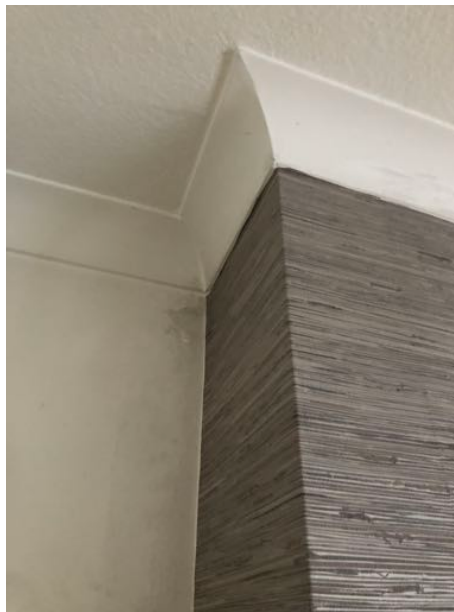
There is a chimney breast retained on the ground and first floors at the north wall. At ground floor it appears structurally sound and free from splay or distortion. It is fitted with an electric fire, which was not tested. There is poor decoration at the junction between the chimney and the wall, possibly relating to historic damp, however, a sample of damp meter readings in this location tested dry. Condition Rating 2.

At first floor the chimney breast is built into a fitted wardrobe unit in the master bedroom and was not inspected as there was no access.

*Informative: the presence of this chimney breast lends credibility to the likelihood of there having previously been a chimney stack above the roof in the vicinity of the sootblackened timbers found in the loft.*

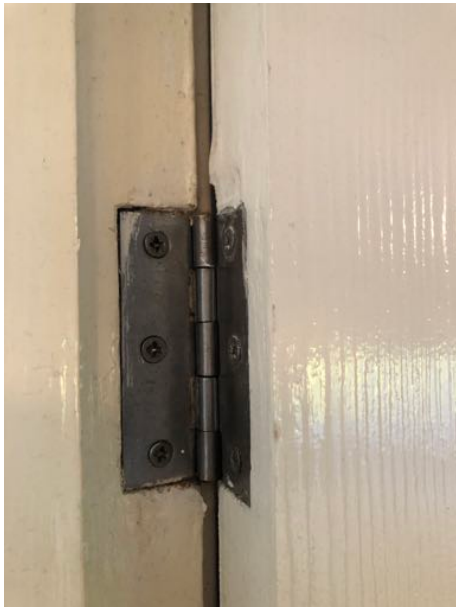
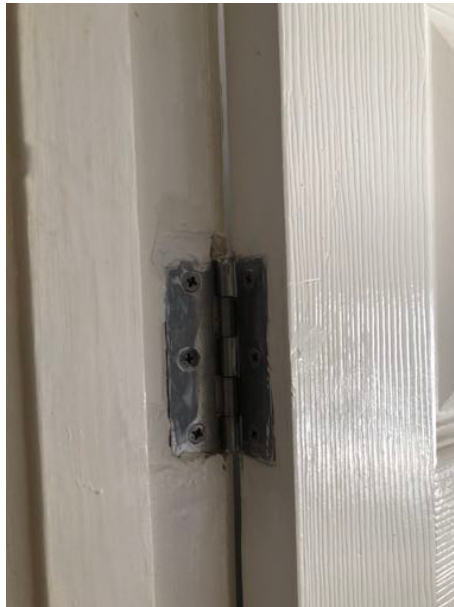
Internal joinery is of typical softwood construction and appears generally satisfactory. This includes the doors, their frames, and architraves. The skirtings appear to be original and redecorated numerous times. The doors appear to have been replaced with modern hollow-core doors, however, it appears that some older hinges may have been retained. These are in poor decorative condition and show evidence of DIY redecoration and gappy fit. Condition Rating 2.

The stairs, handrail, and balustrade are all solid and firm-to-fit with no evidence of major gaps or movement, squeaks, or flexion. The handrail is firm and fitted at the correct height. The pitch of the stairs is extremely steep, however, on the whole the stairs are in good condition. Condition Rating 1.

*Informative: the door between the kitchen/living area and the stair landing at ground floor does not appear to be a fire door, and therefore there is no fire compartmentation to the primary means of escape from upstairs room, as there should be in accordance with building regulations.*

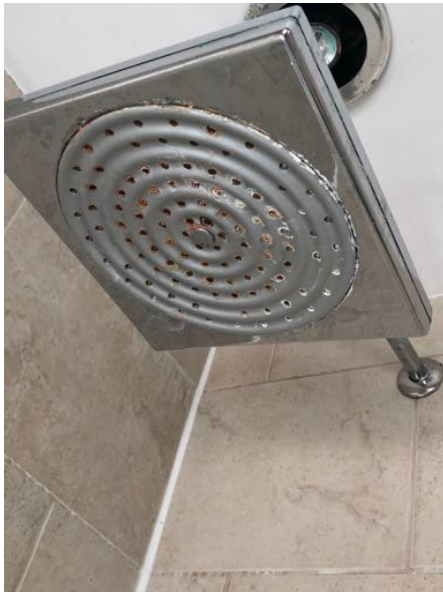
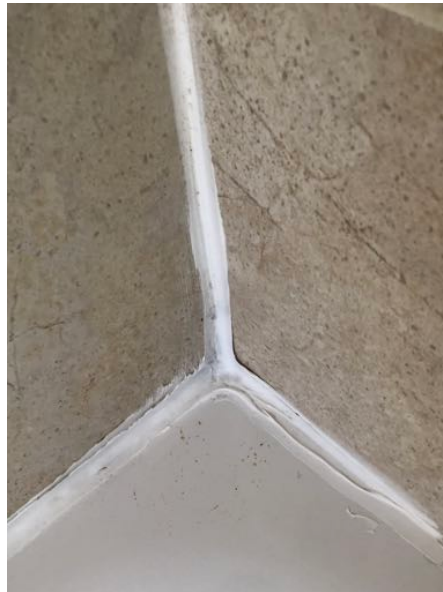
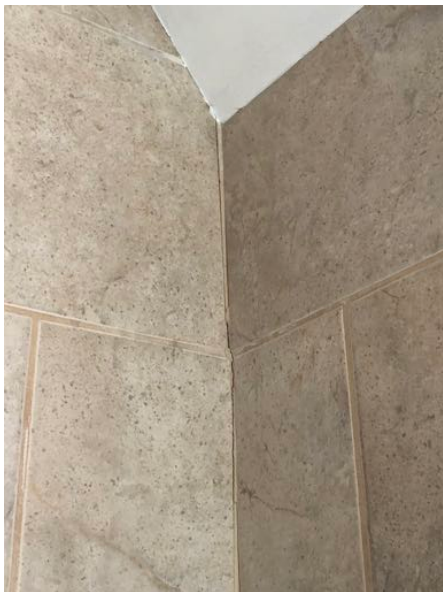
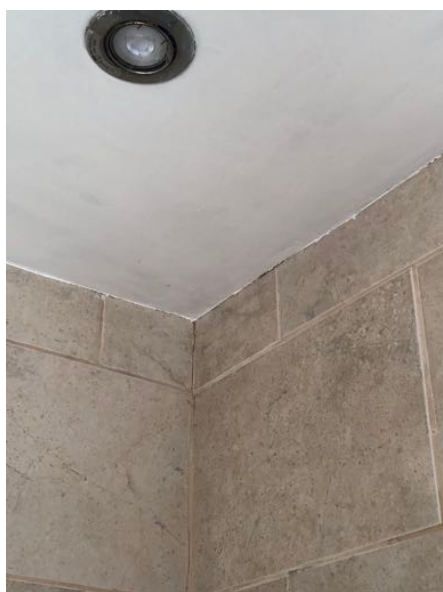
Sanitary fittings appear modern and serviceable throughout, but were not inspected in detail. The first floor bathroom showerhead is in poor condition with limescale buildup and rust. Also, the mastics and many grout joints at ceiling/wall/bath junctions in this room are in poor condition and would benefit from being cut out and replaced to maintain water tightness. Condition Rating 2.

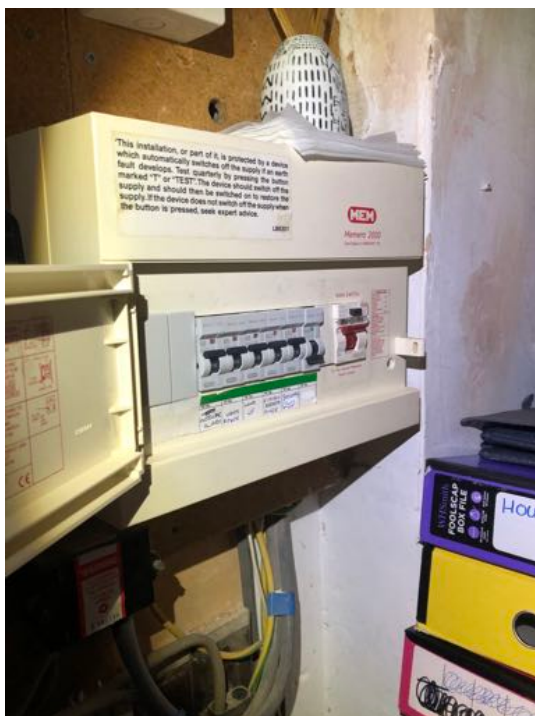
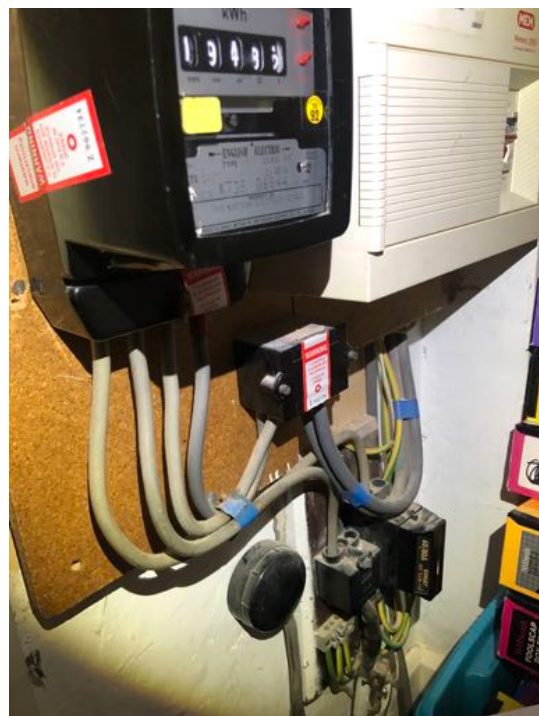
There is a mains electricity supply and the consumer unit and meter are located in the cupboard under the stairs; both appear modern. The electricity supply was on when I inspected. You should ensure that access to these services is kept clear at all times.

Guidelines advise that electrical installations should be tested every 10 years or upon change of ownership or occupation. You are recommended to consider the merits of this advice. You should ask your legal advisor to confirm the validity of any test evidence (see section I). If a recent test certificate, dated within the last 12 months, is not available for the installation, then I recommend it is tested (see section I2). Condition Rating 3.

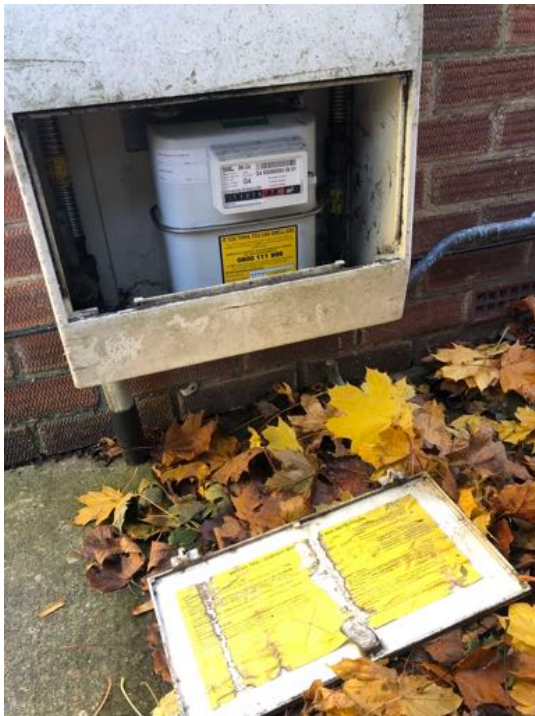
There is a mains gas supply, and the meter and control valve are located in a surface mounted cabinet on the exterior of the north elevation. The cabinet hinges are broken. You should ensure that access to these services is kept clear at all times.

I have not seen a Gas Safe certificate, your legal advisor should check that there is a Gas Safe certificate and you should ask your legal advisor to confirm the validity of this evidence (see section I). If a recent test certificate dated within the last 12 months is not available for the installation, then I recommend it is tested (see section I2).

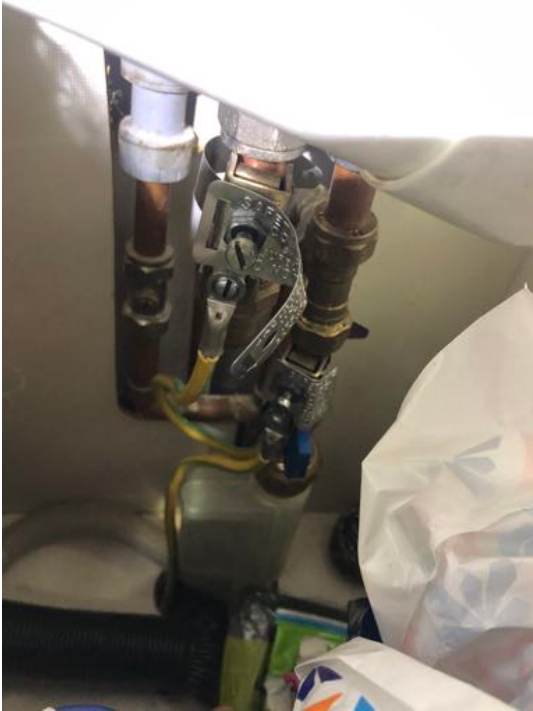
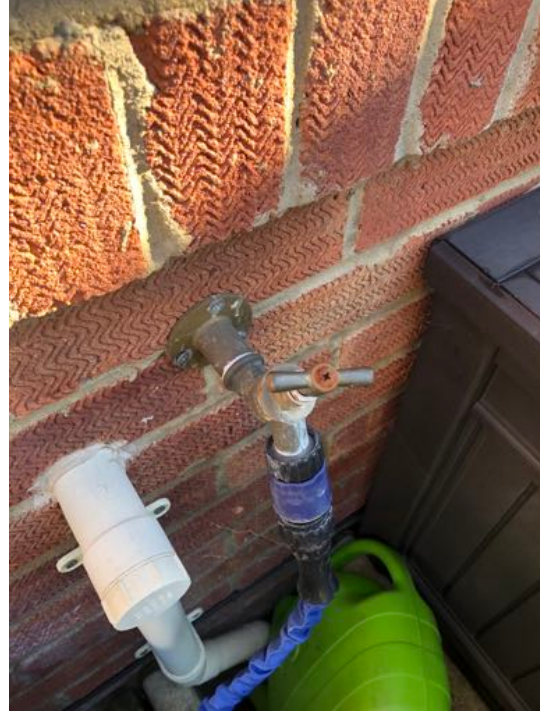
There is an independent mains water supply to the property. The water was on at the time of my inspection and pressure was good. There is a stop valve located under the sink in the kitchen.

Water regulations change regularly and often, and it was not possible to confirm if all the plumbing systems conform to current regulations. We recommend that specific enquiry be made of the vendors through your solicitor to ascertain whether any alterations to the internal plumbing have been made, and if so to check that these were done by qualified and competent contractors. Condition Rating 3.

There is an outside tap at rear which should be insulated to prevent freezing in cold weather. Condition Rating 2.

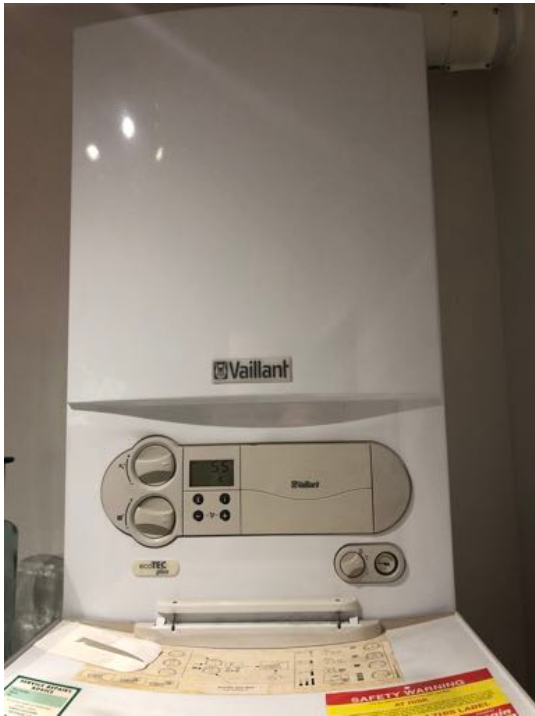
The heating system comprises a gas-fired combination boiler installed in the kitchen. The heating was off at the time of my inspection. I was unable to verify the output of the boiler and no calculations have been made to verify its adequacy. Furthermore I was unable to verify if the boiler is correctly ventilated in accordance with current regulations. The boiler flue traverses the ground floor W/C at high level and vents through a flue in the north elevation.

All heating installations should be installed and serviced regularly (usually every year) by an appropriately qualified person. You should ask your legal advisor to confirm the validity of the gas safety evidence provided (see section I). Condition Rating 3.

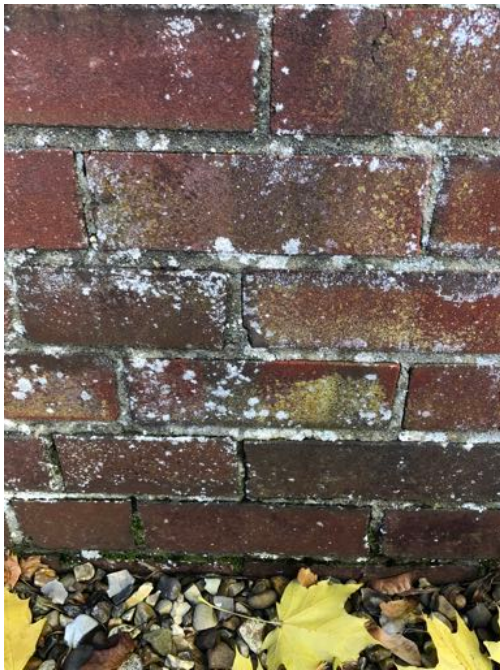
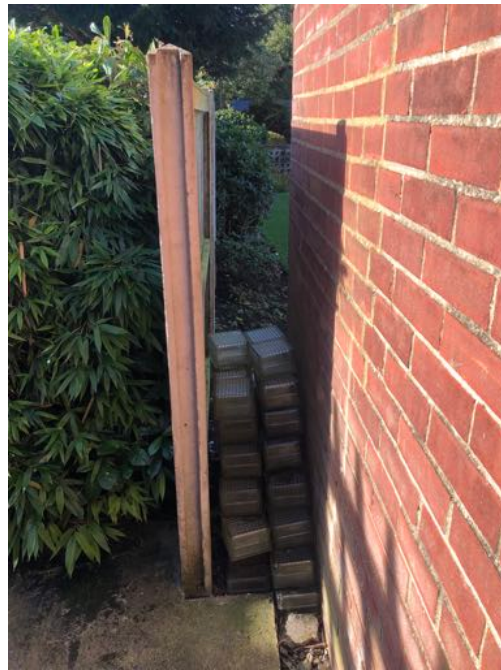
There is a gap between the fence and the party wall of #233 Any Street to the north. This poses a security issue. Condition Rating 2.

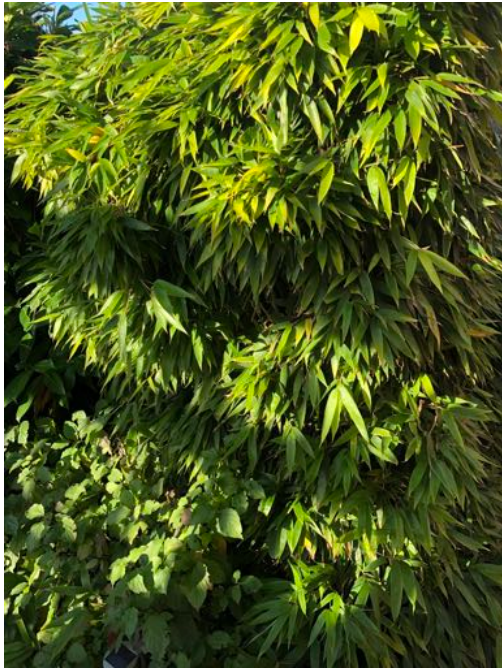
*Informative: There is a mature bamboo in the northeast corner of the rear garden along the boundary fence. Bamboo is very fast growing and can be a source of nuisance due to the frequent pruning required to keep it in check.*
