LEVEL 2 Your Survey Report

Property Address 70 Any Street
Norwich
NR1 1AA

Inspection date 14 October 1066

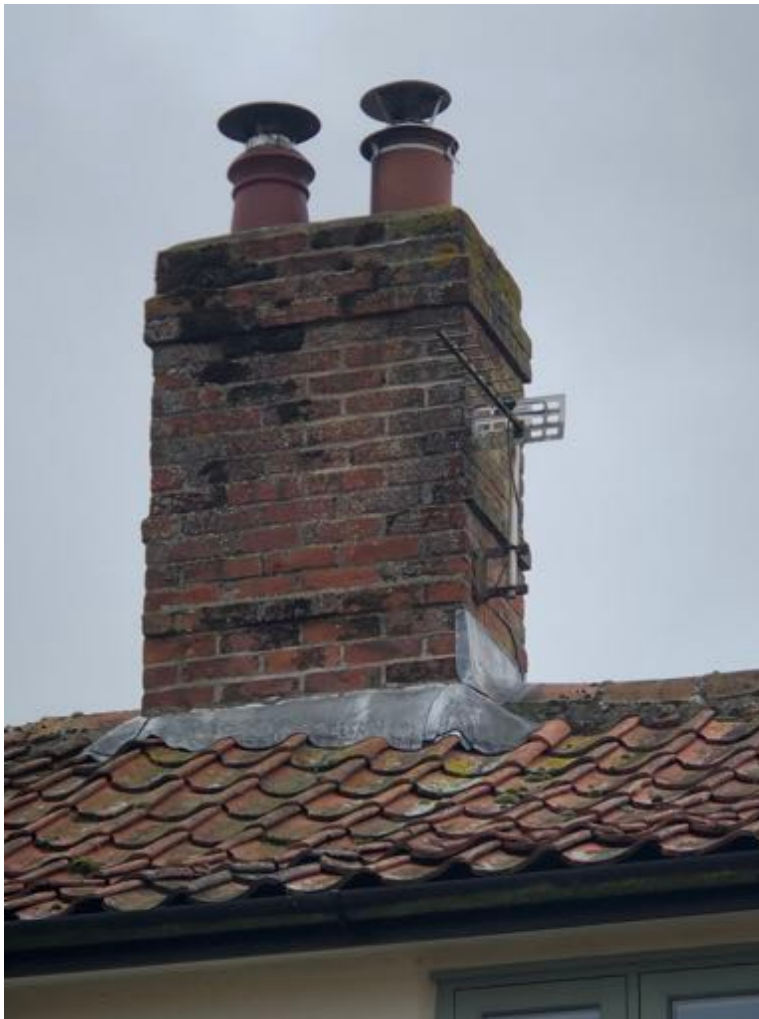
The property has a single chimney at the roof ridge, shared with the neighbouring property over the party wall. There is a single clay pot, capped and vented, and the pointing is in average condition. The edges of the flaunching were visible and appeared to be in satisfactory condition. The flashing on the north side is visibly lifting from the roof tiles in several places and this may create a point of water ingress during severe weather, particularly wind-driven rain. I suggest the flashings are repaired and the chimney repointed in due course. Condition Rating 2.

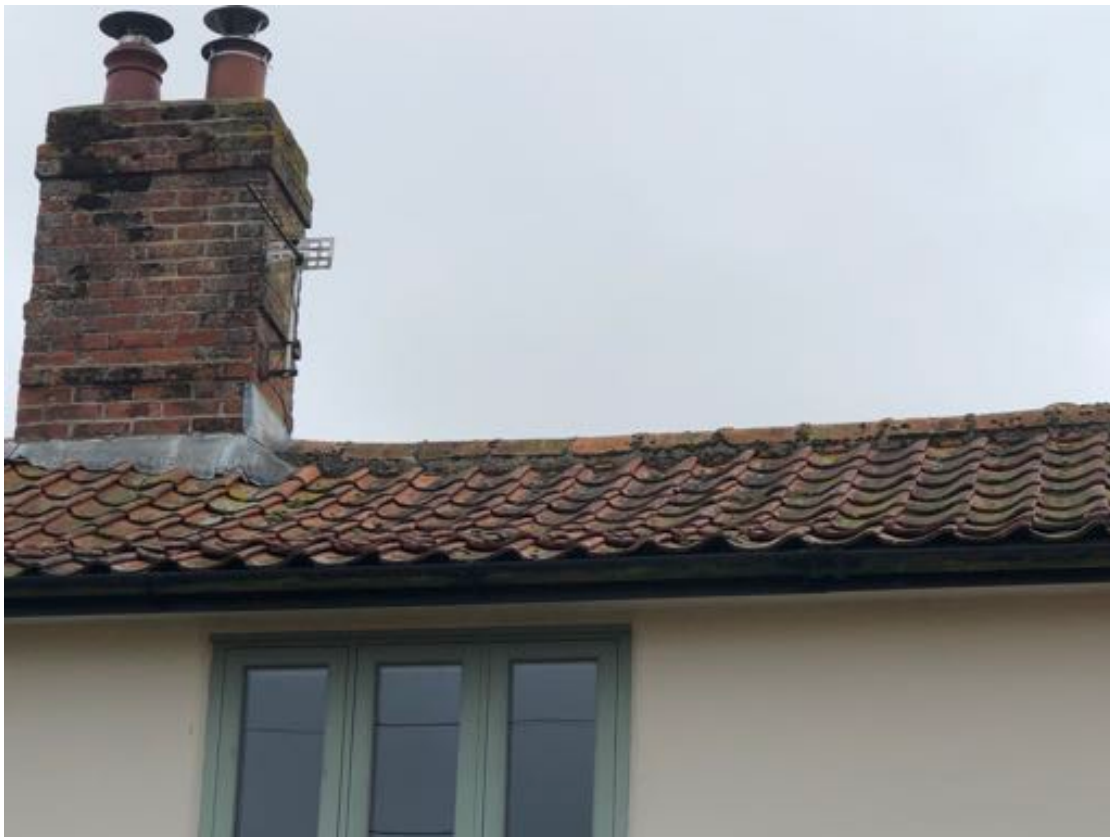
The roof is pitched and clad in clay pantile. There is visible deflection along the ridgeline, consistent with timber framing in a building of this age. There is considerable moss growth and some lichen, although the tiles largely appear to be intact with nothing missing and no obvious holes. You should have the roof cleared of moss as it can absorb large amounts of water then freeze in cold weather, which can cause roof tiles to crack and leaks to occur. Condition Rating 2.

The roof over the single-storey kitchen wing is in marginally better condition, with evidence of newer tiles.

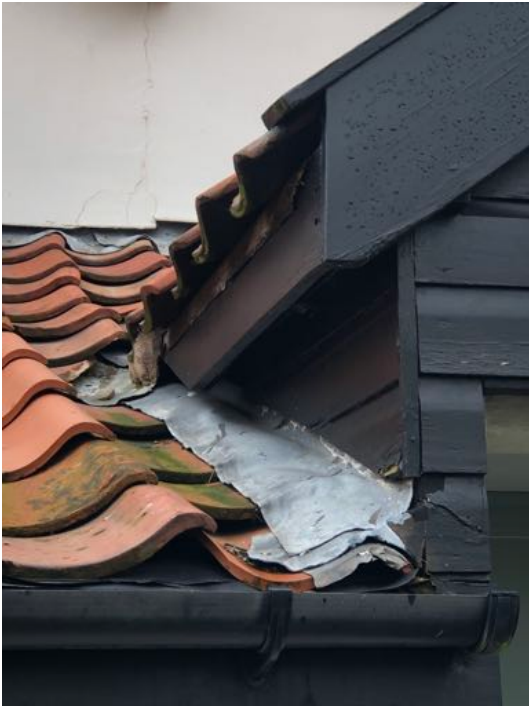
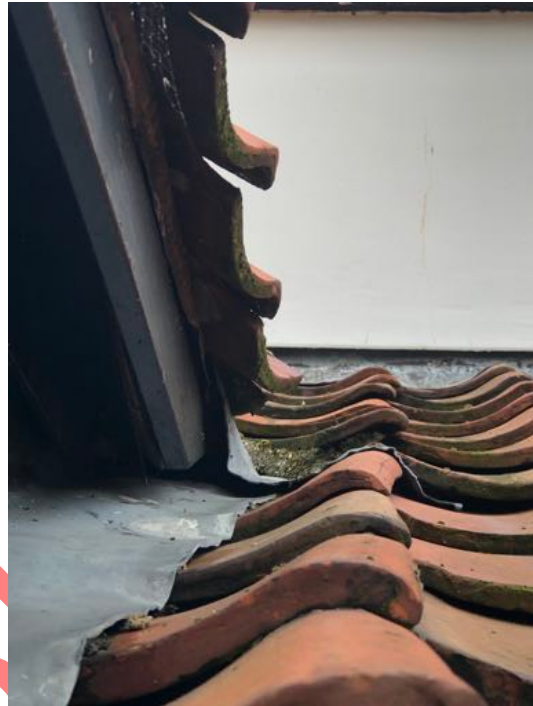
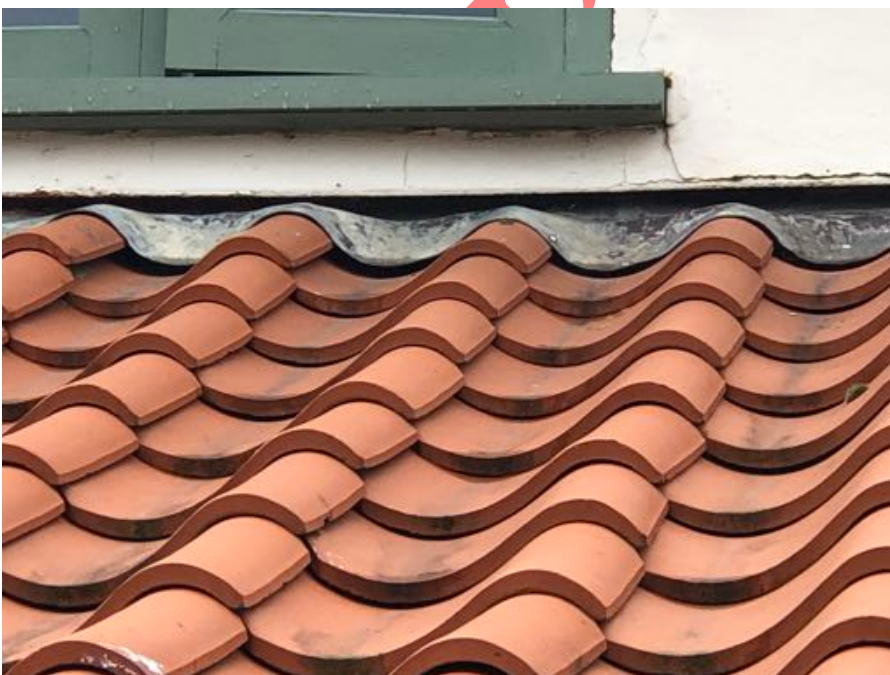
The valley flashings over the kitchen wing and the flashing between the west elevation of the main house and the kitchen roof show gaps and are poorly laid, with evidence of localised repairs (possibly DIY). These should be refitted correctly and tightly to the roof tiles to prevent the possibility of water ingress. This is particularly important in houses with clay lump walls, as severe enough damp penetration can affect the structural integrity of the walls themselves. Condition Rating 2.

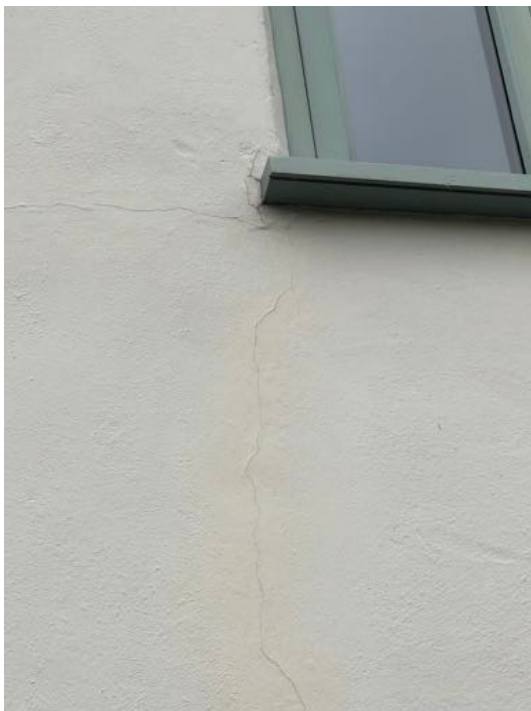
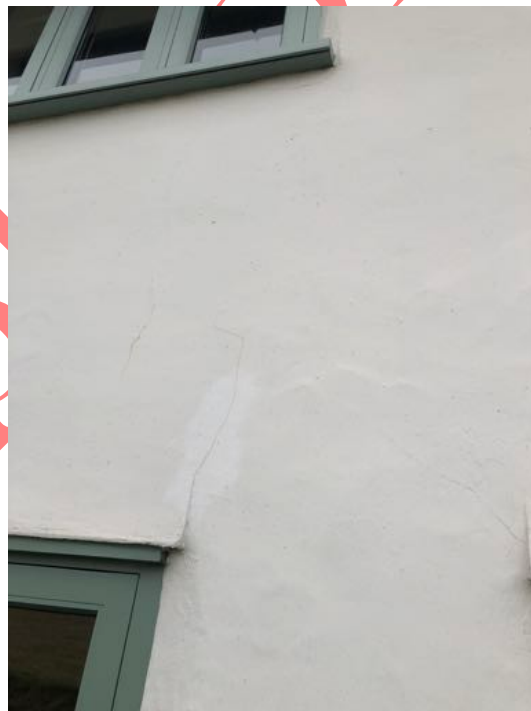
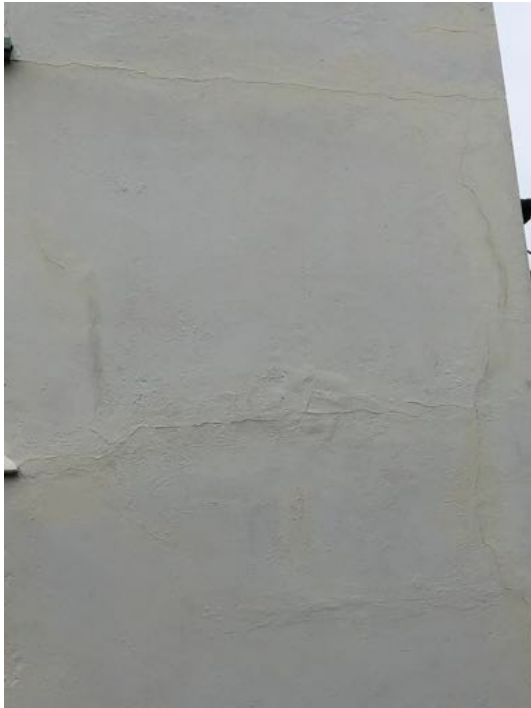
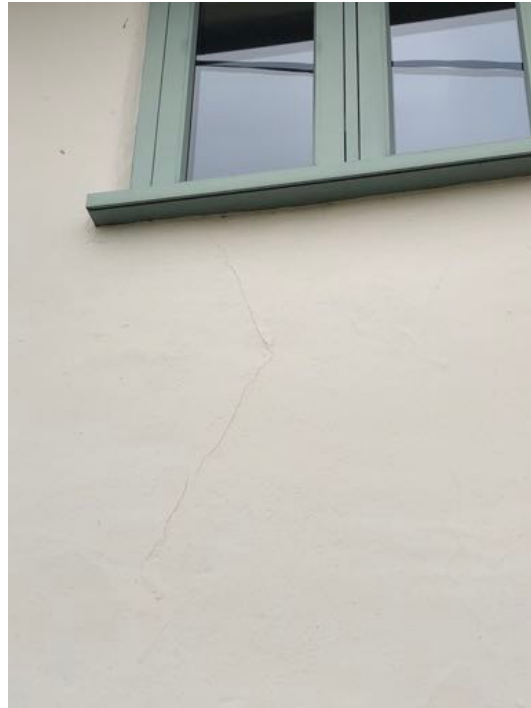
The main walls are of clay lump (aka 'adobe') construction over flint rubble footing walls, typical for some small non-coastal buildings in East Anglia from c. 1700-1850. The walls are part-rendered, and the render may obscure underlying defects not visible from the exterior. The render forms a drip at its bottom edge, typically $\pm 40\text{mm}$ in depth, which helps shed water away from the underlying walls. This type of construction does not typically have a DPC. The render was cracked and discoloured in places, likely due to damage caused during installation of the replacement windows. You may wish to make localised repair and redecorate the render in due course. Condition Rating 2.

Informative: clay lump buildings require lime or earth based renders and special treatment when redecorating render / impervious coatings. Modern cementitious renders and modern paint are not usually appropriate, and use of such may cause damage to the underlying wall structure. You should ensure that any contractor you instruct is experienced in this building type.

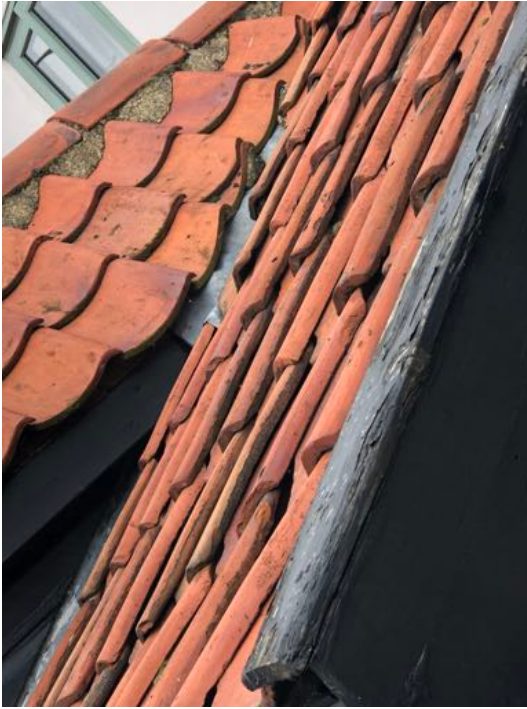
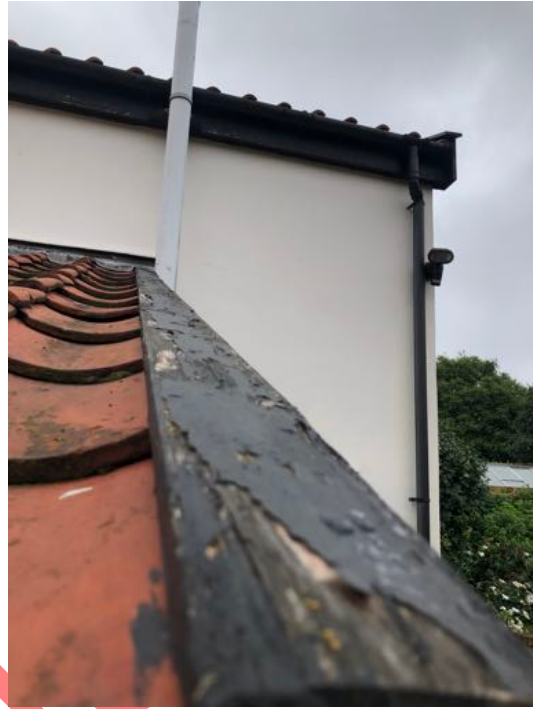
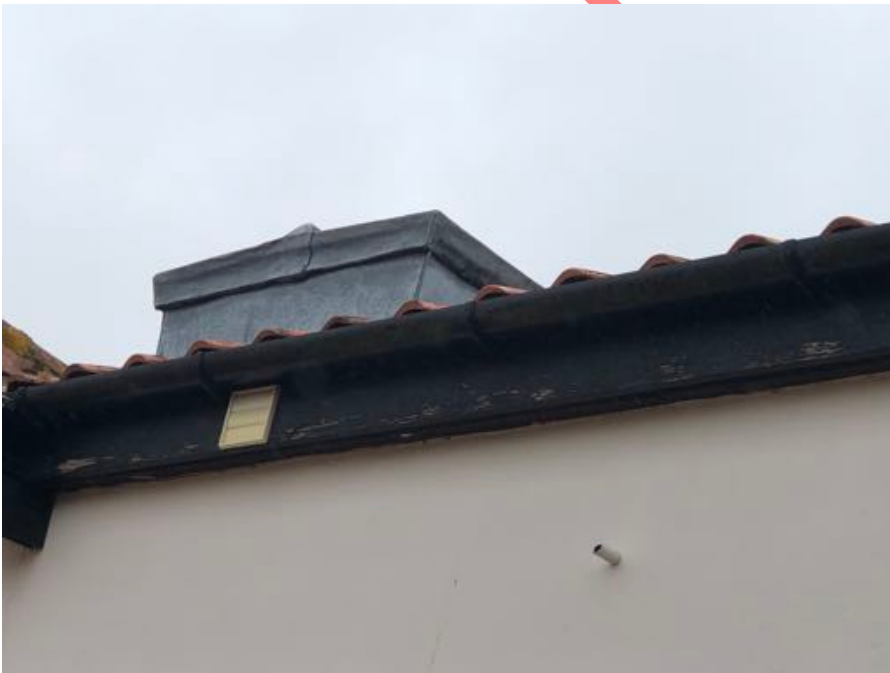
The bargeboards, fascias, and soffits are painted timber and in average or poor condition throughout. Most would benefit from redecoration soon. Condition Rating 2.

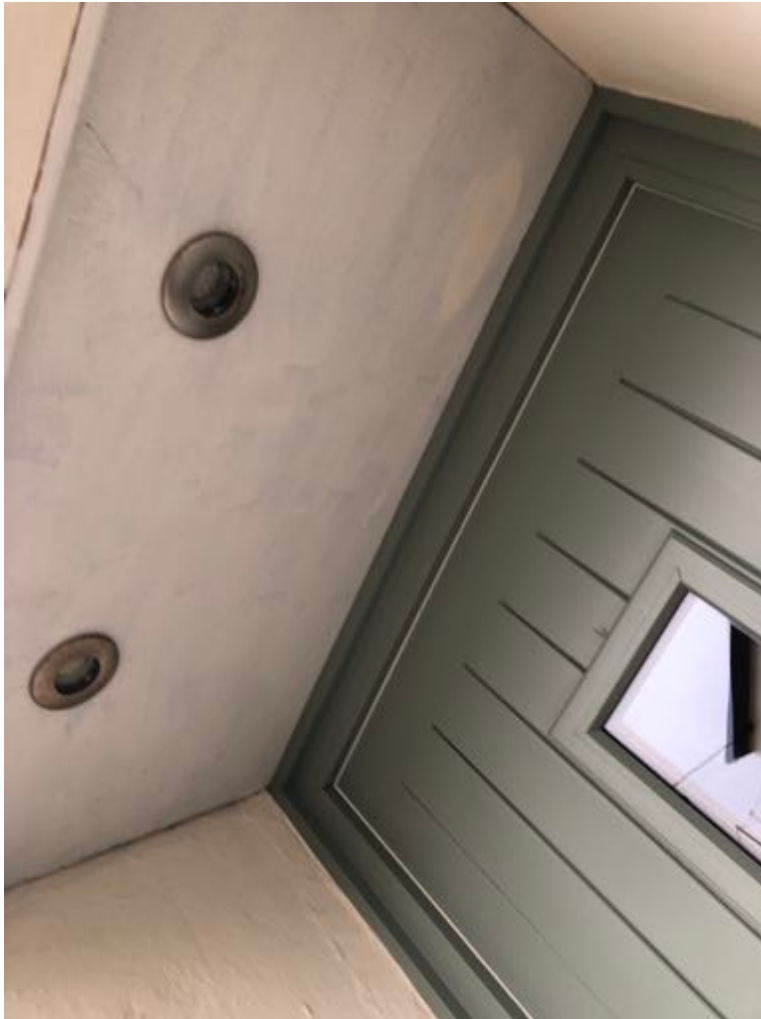
The soffit over the porch is poorly fitted and poorly finished. There is evidence of surface rust to the light fittings, which may not be IP-rated for outdoor use. You may wish to repair or replace this area soon. Condition Rating 2.

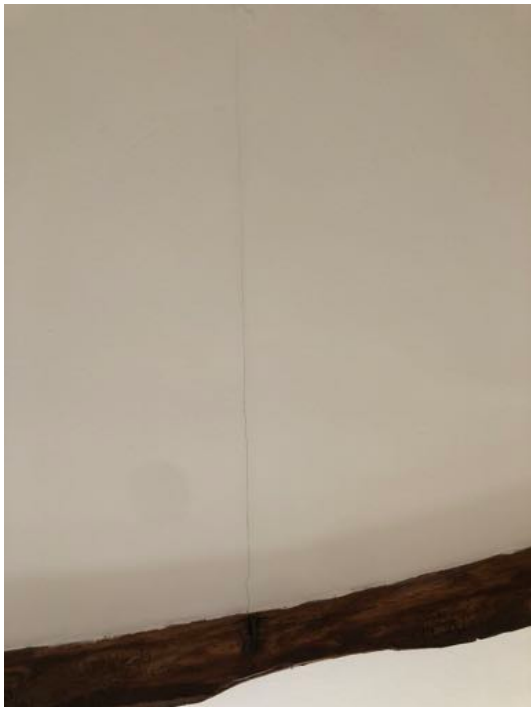
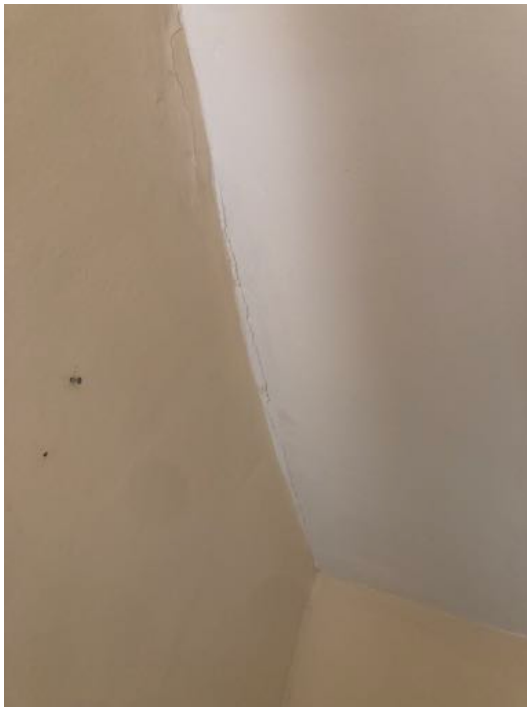
The ceilings are painted plaster between exposed timbers. At first floor there are several hairline decorative cracks in bedrooms 1 and 2; damp meter readings in these areas tested dry. Condition Rating 2.

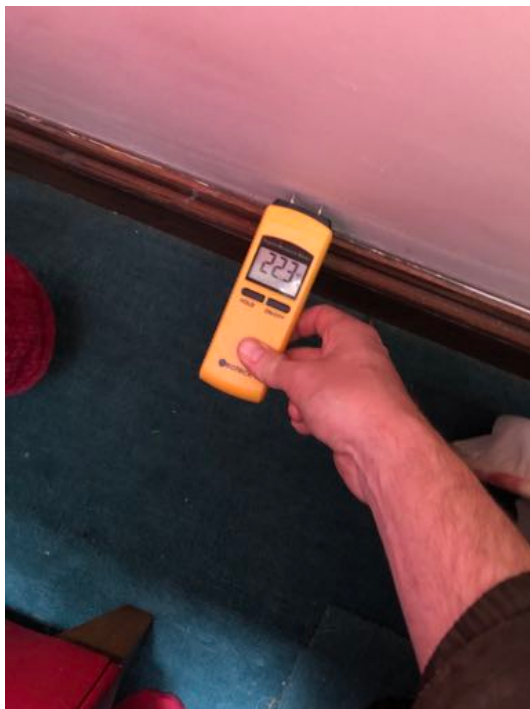
There were localised damp patches in the sitting room behind the curtains. This is likely due to condensation and a lack of internal ventilation; as earth construction is particularly vulnerable to moisture penetration you should try to ensure good ventilation in areas such as this, where moisture can easily be trapped. Condition Rating 2.

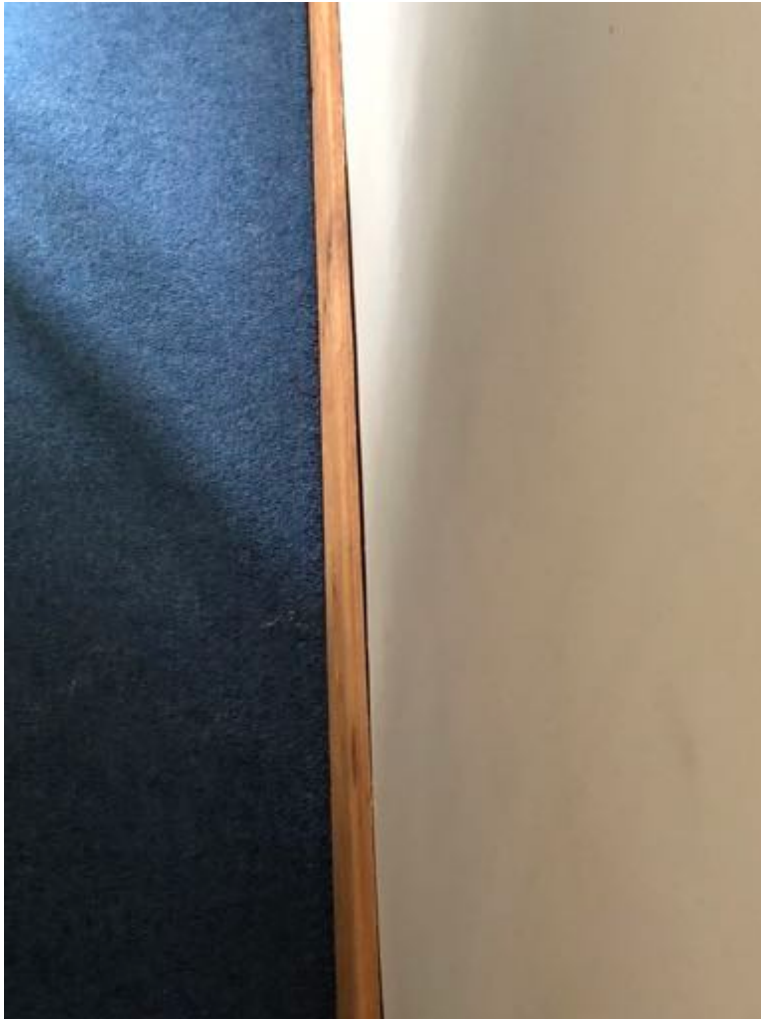
The ground floor is of solid construction. Where solid floor edges were inspected they were generally free of surface defects and 'firm to foot.' There were some minor gaps to skirting boards commensurate with the age-related unevenness of the building generally. Condition Rating 1.

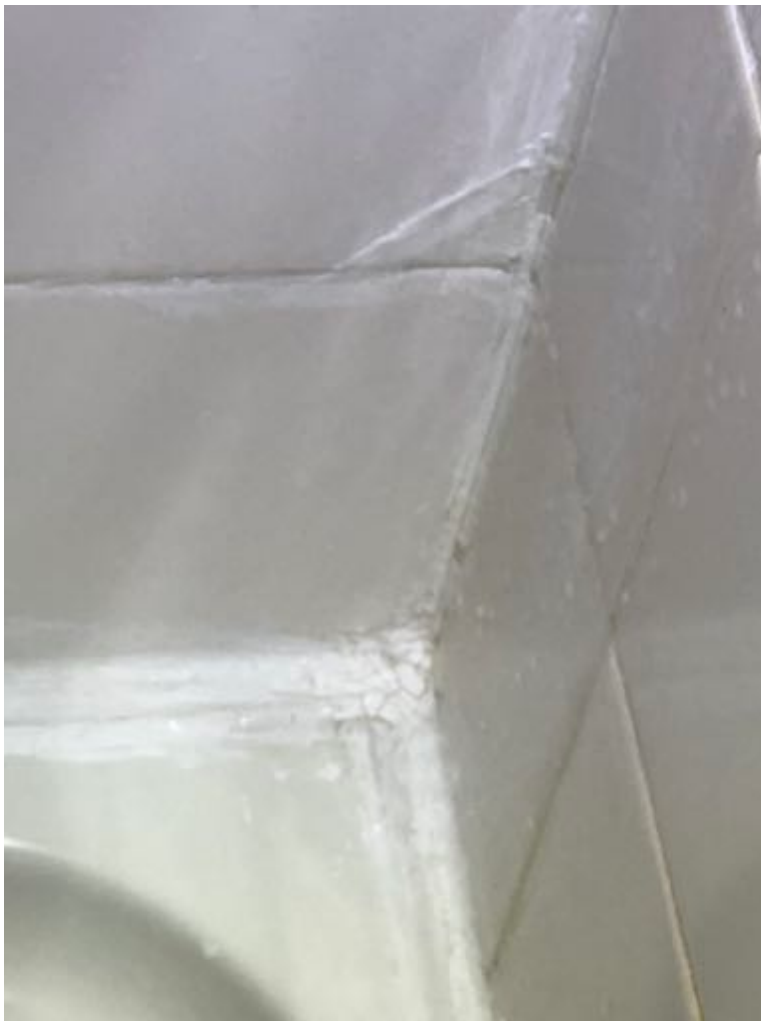
The bathroom fittings in the upstairs shower room are all quite dated and would benefit from modernisation; they were not tested. The floor is carpeted which is a poor choice for bathrooms as it traps moisture and can cause mould growth. Condition Rating 2.

The sealants in the shower corners and between the tile and shower tray are either not made of flexible silicone or are badly degraded. Sealants around the edges of baths, showers, and wash hand basins can leak and damage adjacent surfaces. If not repaired quickly, wood rot can soon develop. You should have these replaced as soon as possible with a flexible silicone sealant suitable for bathroom applications. Condition Rating 2.

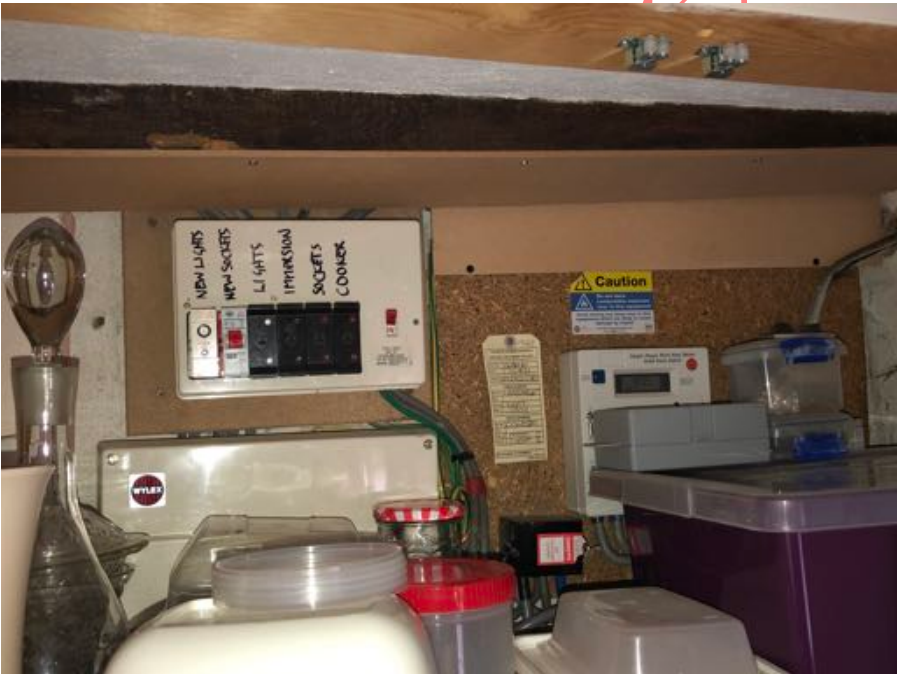
There is a mains electricity supply and the consumer unit and meter are located in the sitting room cupboard. You should ensure that access to these services is kept clear at all times.

Condition Rating 3.

If a recent test certificate, dated within the last 12 months, is not available for the installation, then I recommend it is tested (see section I2).

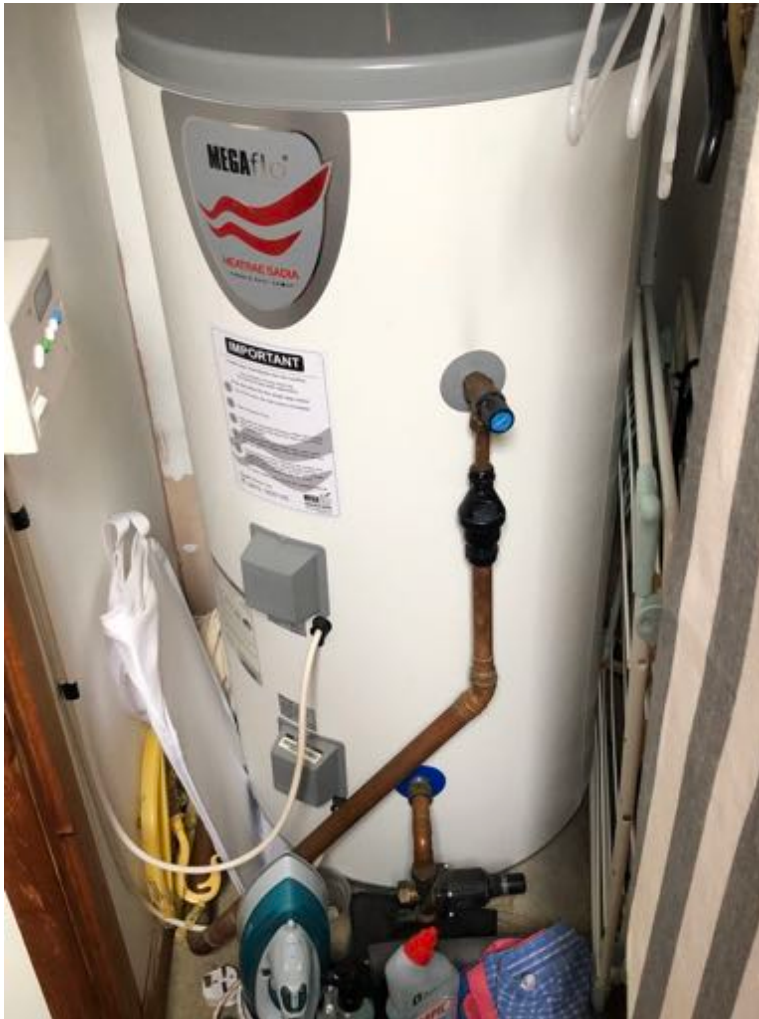
Water heating is provided by an unvented cylinder ('Megaflo') in the first floor stair landing cupboard. This was not tested and no assertion can be made as to the adequacy of the system.

All water heating installations should be installed and serviced regularly (usually every year) by an appropriately qualified person. You should ask your legal advisor to confirm the validity of the safety evidence provided (see section I). Condition Rating 3.

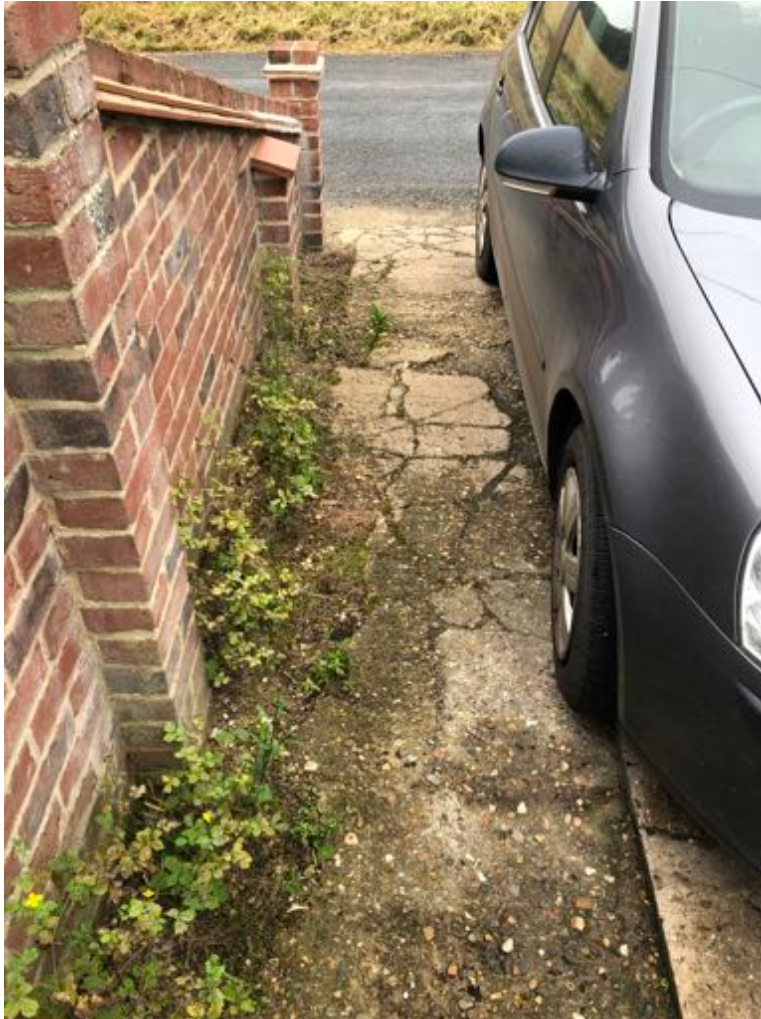
The paving to the drive is in generally poor repair, with badly cracked concrete and significant weed growth. If left unattended the problem is likely to get worse, which may cause damage to vehicles when parking or undermine the brick boundary wall. You should consider having the driveway paving repaired or replaced soon. Condition Rating 2.
