Sample Survey Report

17 Real Street
Norwich
NR1 1AA

14 October 1066

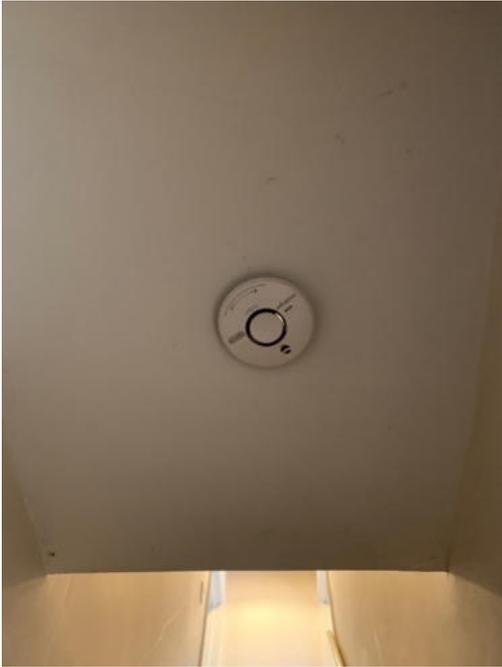
The property has battery-powered smoke detectors at ground and 1st floors, but no heat detector is fitted in the kitchen. The stairs are very steep and awkward, typical for properties of this type and age, and the handrail is dangerously loose (see E7). 1st floor windows do not provide secondary means of escape as the lower panes do not open. You are advised to consider the installation of a comprehensive smoke / heat detection system to LD1 standard under BS 5839 Pt 6: 2019 with heat detector in the kitchens and smoke detection in the living rooms and all bedrooms.

Smoke detector (ground floor)

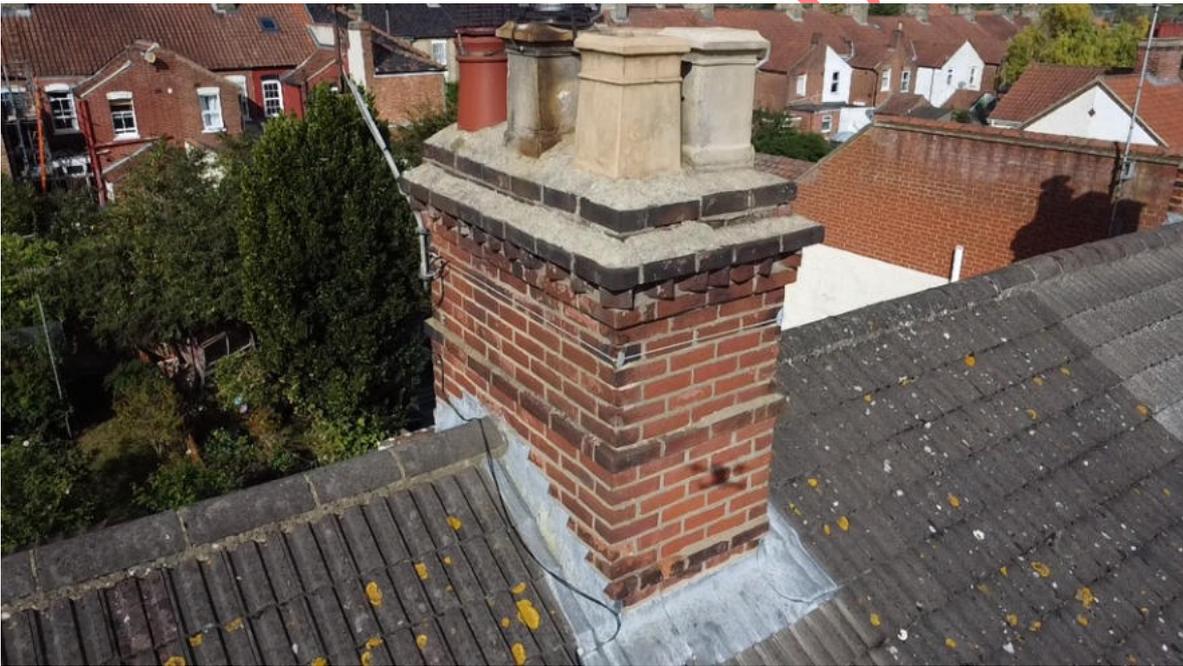
The property has 1# chimney stack at the ridge along the party wall with #19 Real Street. The stack is broadly plumb and carries 6# open pots – 3# of which serve the subject property and 2# of which carry vent cowls – and an aerial. Care needs to be taken with items such as aerials and satellite dishes fixed to chimney stacks, which impose added stresses and strains upon the structure for which it was not designed especially during very windy weather conditions. In extreme cases, structural failure can occur. Even where apparently sound, such fixings should be monitored and checked on a regular basis.

Chimney; general view from front

Localised repairs are recommended now, and repointing should be carried out in lime mortar. The open pot should be fitted with a vent cowl. A significant proportion of the cost of chimney and roof repairs comprises enabling works such as scaffolding and skip hire; works can be combined to economise (see also D2, D3, and D8)

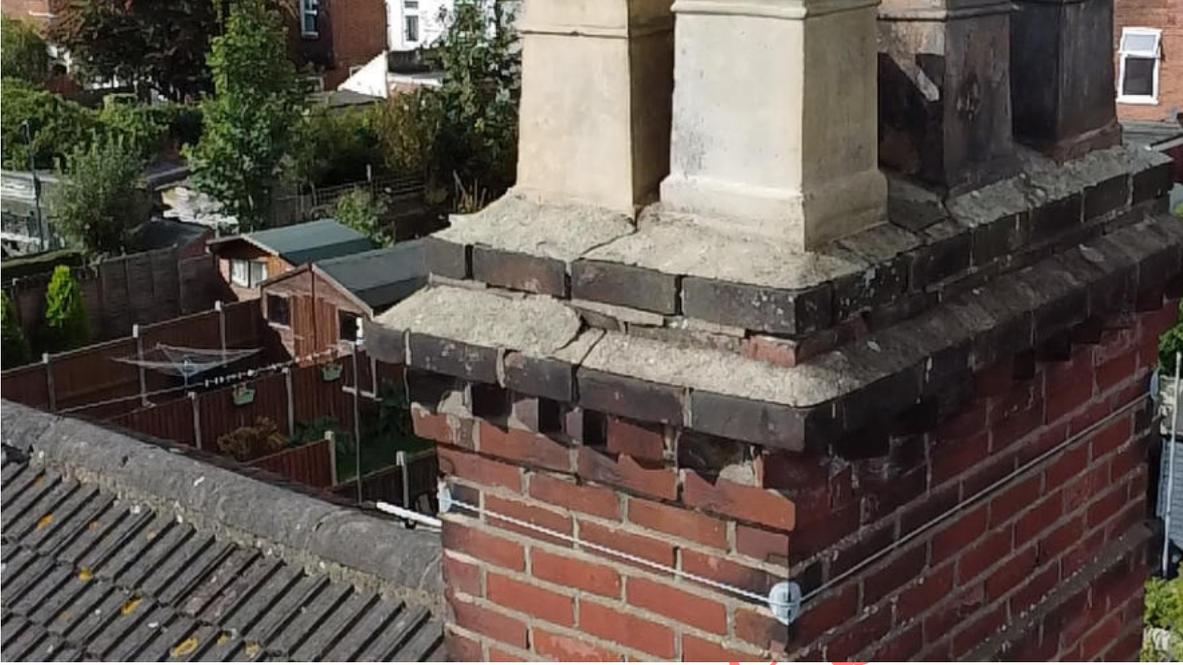
There is evidence of modern repointing with cement mortar, which is inappropriate as the mortar will be harder than the underlying brick and may cause cracking and spalling to the brickwork. Some mortar is failing at the crown and the flaunching, and this combined with the open pot at front is likely contributing to damp penetration seen internally (see E1); the pots are slightly out of plumb also. Flashing is generally neatly fitted.

Cracks to flaunching and crown

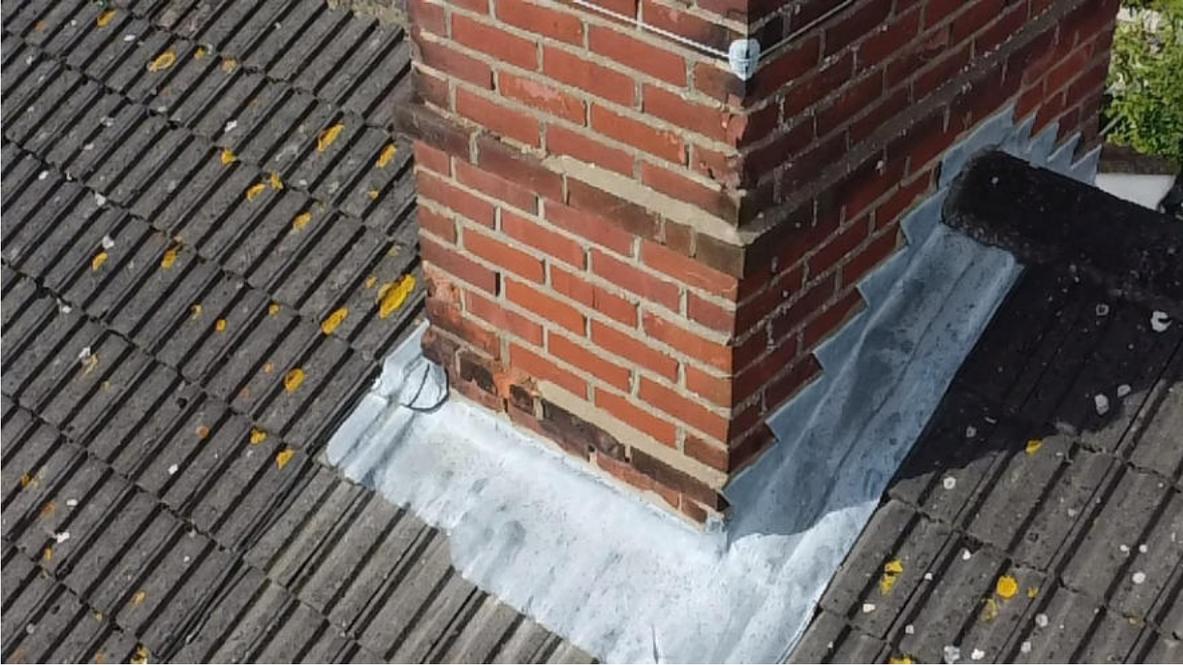
Cement repointing; flashings generally neat

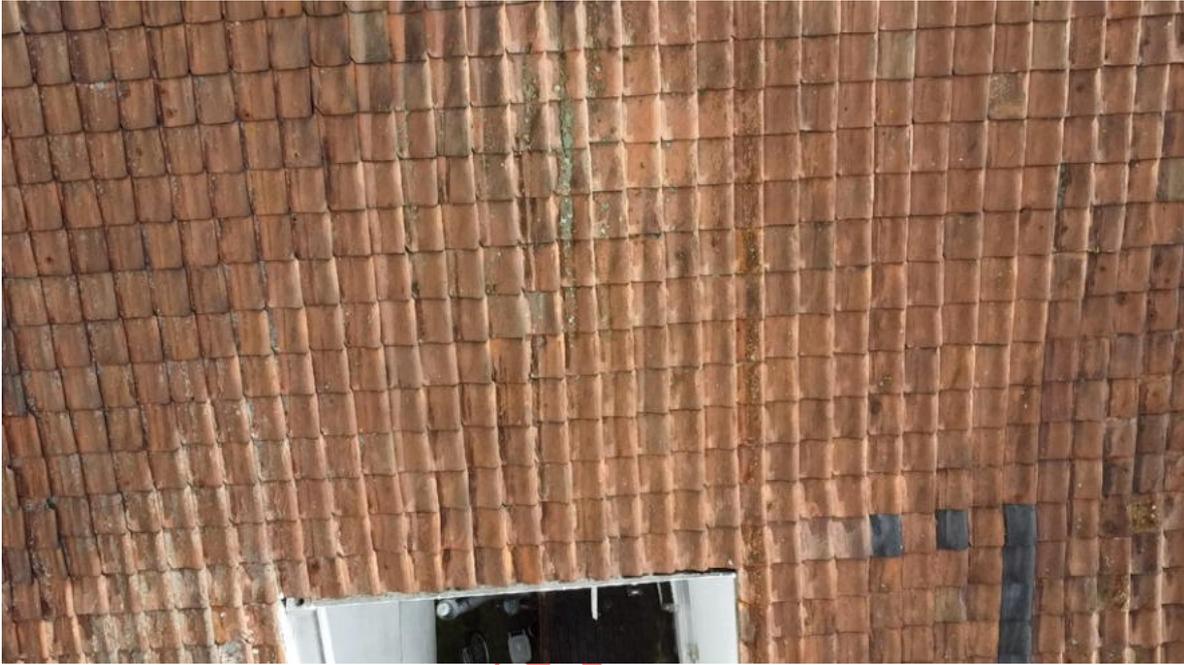
There are some cracked, slipped, and/or missing tiles to the rear slope, which is in generally average condition and exhibiting signs of wear. Some tiles show 'shaling,' a phenomenon where water enters the tile and freezes, causing them to split and crack. Localised repairs and tile replacement are required now, however, given access costs it may prove more economical over the long-term to consider re-tiling the entirety of the rear slope; some structural repair/replacement can also be undertaken to the underlying timbers at the same time (see E1).

Surface wear and shaling

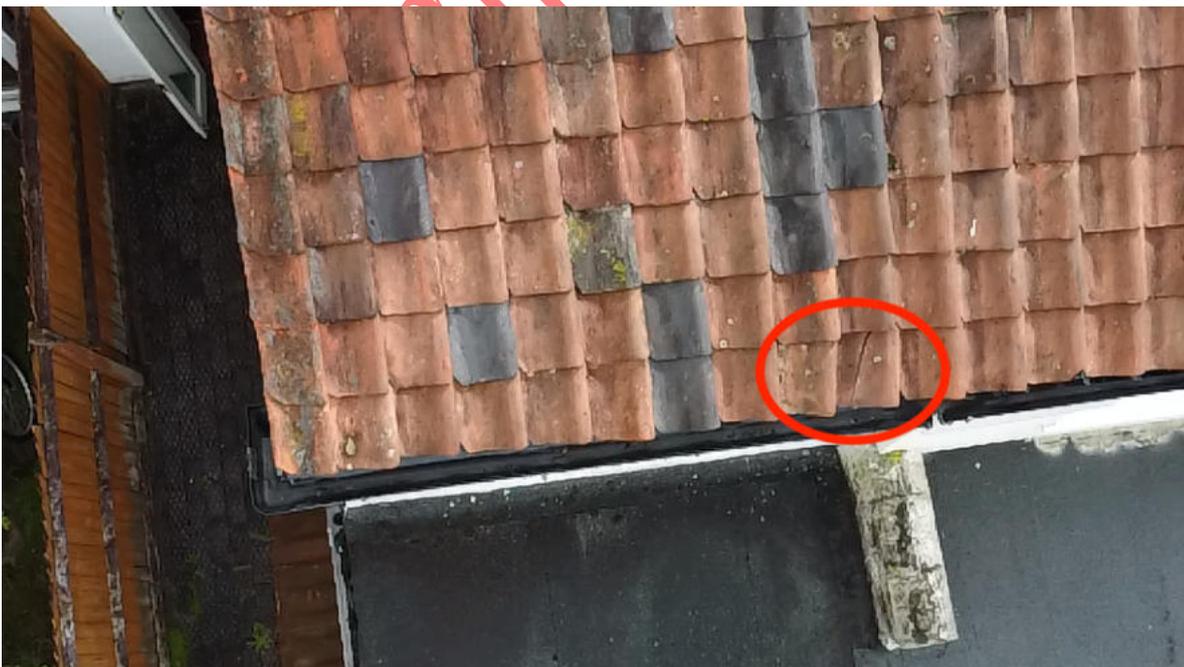
Cracked and slipped tiles

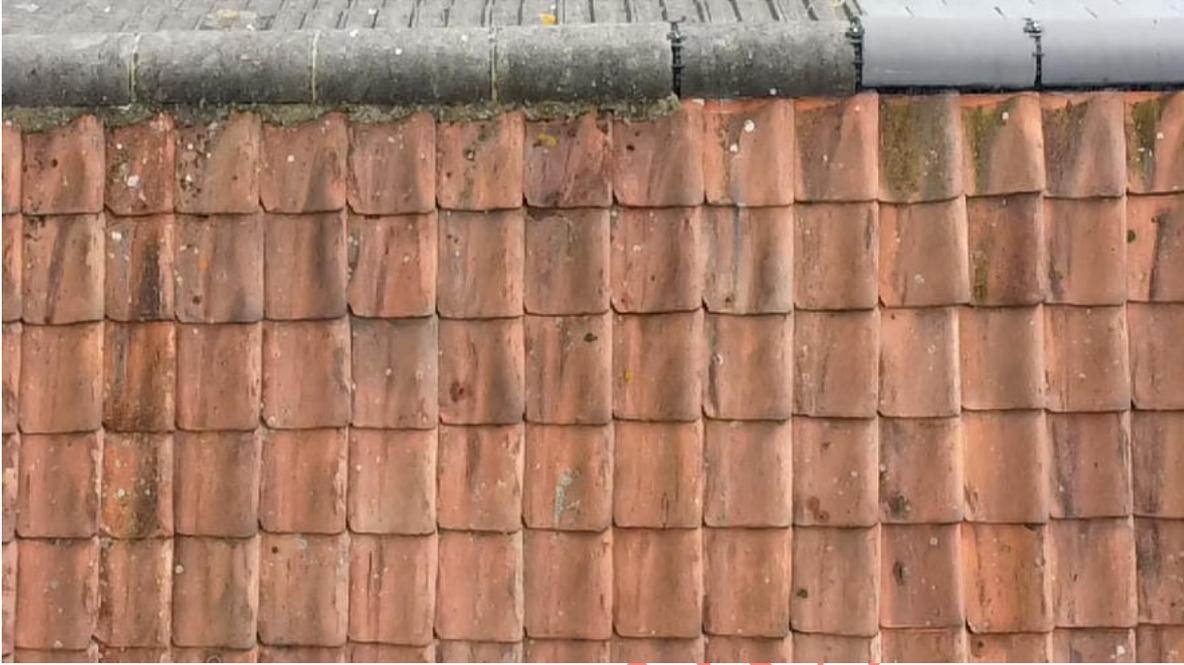
Surface wear; ridge mortar generally in satisfactory condition

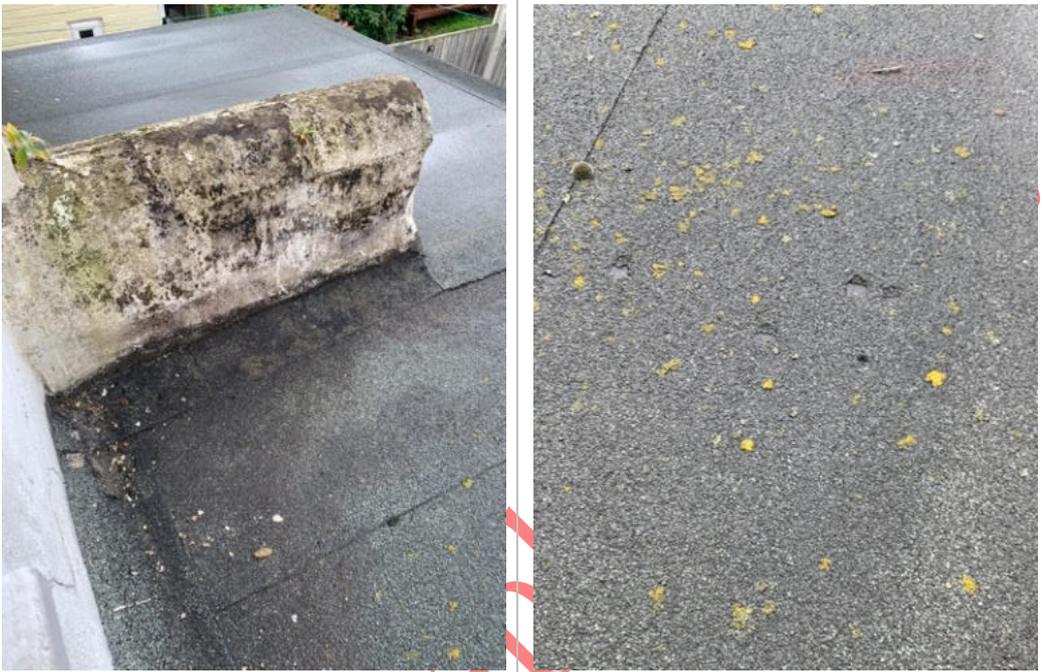
The rear extension has a flat roof comprised of torch-on bitumen felt. There was no evidence of standing water or ponding, however, there is some surface damage and debris, and some seams exhibit moss growth, which should be cleared. You should appreciate that traditional flat roofing materials have a limited life (typically 10 – 15 years) and can be prone to failure, particularly at joints such as the pointing to the upstand with the rear wall and at seams. Apart from regular maintenance the need for renewal must be anticipated eventually. Upgrading to a synthetic rubber such as ethylene propylene diene terpolymer (EPDM) may be more cost effective in the long term, as the expected service life of this type of material can average 50-60 years if installed and detailed correctly.

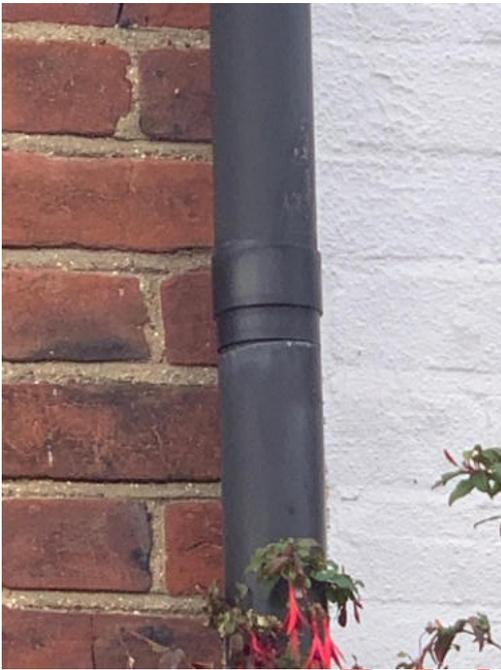
The rainwater goods and external drainage pipes are made of PVC and are in broadly average condition. They are aged and likely to be brittle from UV degradation, and also their rubber seals are beginning to perish, which has led to leaking from the joints.

UV degradation, loose joints

A general overhaul is now recommended. Complete renewal is likely to be more cost effective than localised repair.

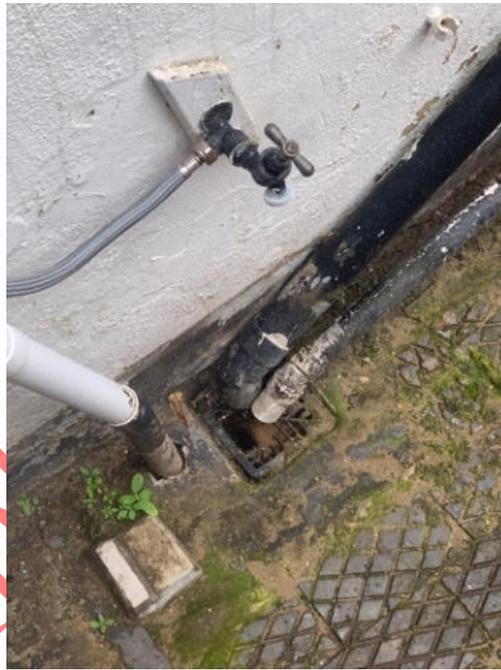
Some gullies and drains were blocked or damaged also; you should make sure to check these periodically and ensure they are free of leaves and other debris so that rainwater can be efficiently carried off to the drains, and that grilles are fitted to prevent blockage.

Damaged gully, brittle drainage pipes

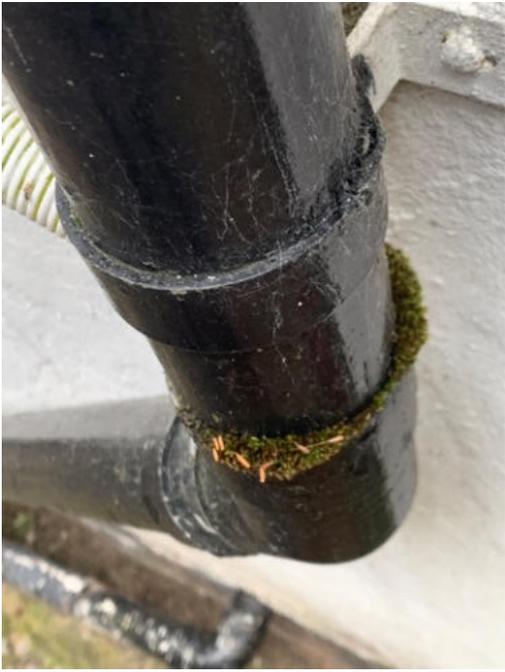
Joint leaks

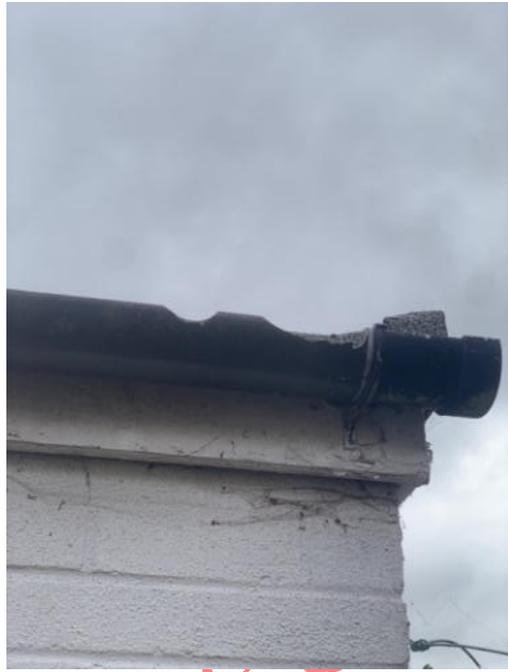
Damaged guttering

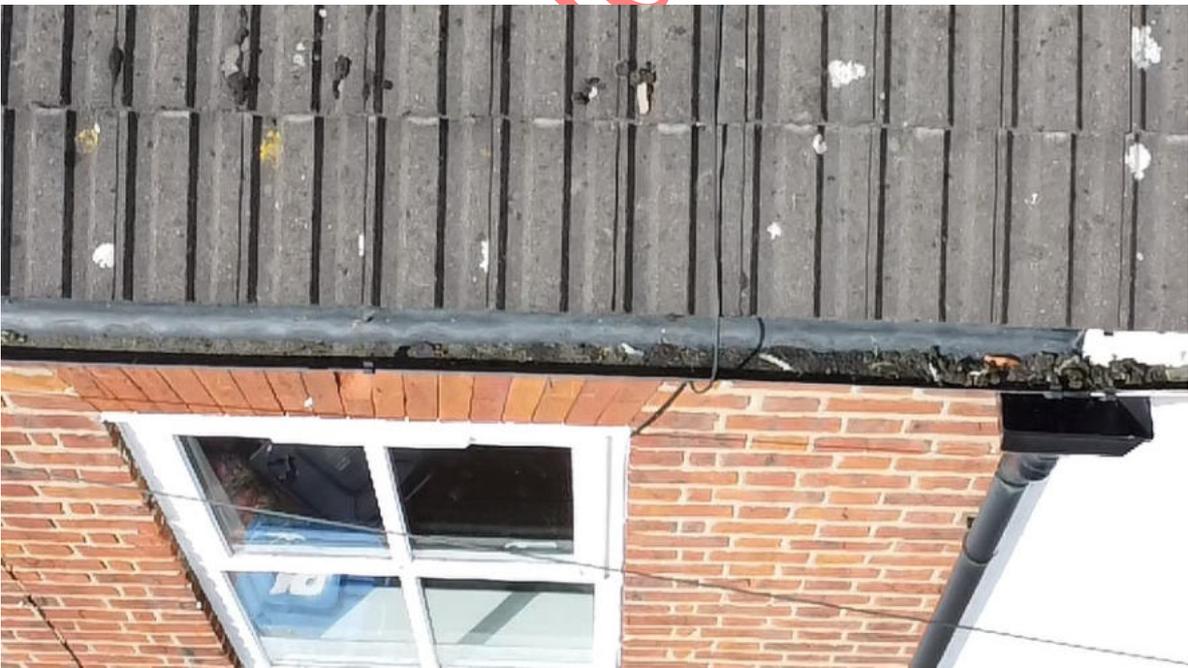
Blockages visible throughout

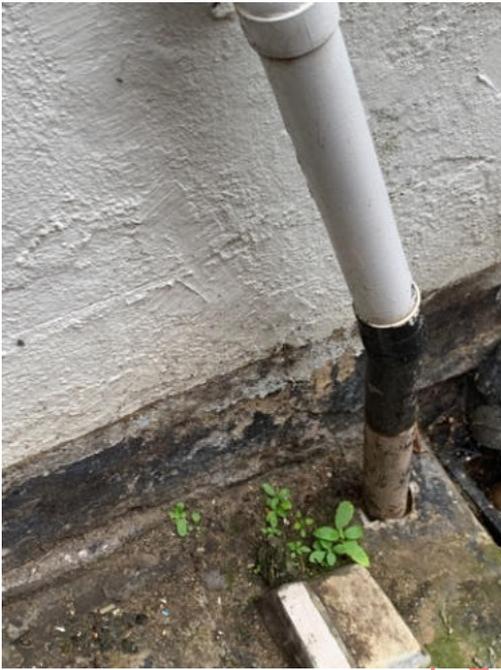
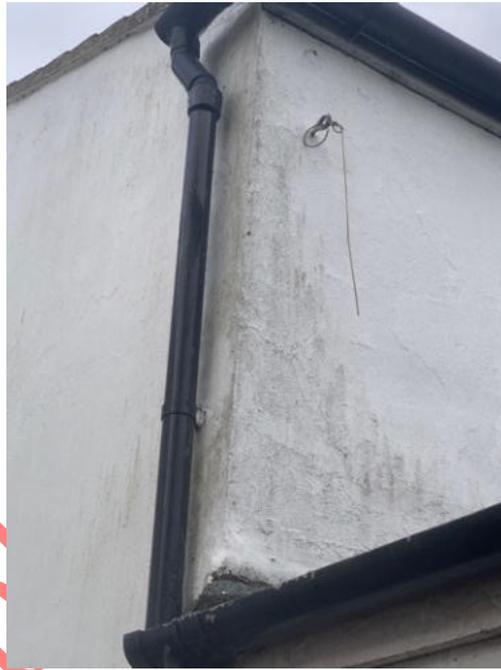
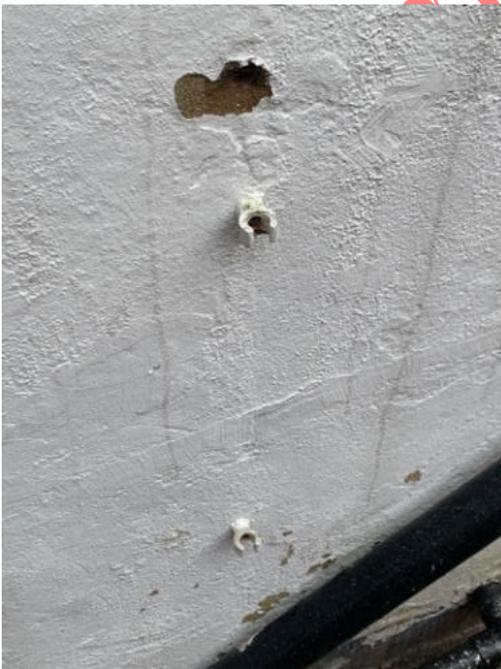
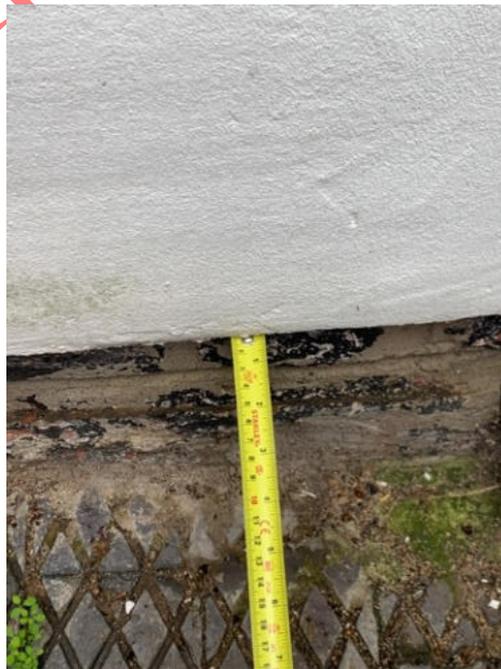
The walls at rear are rendered and painted. Where walls are rendered we cannot comment directly on the condition of walling beneath and it is possible that the rendering may be concealing distortions to brickwork or other defects. It is recommended that the render be regularly coated with good quality masonry paint as its integrity is vital. Once water penetrates its external surface then damp is likely to occur internally and the render itself will continue to deteriorate. The render is in generally average condition and in need of repair and redecoration; areas of paintwork have totally failed, a video file of this defect will be provided to you along with the PDF copy of this report. We would also recommend cutting a 'bell drip' or 'skirt' to the rear elevation (as already exists at the flank elevation) to allow the render to shed water away from the bottom of the walls and prevent damp penetration.

Paint failures throughout

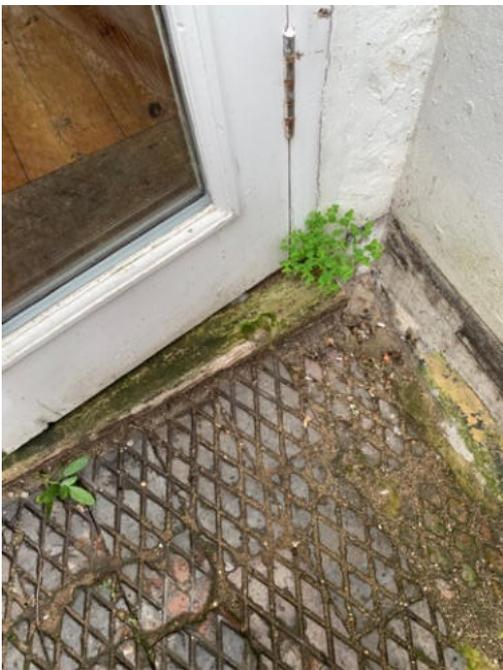
The rear door comprises a pair of hardwood timber framed, double-glazed French doors with toughened glass that are in broadly similar condition to the windows as described in D5, above. There were no visible gaps to the edge seals and no visible damage to the glass, which is toughened 'safety' glass, and no misted panes, however, decorative wear and paint failure is evident throughout and should be addressed now along with window works. Metal threshold plates could be installed to prolong the life of cills.

Early wood rot

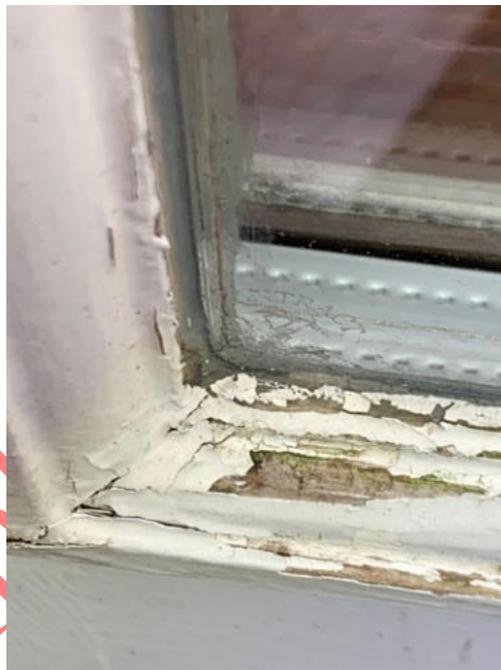
Decorative failures

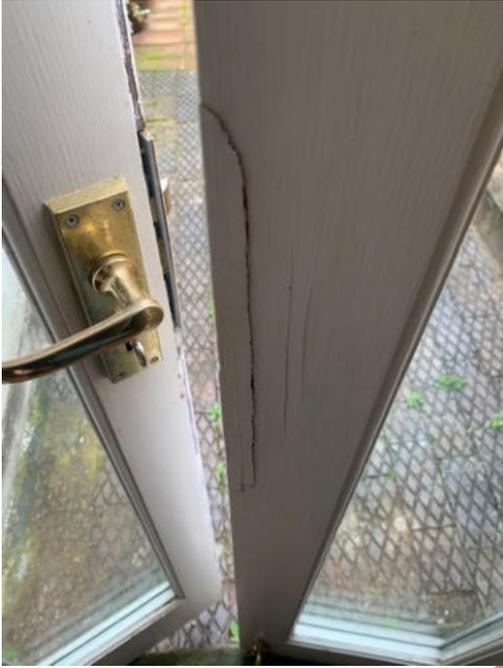
The door opened, shut, and locked, but there is play in the lock rebate which appears to be damaged and may not be fully secure. This is both a safety and an insurance issue, and should be addressed urgently. A video file of this defect will be provided to you along with the PDF copy of this report.

Damage to lock rebate

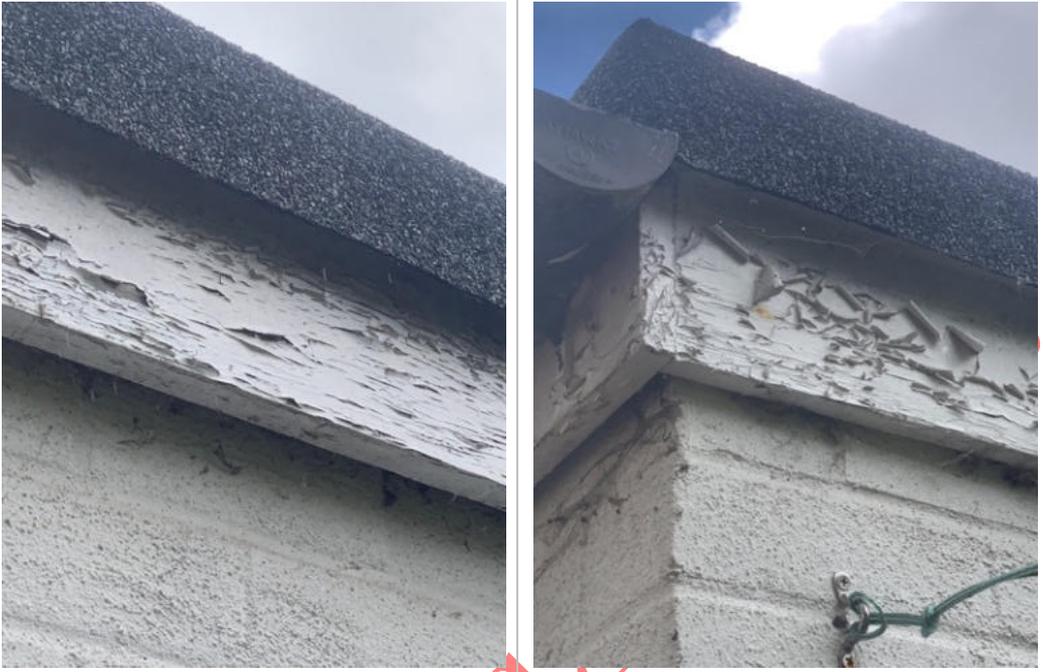
The timber fascia at rear are all in average condition throughout with evidence of decorative failure and require overhaul now. As stated in D5 and D6, above, exterior timber joinery components require regular redecoration to prevent wood rot and ensure good aesthetics.

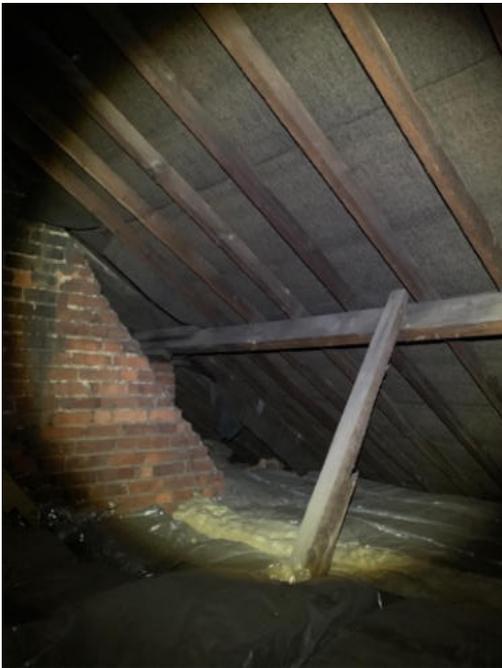
There is no full-height party wall masonry at the #19 side. Party walls act as fire breaks between properties and must be contiguous through their full height and built of fireproof material (e.g. brick/block); the lack of a coherent party wall between the adjacent loft spaces presents a serious risk of fire spreading between the properties and may affect your ability to obtain buildings insurance. The party wall at the #21 side has been added/rebuilt in modern concrete block, and a similar solution should be implemented at the opposite side.

Lack of party wall, #19 front

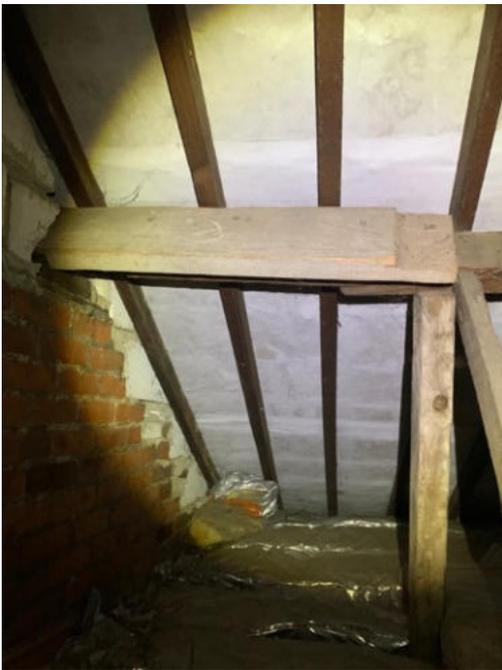
The roof purlins were noted to be visibly deflected, suggesting some degree of structural stress, common in properties of this type and age. Bracing repairs have been made, which appear to be holding, however, we cannot comment on the age nor on future suitability of this arrangement. It would be prudent to ask

Structural reinforcement to rear purlin

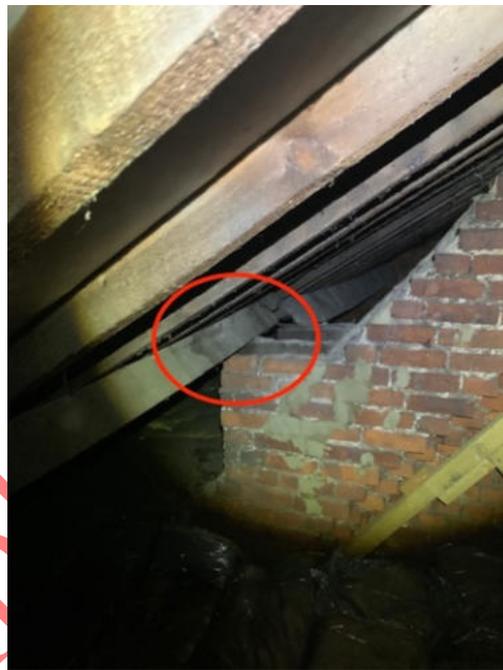
It was historically common for purlins to be built directly into masonry walls or onto chimney stacks, and these junctions are recognised as potential weak points for damp penetration and timber decay. We noted discoloration of purlins in the loft space at these points but had no safe access to test for damp; defects/rot could exist and cannot be fully ruled out.

Discoloration to purlin with direct masonry contact; potential damp/wood rot

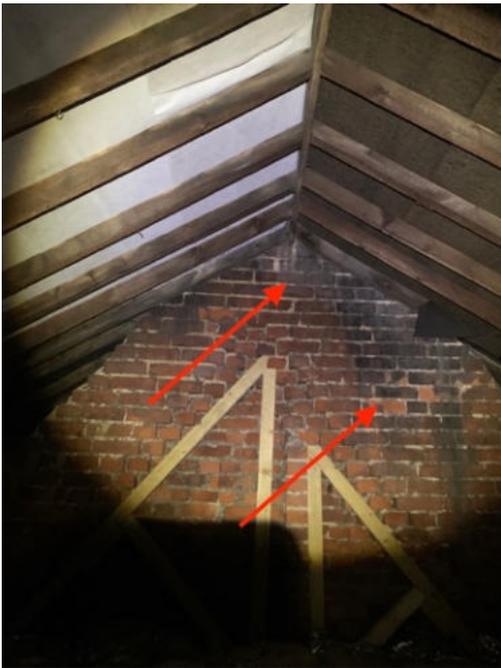
There is evidence of damp penetration to the chimney (see also D1), however, we had no safe access to directly test or check the integrity of the brickwork. Once repairs recommended in section D1 are undertaken and ventilation to the roof space upgraded, the chimney masonry should dry out on its own, ideally assisted by a dehumidifier, and final repairs such as repointing and replacement of perished bricks can then be undertaken. Left untreated the situation will worsen and masonry will continue to degrade.

Evidence of damp penetration and brick spalling to chimney, more noticeable at front (righthand side of photo above)

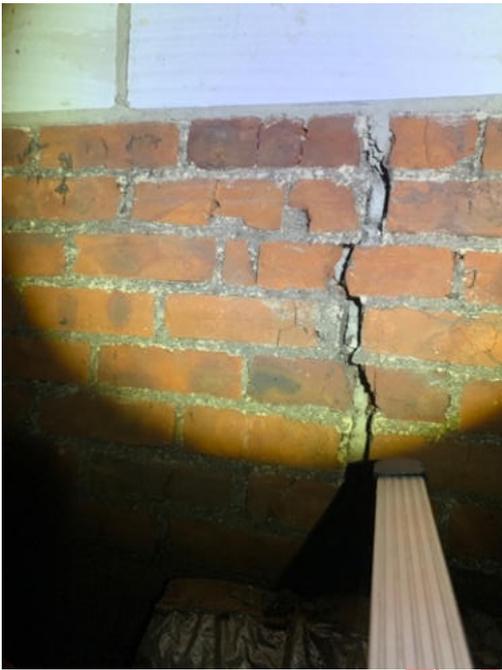
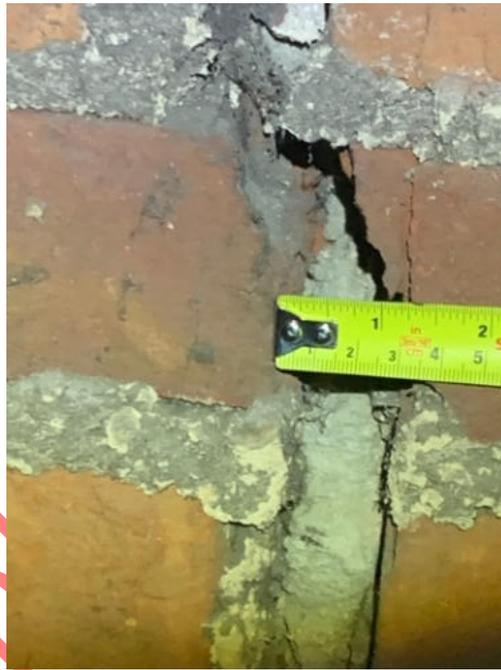
There is a large crack to the party wall at the #21 side, exceeding 30mm in some places. There is no evidence of cracking to the modern concrete block above, suggesting that this is from historic movement, however, you should be aware that it is impossible to confirm from a single inspection whether the issue noted is progressive or historic and that this report does not constitute an indemnity against future structural defects. A structural engineer should be commissioned to specify a helical bar repair or similar, which should be implemented by a competent contractor now. Evidence such as this can be noted on mortgage valuation surveys and severely compromise the property's suitability for mortgage security and therefore limit onward sale.

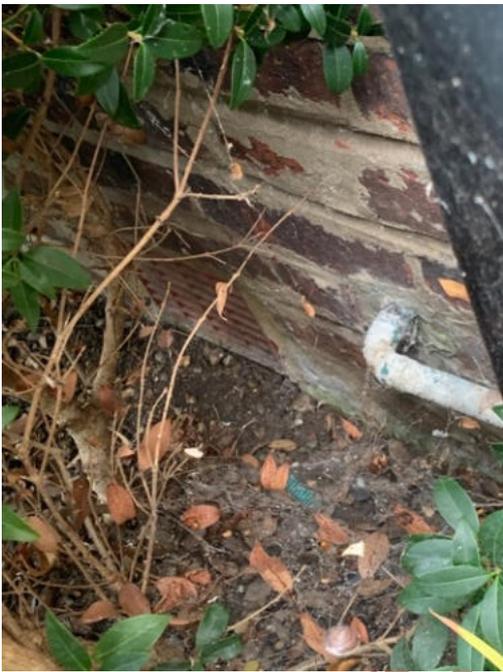
Ventilation to the timber ground floor is inadequate as there is only a single, front airbrick; additional airbricks or grilles should be provided at rear. Furthermore, any airbricks should ideally be situated at least 75mm (3") above external ground levels to prevent rainwater ingress. There is a possibility that rot may have occurred and a precautionary check of timbers in underfloor areas is advisable (see B – Further Investigations, above).

Airbrick; front only

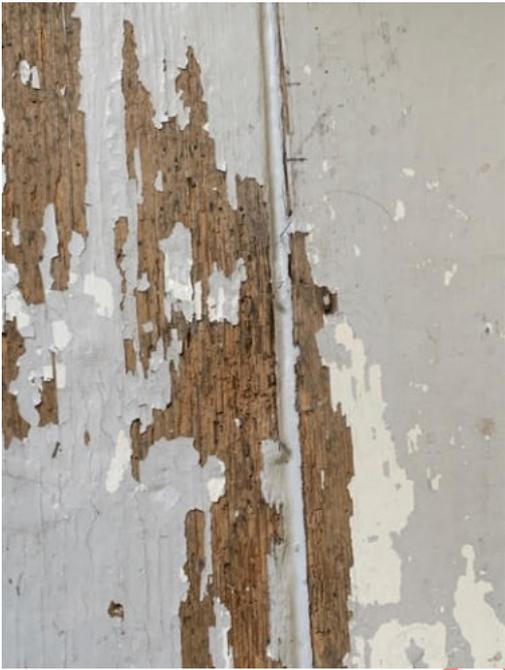
We found signs of historic wood boring beetle (woodworm) infestation, which is common in older properties. Historic woodwork is susceptible to attack in concealed areas such as floor voids and roof spaces, and as per our advice in B – Further Investigations, above, you may therefore consider it prudent to instruct a timber specialist to report specifically on this issue. We suggest any appointed firm are a member of the Property Care Association (PCA) and that you ensure all remedial work is carried out under a long term and meaningful (e.g. insurance-backed) guarantee. Any guarantees or warranties for treatment works already undertaken should also be obtained.

Historic woodworm

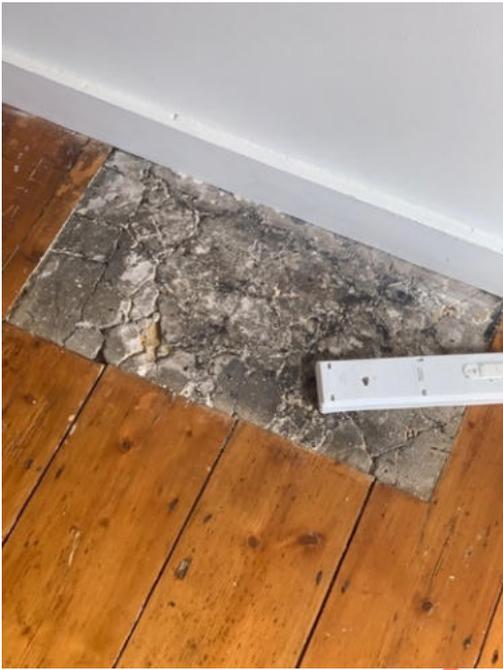
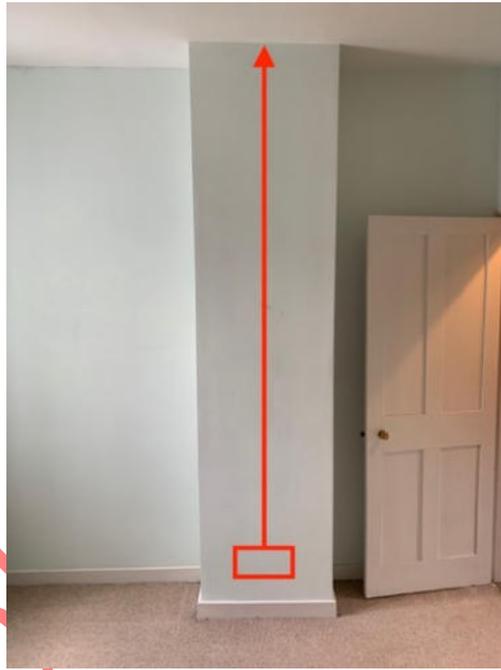
Increase flue ventilation

Where original chimneys have been blocked, provision should be made for through ventilation to reduce the risk of condensation damp. We would therefore recommend the installation of suitable vents in order to increase the level of ventilation to the flue, and vent cowls should also be fitted to any open pots above the roofline (see D1).

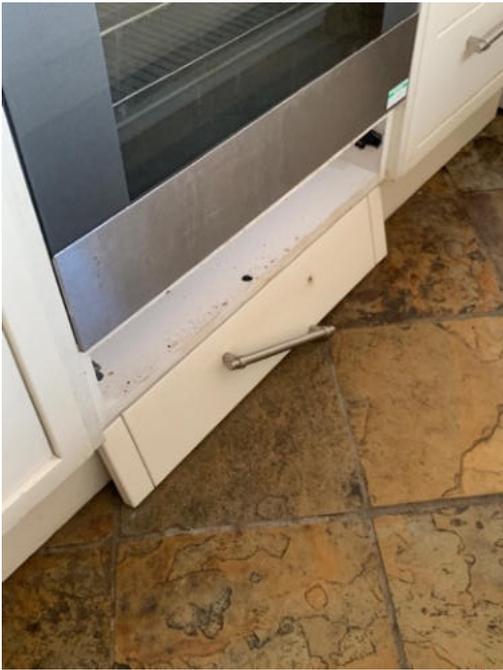
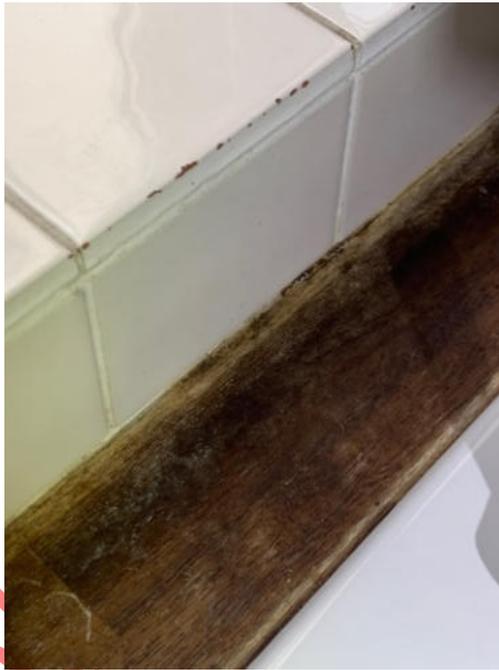
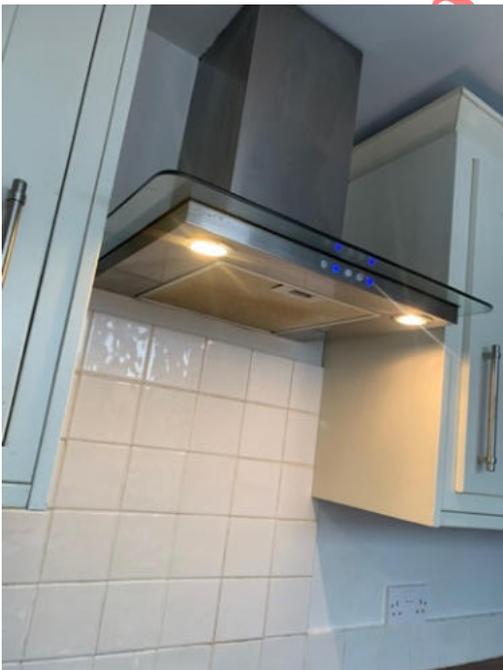
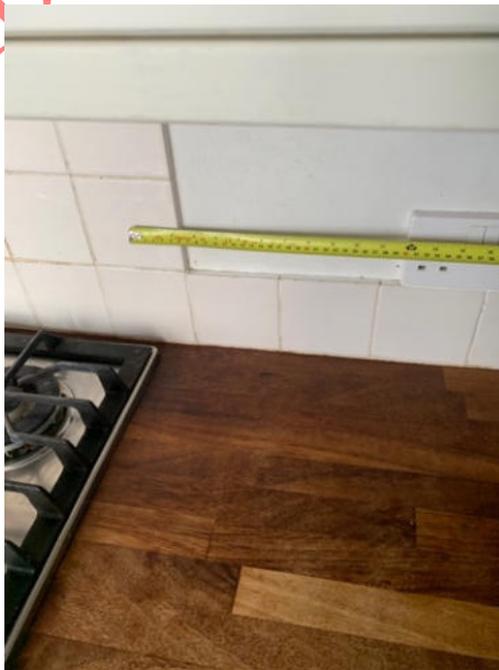
The kitchen is fitted with built-in fittings that are dated and in average condition; some joinery is damaged. Flexible sealants are failing in places, and these should be replaced and monitored for degradation and kept clean as their failure can result in damp ingress and wood rot. There is mechanical ventilation present, which was functioning correctly during our inspection. There are electrical points located on the splashback that are too close to the hob. NIC/EIC good practice is to allow a minimum clear distance of 300mm; the present arrangement may pose a fire risk from trailing cables to small appliances.

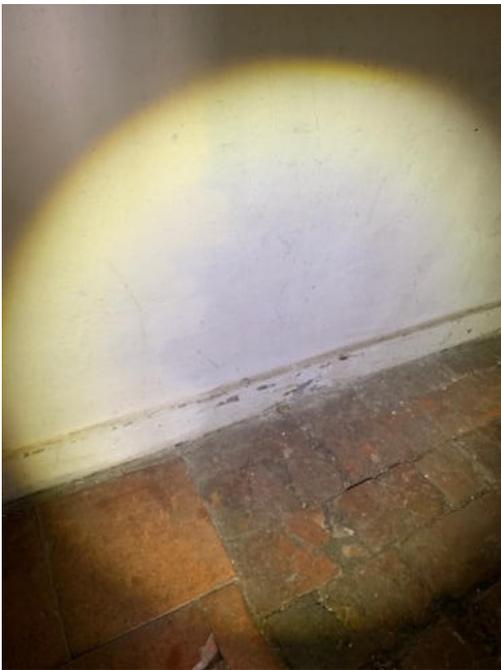
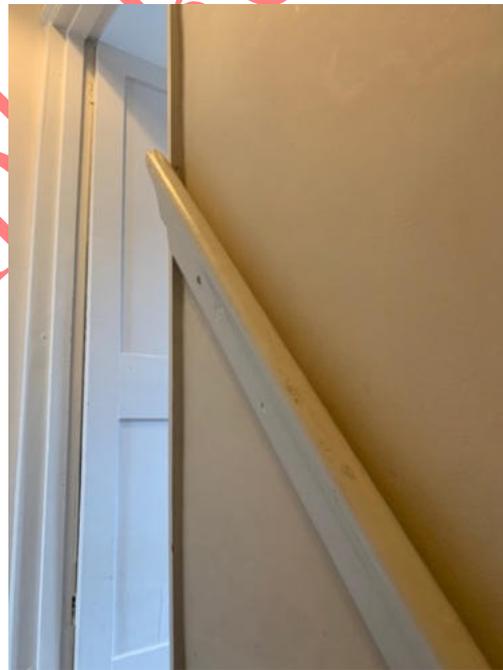
The handrail is dangerously loose and unlikely to take the weight of an adult reaching for it in a fall. In its present condition it poses a serious hazard and should be upgraded as a matter of urgency; a video file of this defect will be provided to you along with the PDF copy of this report.

Loose handrail; hazard, urgent repair

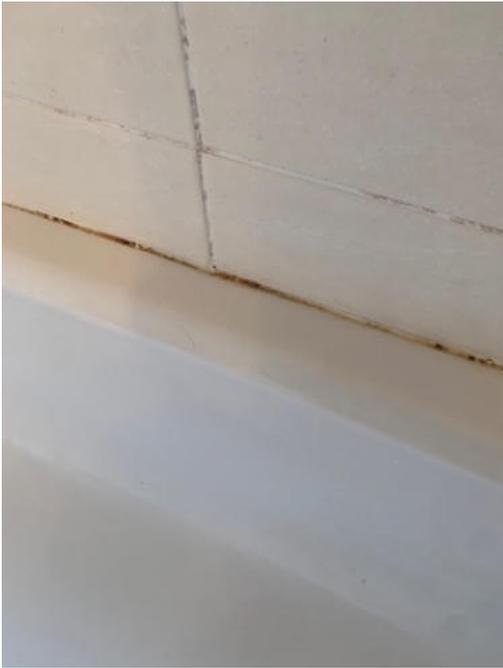
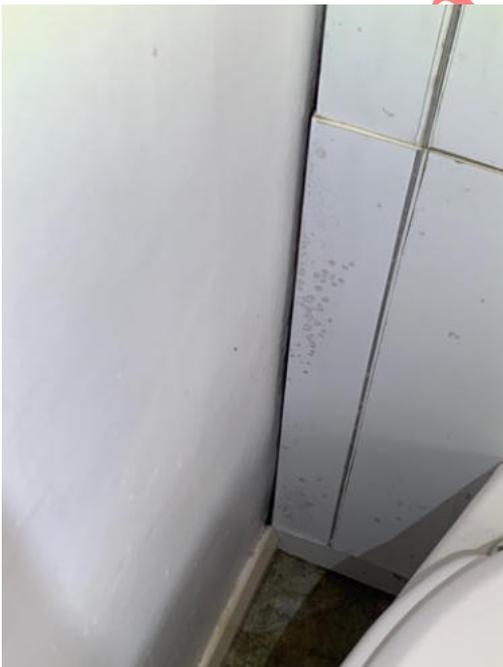
The bathroom is fitted with dated sanitaryware and is in generally average condition. Some sealants around the edges of sanitaryware were in poor condition and should be replaced as they can leak and damage adjacent surfaces. If not repaired quickly, wood rot can soon develop. There is damage to joinery and some areas are poorly finished. Mechanical ventilation is present and was functioning correctly during our inspection.

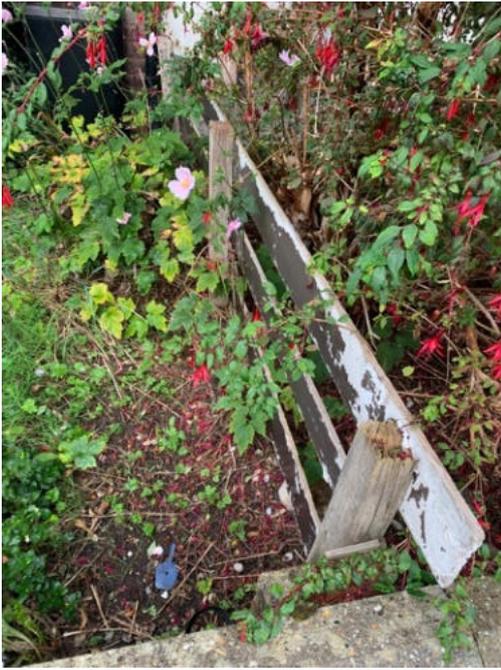
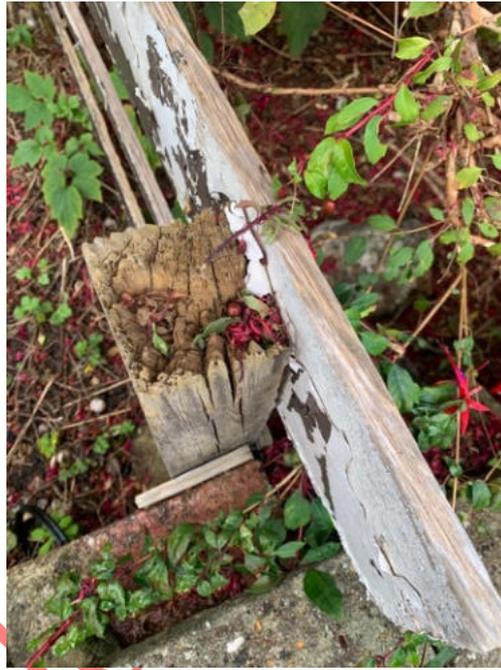
The front garden boundaries show wood rot and wear and are due for replacement now. The brick garden wall at front is in poor condition, with loose brickwork/coping that can be moved easily by hand. In its current condition this may pose a serious safety risk to passers-by and there is therefore a public liability consideration. You should attend to this defect as soon as possible; a video file will be provided also.

Wood rot

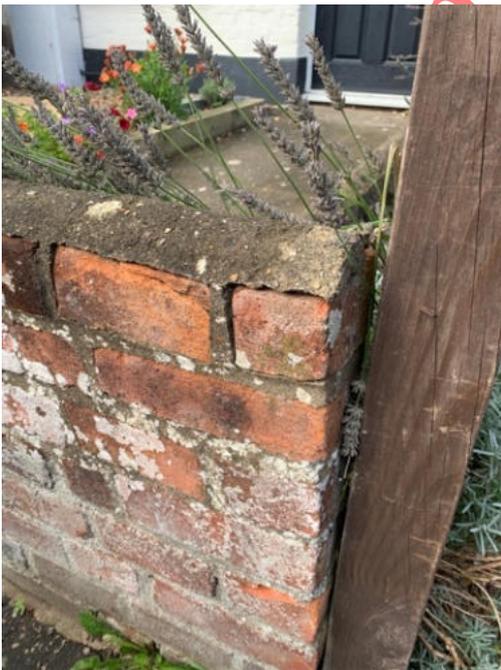
Loose brickwork/coping

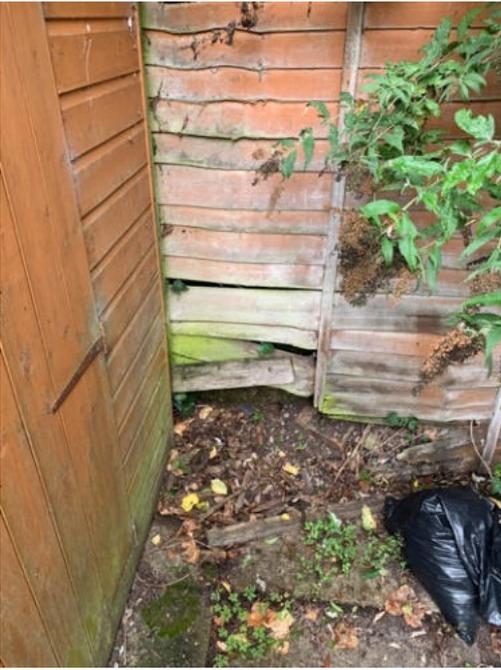
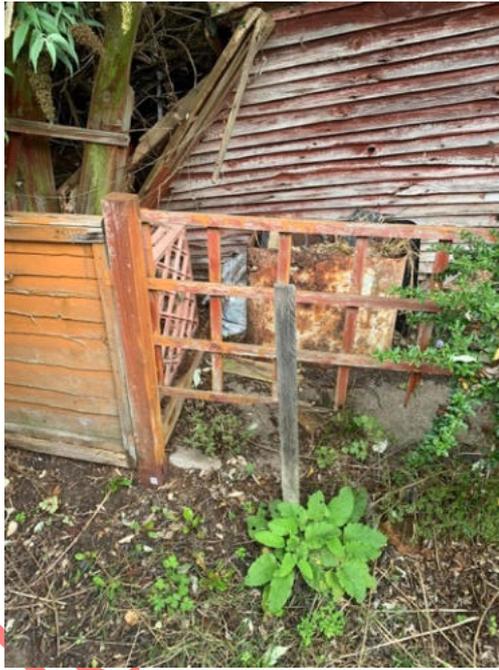
There is damage to fence panels at rear and repairs are required now. Your legal advisor should confirm responsibility for all boundaries, and also confirm rights of way and shared maintenance responsibilities for the bisecting garden path and shared passage between #37 and #39. The gate to the shared passage was in satisfactory condition and opened, shut, and locked cleanly during out inspection.
