# Peer | King Surveyors

## LEVEL 3 Your Survey Report

Property Address 42 Any Street  
Norwich  
NR1 1AA

Inspection date 14 October 1066

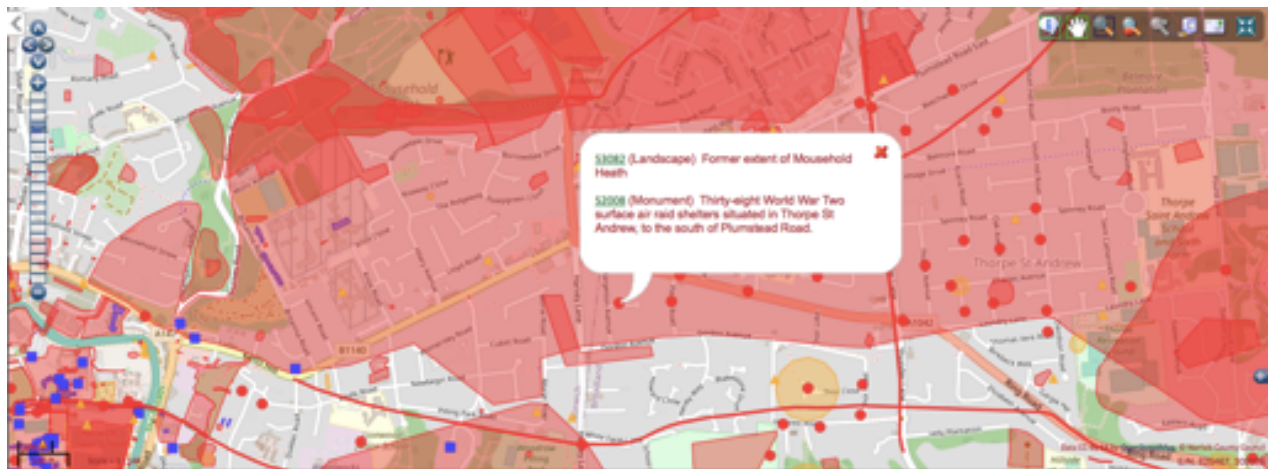
The property is in an area that is unlikely to flood (see section 12 Risks). We have been provided with excerpts from your local search indicating the likelihood of mining cavities and sinkholes in the local area. Although it is likely that there was historic chalk mining in this part of Norwich, our search of the Norfolk Heritage Explorer has only yielded references to World War II bomb shelters (see below):

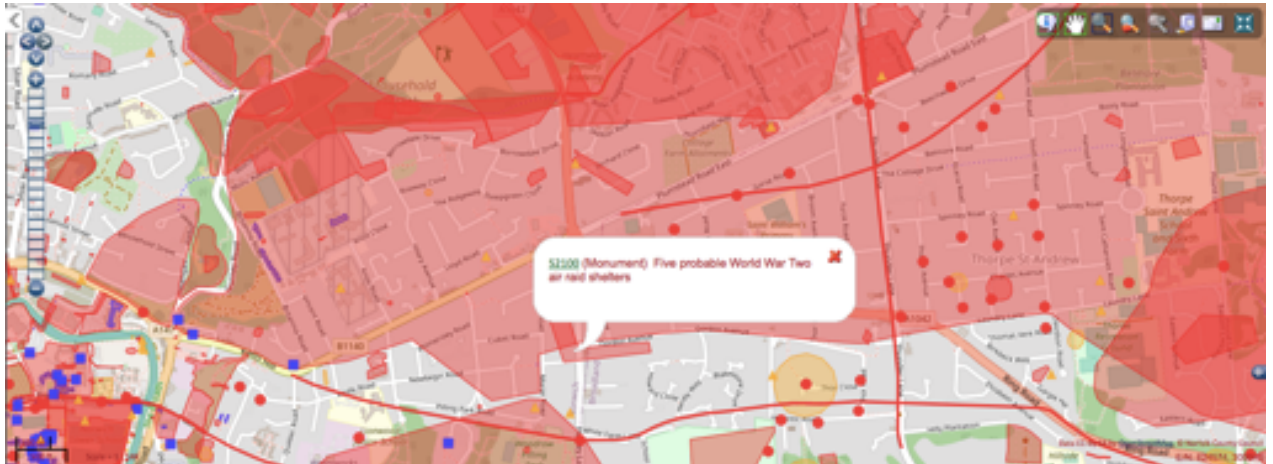
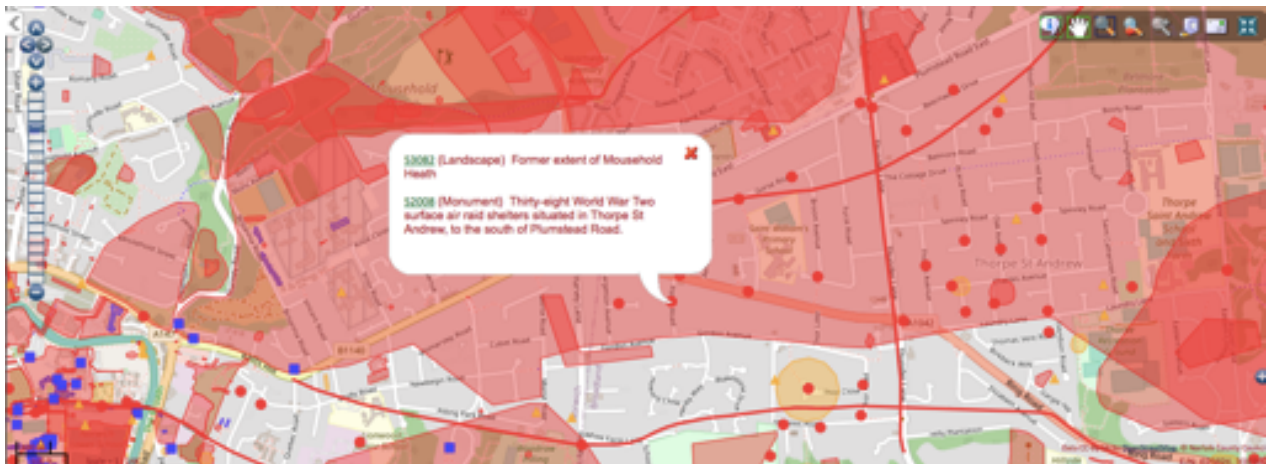
... Local environment continued

You should ensure that you are able to obtain buildings insurance without onerous terms, including cover for subsidence and land heave. Cover may be more expensive than usual or may be difficult to get.

During my inspection I found no evidence of historic or current subsidence (see *D – Outside the Property*, below).

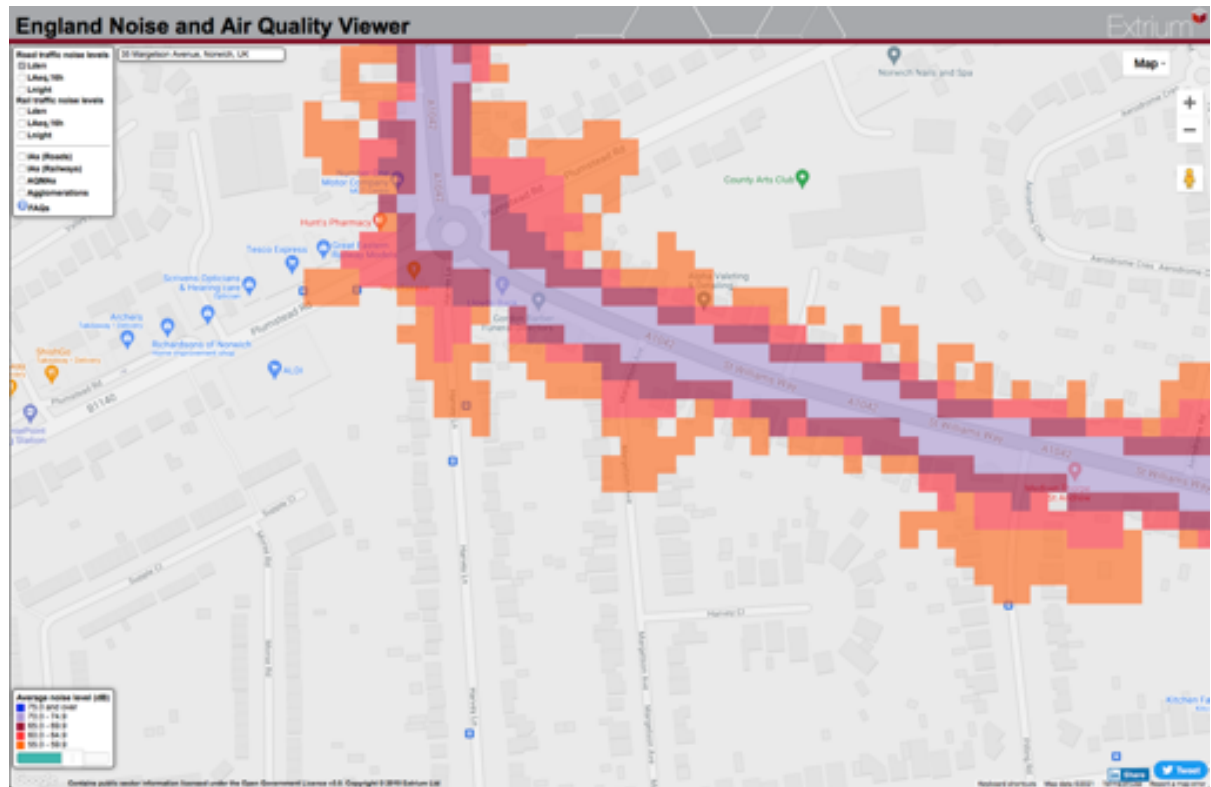
There was audible road noise from the A1042 during my inspection. Data suggests that the property is in a location that may suffer some nuisance from traffic noise on this road (see below).

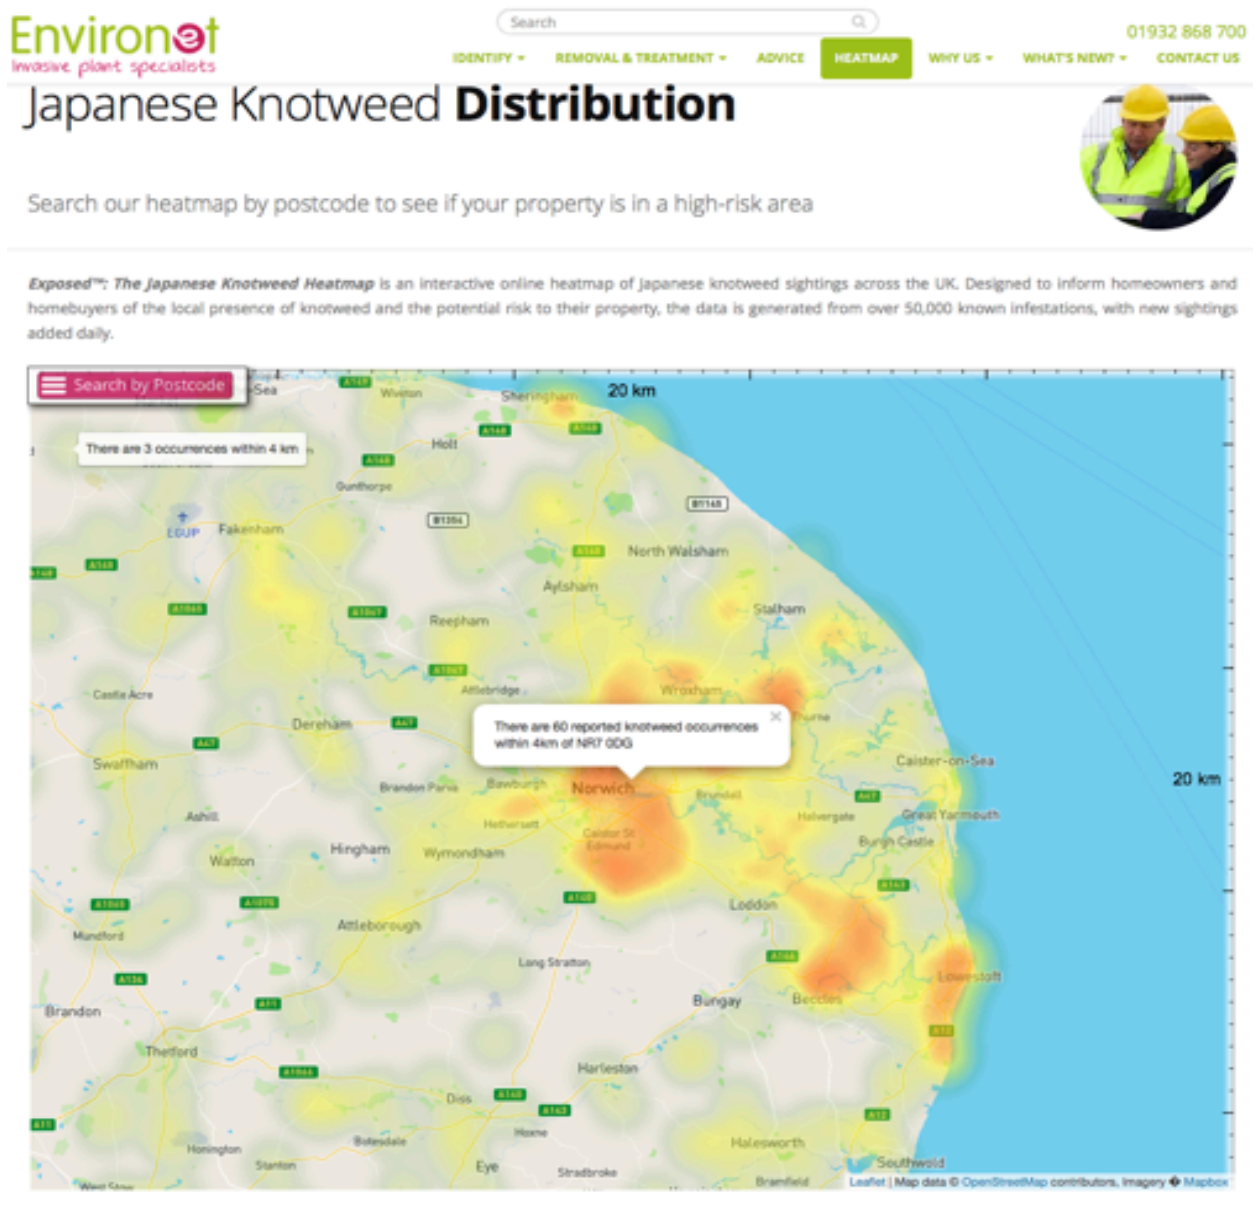
We have not checked for Japanese Knotweed (JKW) or other invasive plants, however, if any suspected invasive plants were visible during our inspection these will be noted. The property is in a medium level 'hot-spot' for JKW (see below). It is recommended that you commission an inspection and report from a qualified specialist if you have concerns about invasive plants, as we cannot rule out the possible presence of JKW or other invasive plant species.

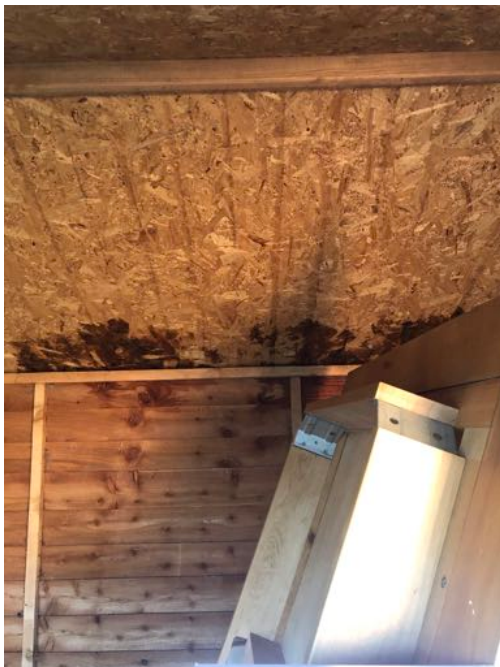
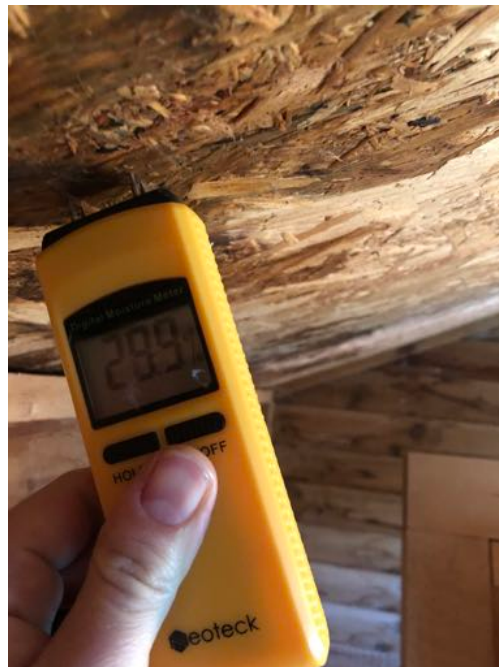
There is a pair of timber garden sheds at the rear (west) property boundary. Both are broadly in good condition, however, there is visible damp penetration to both shed roofs along their rear slopes. Condition Rating 2.
