Sample Survey Report

17 Real Street
Norwich
NR1 1AA

14 October 1066

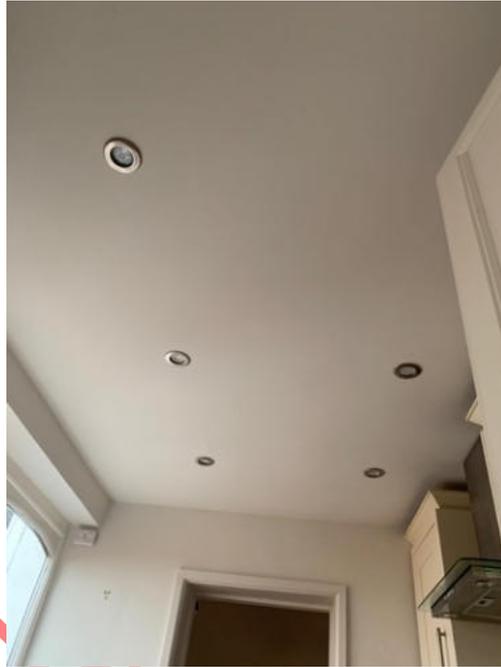
The property has battery-powered smoke detectors at ground and 1st floors, but no heat detector is fitted in the kitchen. The stairs are very steep and awkward, typical for properties of this type and age, and the handrail is dangerously loose (see E7). 1st floor windows do not provide secondary means of escape as the lower panes do not open. You are advised to consider the installation of a comprehensive smoke / heat detection system to LD1 standard under BS 5839 Pt 6: 2019 with heat detector in the kitchens and smoke detection in the living rooms and all bedrooms.

No heat detection in kitchen

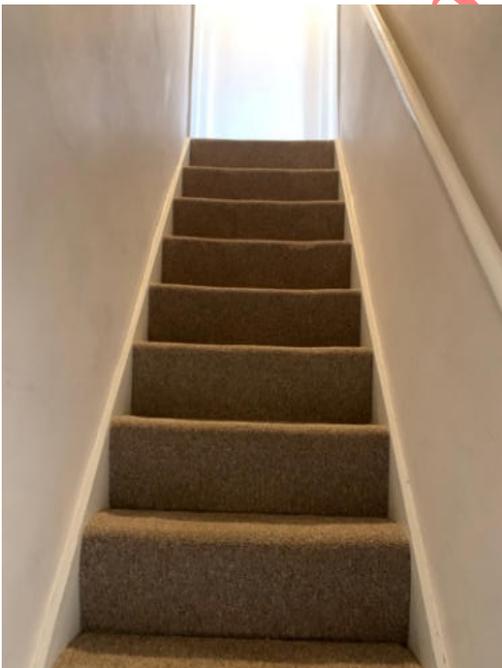
Stairs difficult; consider occupancy requirements

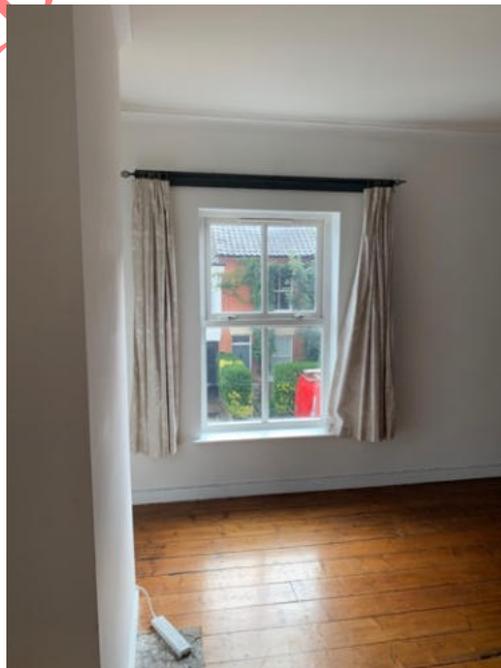
1st floor windows: no secondary means of escape

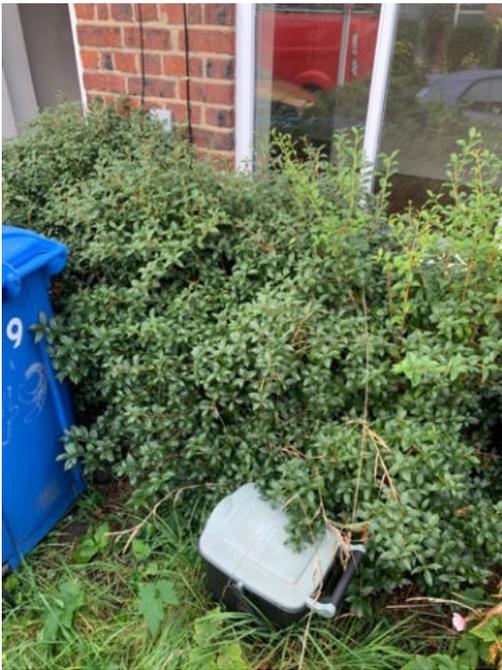
Mature planting obscured our view of parts of the building exterior:

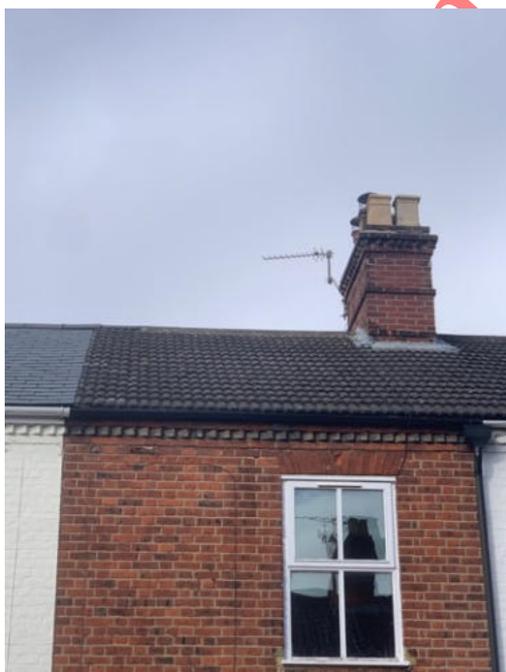
Front slope

There is minor undulation and unevenness to the roof covering, common in properties of this type and age due to long-term shrinkage and minor movement in the roof timbers under the covering. This will be exacerbated by the weight of the concrete tiles to the front, which are significantly heavier than the clay tile for which the structure was originally designed. We noted no cracked or missing tiles to the front and there is no significant moss build-up.

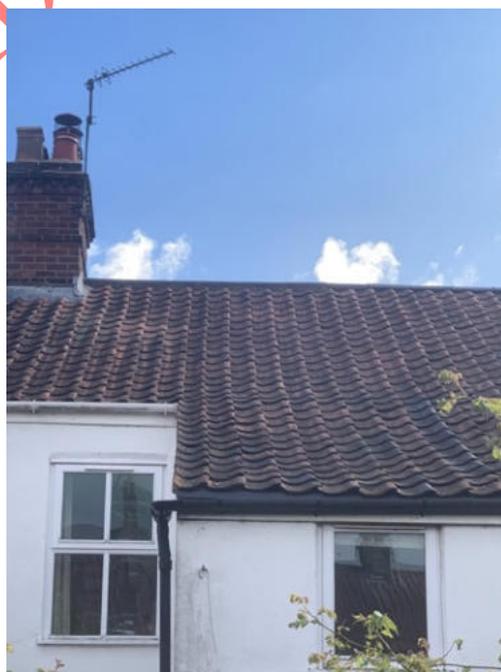
Rear slope

There are some cracked, slipped, and/or missing tiles to the rear slope, which is in generally average condition and exhibiting signs of wear. Some tiles show 'shaling,' a phenomenon where water enters the tile and freezes, causing them to split and crack. Localised repairs and tile replacement are required now, however, given access costs it may prove more economical over the long-term to consider re-tiling the entirety of the rear slope; some structural repair/replacement can also be undertaken to the underlying timbers at the same time (see E1).

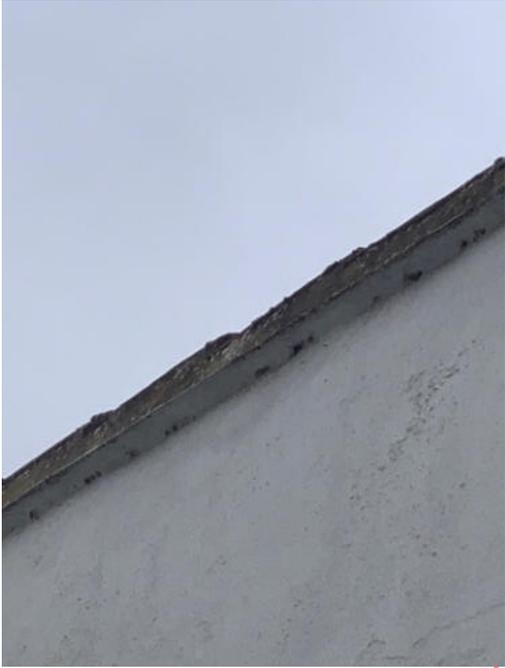
D2	Roof Coverings	2
<p>The mortar bedding at roof verges, also called a cement fillet, is in good condition. No attention is required at this time, however, the area should be reviewed occasionally and refurbishment carried out if cracking appears. The undercloaking (thin grey tiles under the verge tiles) is comprised of a material highly likely to contain asbestos cement. According to the Institute of Environmental Health such asbestos based products should not be a cause for concern, however, they should not be disturbed or drilled without taking suitable safety precautions.</p>

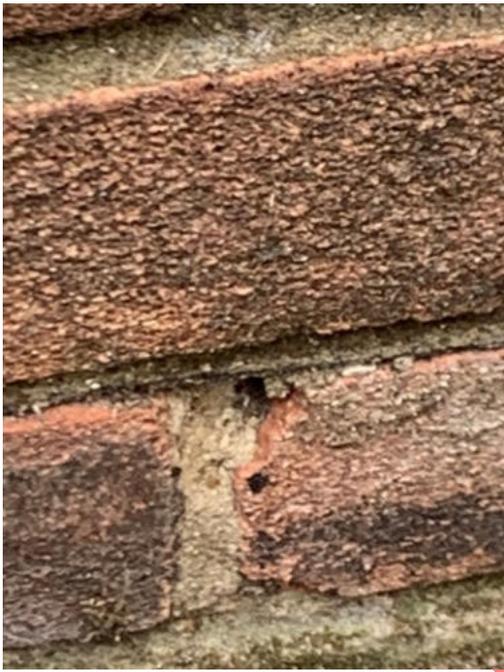
Bitumen DPC

The rear extension walls are of brick-faced cavity masonry with the bricks laid in stretcher bond (i.e. one-over-two). The damp proof course (DPC) is comprised of bitumen, typical for a construction of the mid-late 20th century. The extension is partially painted, and as with render, where walls are painted we cannot comment directly on the condition of walling beneath and it is possible that the paint may be concealing defects. It is recommended that the paintwork be regularly renewed with good quality masonry paint. The extension appears generally sound with good quality pointing and free of structural defect.

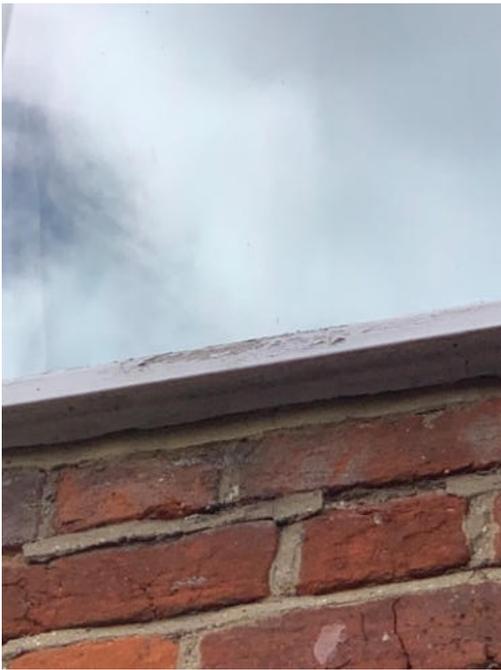
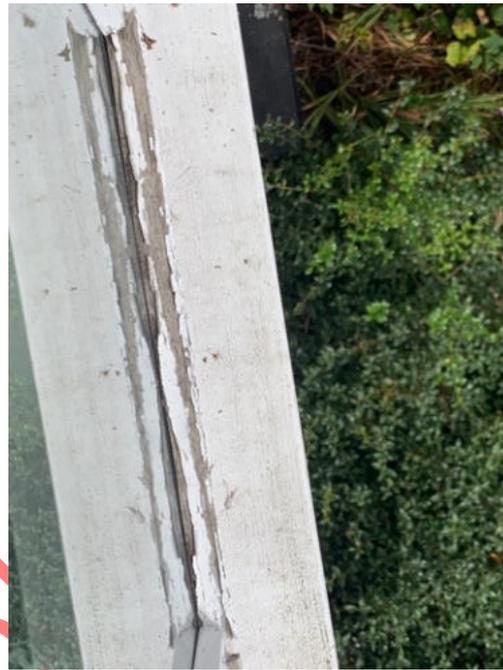
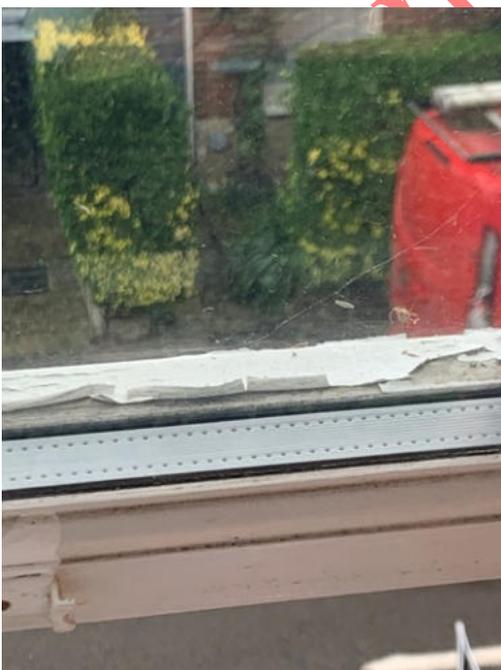
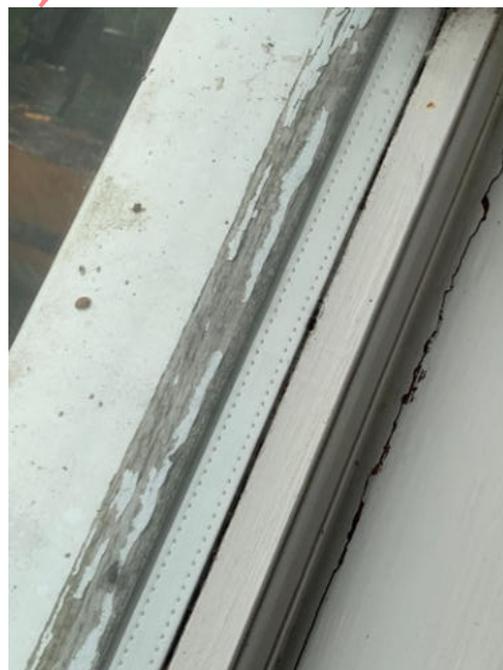
The windows are timber-framed, double-glazed units and appear to be in average condition. There was no visible misting between the panes in the double-glazing, however, edge seals are in average condition and there is some decorative wear throughout. Exterior timber joinery components require regular redecoration to prevent wood rot and ensure good aesthetics, and a programme of redecoration and localised repair is due now. Windows were tested and found to operate cleanly throughout, and there are trickle vents and therefore means of providing passive ventilation. See also Means of Escape, above, regarding 1st floor window openings.

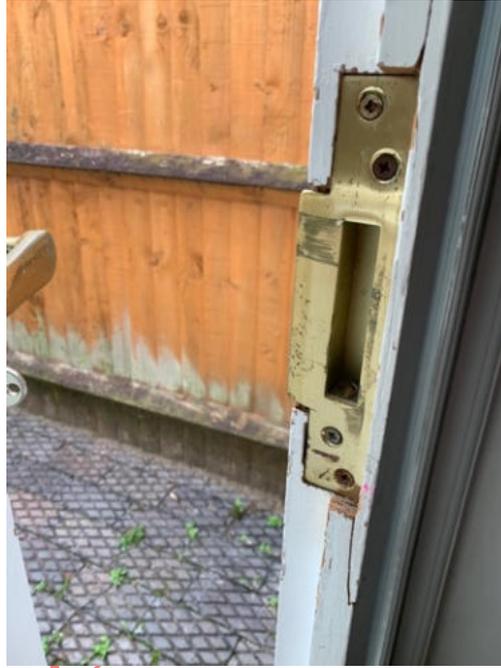
The rear door comprises a pair of hardwood timber framed, double-glazed French doors with toughened glass that are in broadly similar condition to the windows as described in D5, above. There were no visible gaps to the edge seals and no visible damage to the glass, which is toughened 'safety' glass, and no misted panes, however, decorative wear and paint failure is evident throughout and should be addressed now along with window works. Metal threshold plates could be installed to prolong the life of cills.

See also video

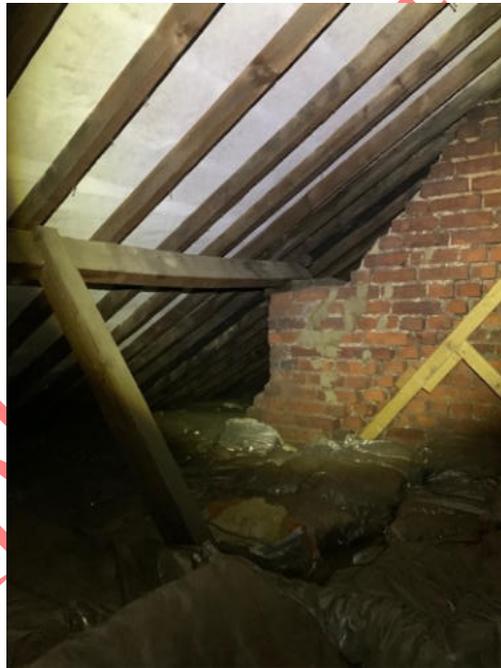
Element #	Element Name	Comments (if applicable)
D6	Outside Doors & Patio Doors	Play in lock rebate to rear doors; security
E1	Roof Structure & Roof Space (Loft)	Lack of party wall, structural repairs required
E7	Woodwork	Loose handrail to stairs; hazard
F1	Electricity	Safety Certificate
F2	Gas / Oil	Safety Certificate
F3	Water	Regulations Certificate (if applicable)
F4	Heating	Safety Certificate
F5	Water Heating	Safety Certificate

Ditto #19 rear

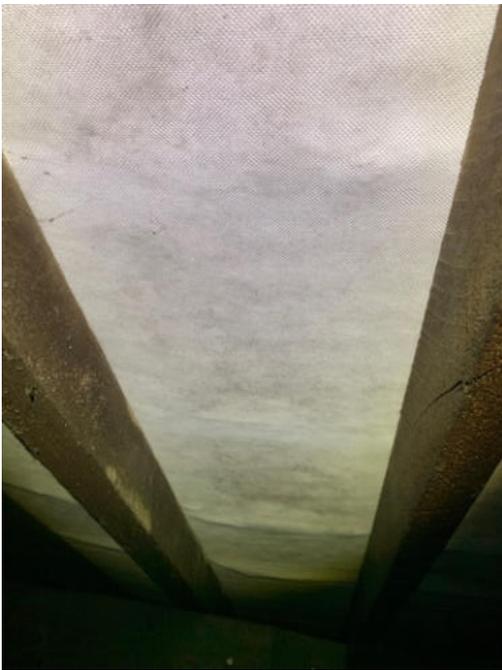
The roofing felt to the front slope is of an older, non-breathable bitumen type and is in satisfactory condition with no holes or tears visible. This type of roofing felt will not provide ventilation into the loft void, as there should be in order to prevent damaging condensation from occurring on the roof timbers. The rear slope felt is a modern, breathable type and is also in satisfactory condition. The roofing felt should provide ventilation into the loft void, however, breathable roofing felt is often not as 'breathable' as manufacturers claim, and some black mould build-up has begun to occur from condensation build-up over time, particularly as only ½ the roof space is fitted with breathable felt. Black mould causes health issues as well as blocking the pores of breathable membranes, which accelerates the problem, and we would recommend upgrading roof ventilation now as part of the works. A sample of damp meter readings on a selection of roof timbers tested dry.

Breathable felt (rear slope)

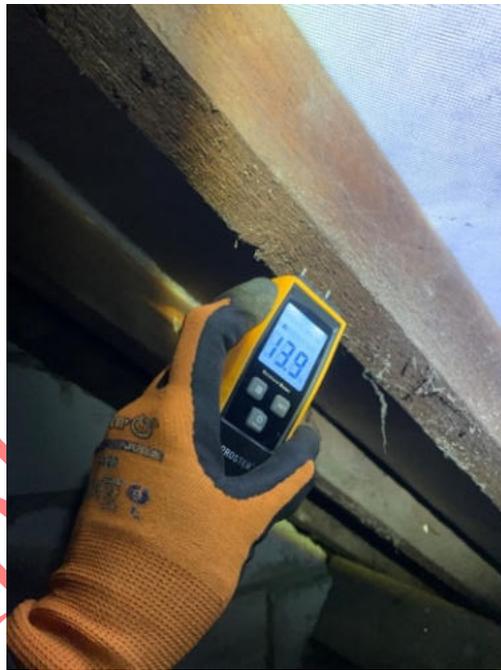
Low ('dry') damp meter readings

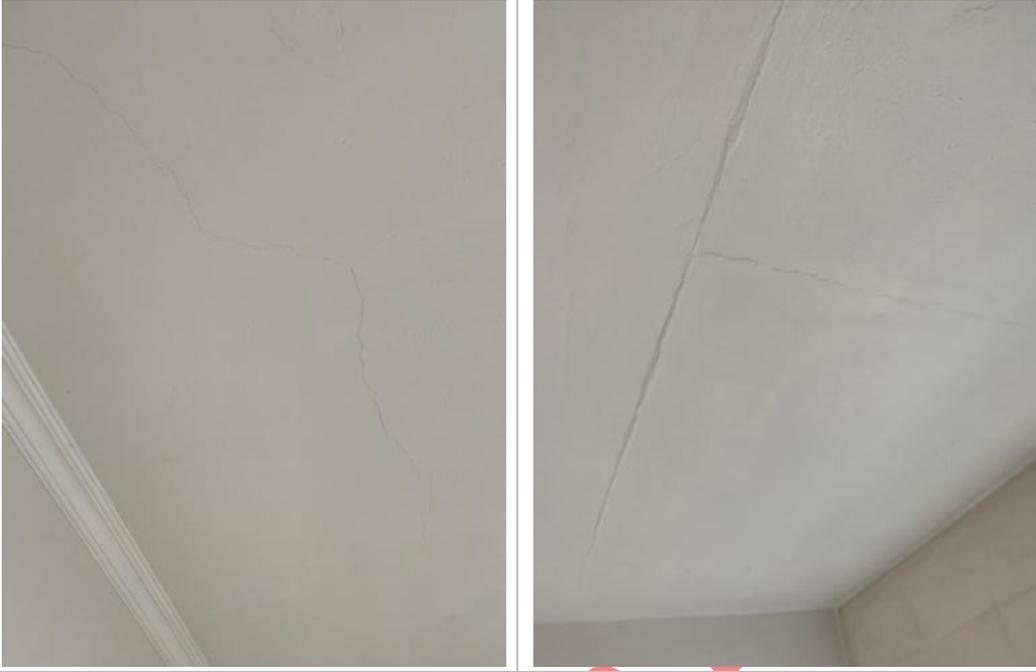
E2	Ceilings	2
<p>The ceilings are predominantly painted lath and plaster, with evidence of historic cracks and decorative imperfections consistent with the age and overall condition of the property; they are in average condition throughout.</p>

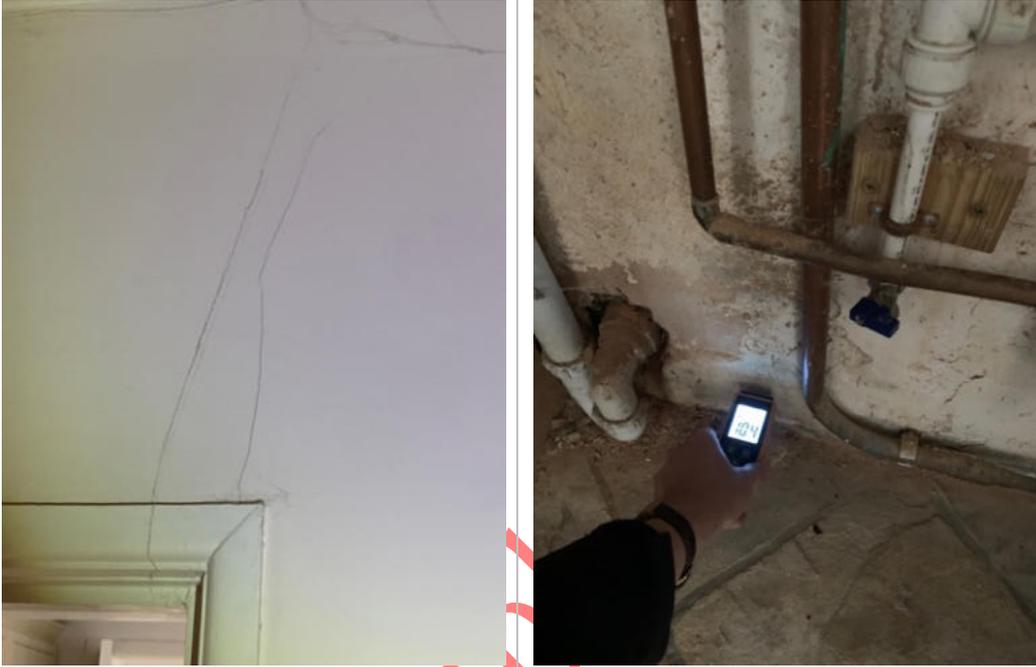
E3	Walls & Partitions	2
<p>The internal walls are predominantly skim plastered and painted lath and plaster, with evidence of historic cracks and decorative imperfections consistent with the age and overall condition of the property; they are in average condition throughout.</p>		
<p>There was no evidence of structural movement or moisture penetration, and all sample damp meter readings to the perimeter walls at ground floor level tested dry.</p>

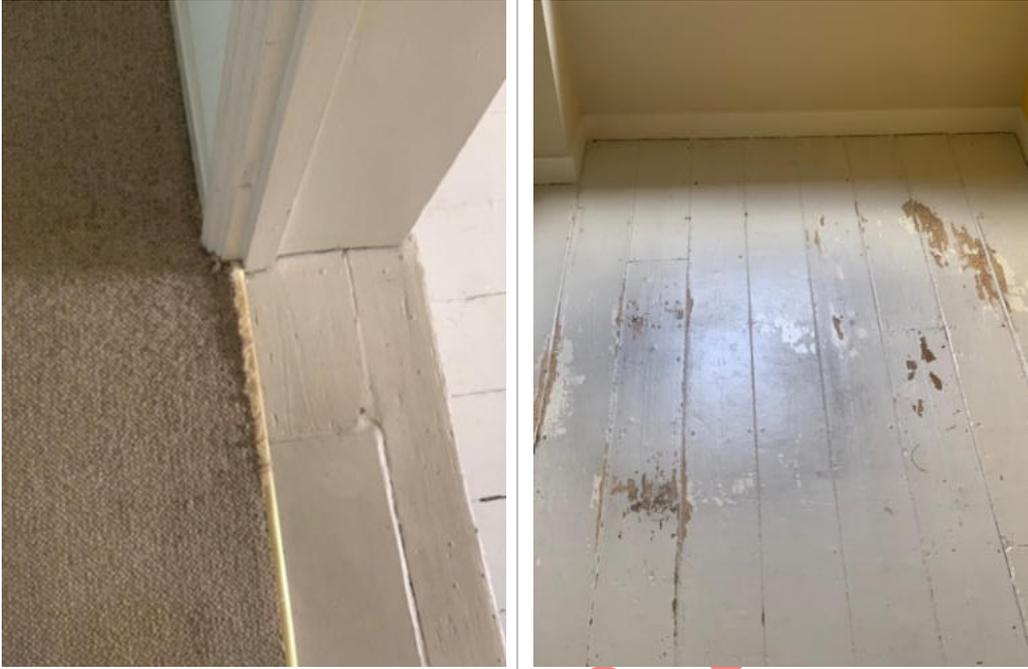
The carpets, tiles, and floor finishes throughout the property were generally in dated condition and would benefit from renewal.

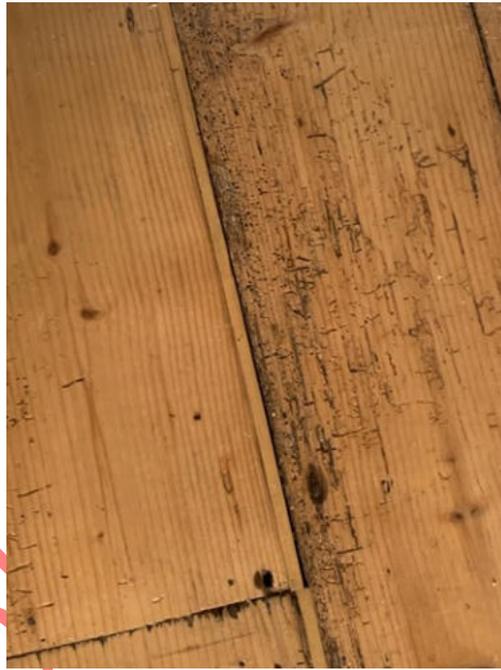
We found signs of historic wood boring beetle (woodworm) infestation, which is common in older properties. Historic woodwork is susceptible to attack in concealed areas such as floor voids and roof spaces, and it is impossible to inspect all areas without, for example, taking the floors up, which is outside the scope of this report. You may therefore consider it prudent to instruct a timber specialist to report specifically on this issue. We suggest any appointed firm are a member of the Property Care Association (PCA) and that you ensure all remedial work is carried out under a long term and meaningful (e.g. insurance-backed) guarantee. Any guarantees or warranties for treatment works already undertaken should also be obtained.

Ditto left

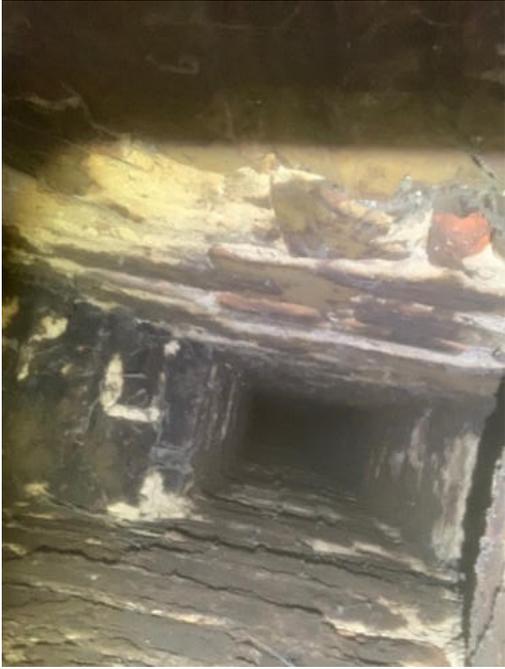
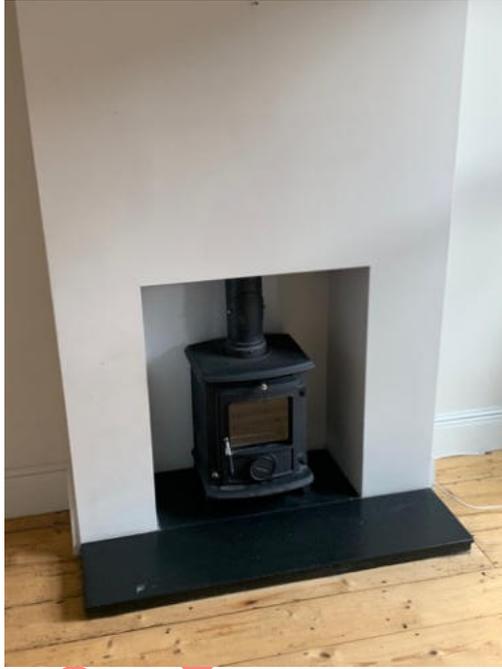
We cannot comment on the condition or adequacy of flues or the existence of any flue liners, but always recommend careful sweeping prior to usage. There is a wood burner present which was not tested. **Condition Rating NI.**

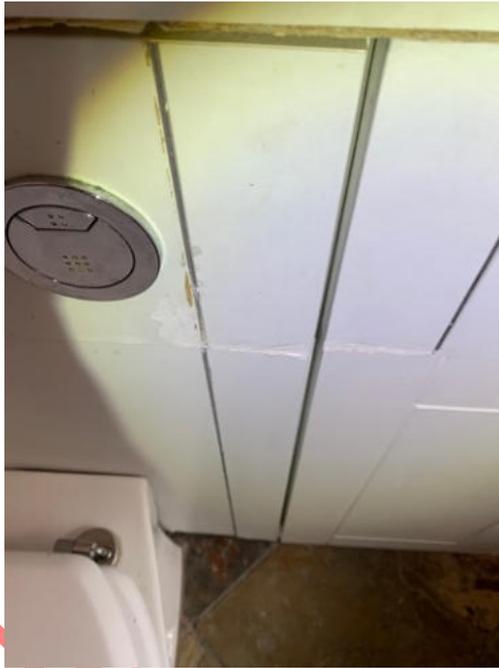
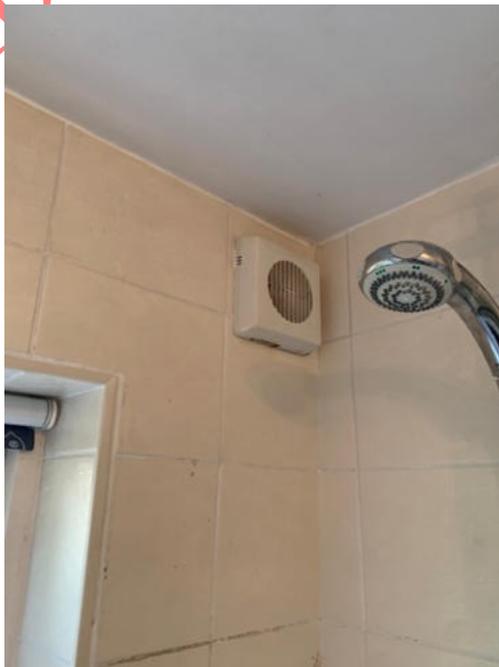
The bathroom is fitted with dated sanitaryware and is in generally average condition. Some sealants around the edges of sanitaryware were in poor condition and should be replaced as they can leak and damage adjacent surfaces. If not repaired quickly, wood rot can soon develop. There is damage to joinery and some areas are poorly finished. Mechanical ventilation is present and was functioning correctly during our inspection.

Stair handrail; urgent/hazard (see E7)
Rear door lock rebate (see D6)
Boundary repairs to front (urgent) and rear (see G3)
Works at height including repairs to chimney, roof (including some structural timbers), guttering, fascia (see D1, D2, D3, D8, and E1)
Repairs to render, install bell drip, upgrade subfloor ventilation (see D4 and E4)
Localised repair and redecoration to windows and doors (see D5 and D6)
Install party walls at loft level to #51 side, structural repairs to #47 side (see E1)
Localised repairs to kitchen, re-site plugs (see E6)
Replace flexible sealants to bathroom (see E8)

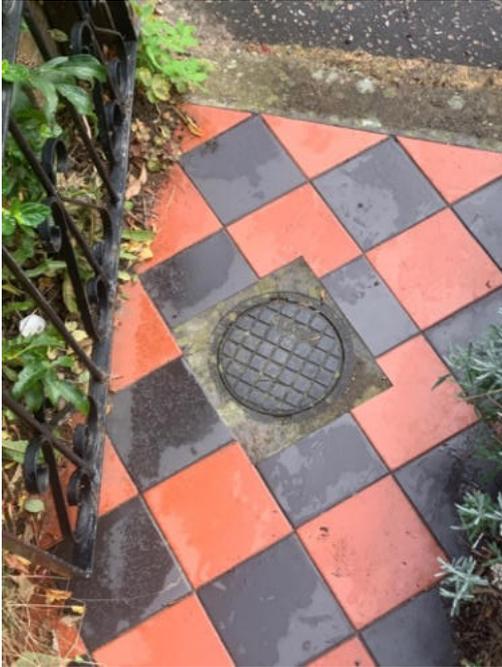
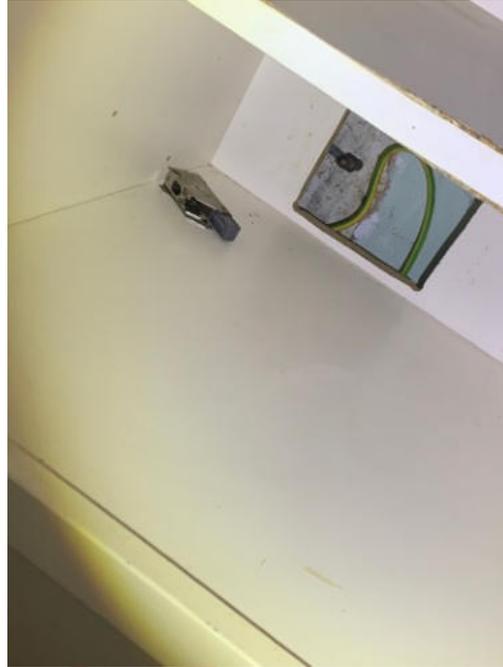
The water meter/shut-off valve are located in the front garden path. There is an internal stopcock located under the kitchen sink.

Safety warning: Water regulations change regularly and often, and it was not possible to confirm if all the plumbing systems conform to current regulations. We recommend that specific enquiry be made of the vendors through your solicitor to ascertain whether any alterations to the internal plumbing have been made, and if so to check that these were done by qualified and competent contractors. Outside taps should be insulated to prevent freezing in cold weather.

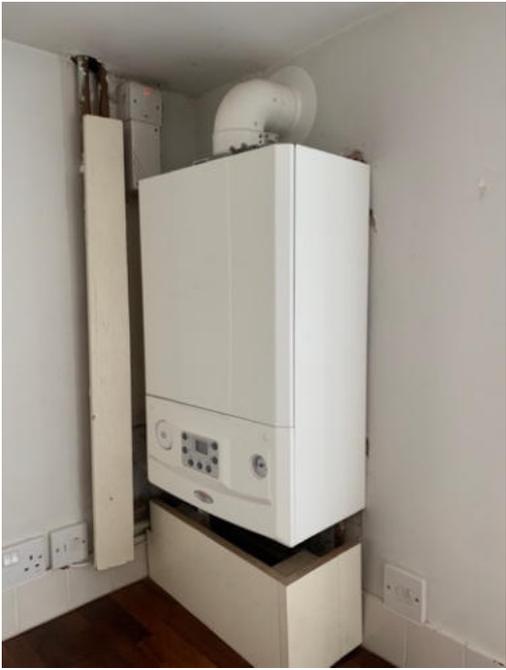
Heating is provided by a gas-fired combination boiler located in the kitchen.

Safety warning: We were unable to verify the output of the boiler and no calculations have been made to verify its adequacy. Furthermore, we were unable to verify if the boiler is correctly ventilated in accordance with current regulations.

All heating installations should be installed and serviced regularly (usually every year) by an appropriately qualified person. You should ask your legal advisor to confirm the validity of the gas/oil safety evidence provided (see section I).

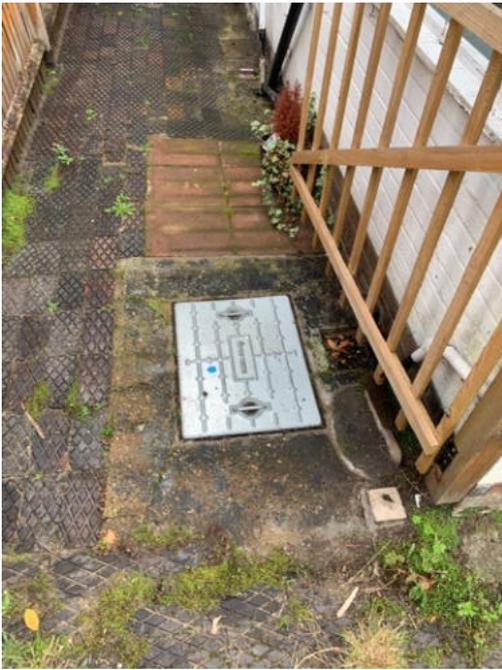
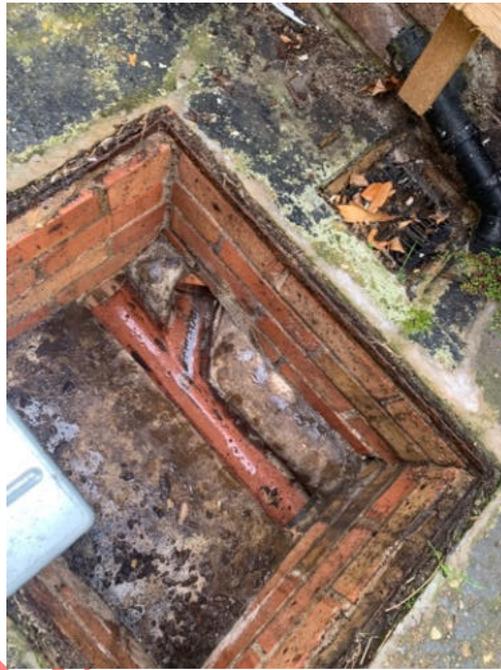
It was possible to raise 1# manhole cover on the site and drains inside the inspection chamber were clear, however, we are unable to comment on the efficacy or condition of the drainage system as a whole. If you have any doubts about the condition of the drains we recommend you have a CCTV drain survey undertaken.

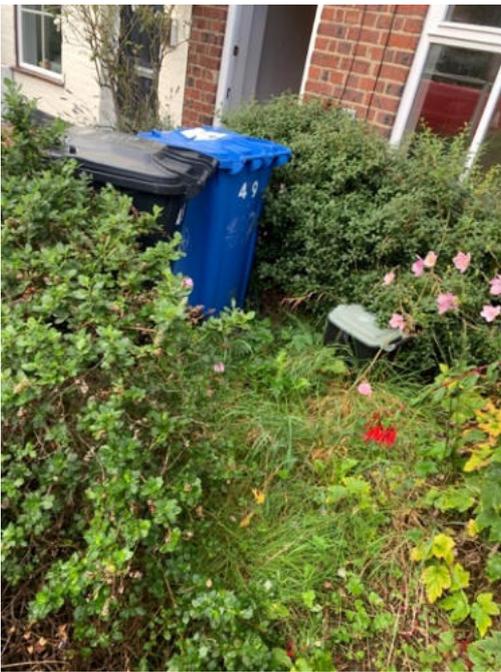
Parts of the grounds were in an overgrown state and therefore could not be inspected:
